Technical Bulletin

Subject: **Shifter Lever, Vibrating/Knocking**

Number: **99-04**

Model(s): **New Beetle, Golf, New Jetta with 02J Transmission**

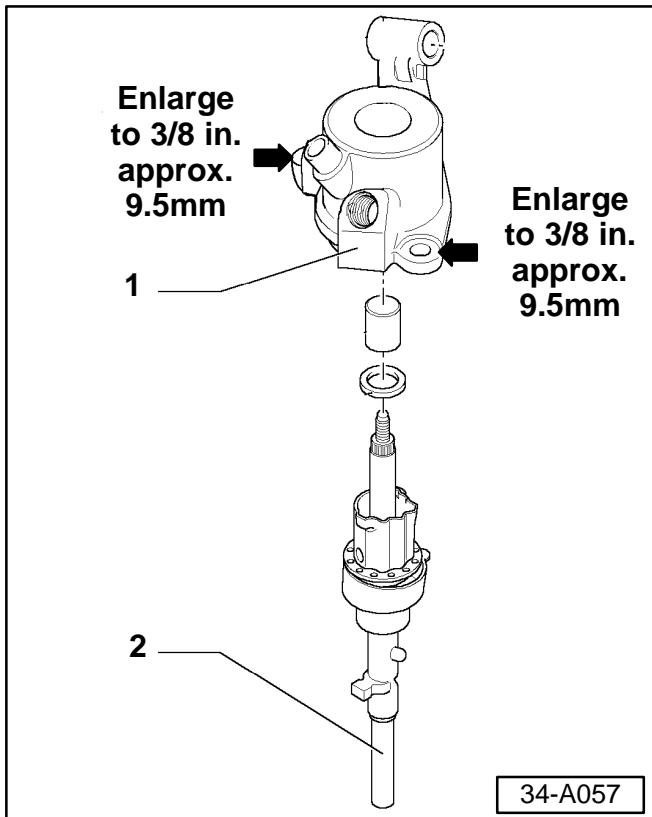
Shifter lever vibrating/knocking in 1st, 2nd, 3rd or 4th gears.

May be caused by transmission vibrations traveling through the selector shaft and shifter cables to the shifter lever.

- ◀ - Remove selector mechanism cover -1- from transmission, see Repair Manual "Gear Selector Mechanism (from 5/99), servicing".
- Remove selector shaft -2-, see Repair Manual "Transmission Selector Mechanism (from 5/99), disassembling and assembling".
- Enlarge both selector shaft housing attachment holes -arrows- to 3/8 in. (approx. 9.5mm).
- Install Part No: 02J 301 233C (selector shaft -2-) see Repair Manual "Transmission Selector Mechanism (from 5/99), disassembling and assembling".
- Reinstall selector mechanism cover -1- into transmission using sealant AMV 188 200 03 or equivalent.
- If necessary adjust Shift cables see "Gear Selector Mechanism (from 5/99), servicing".

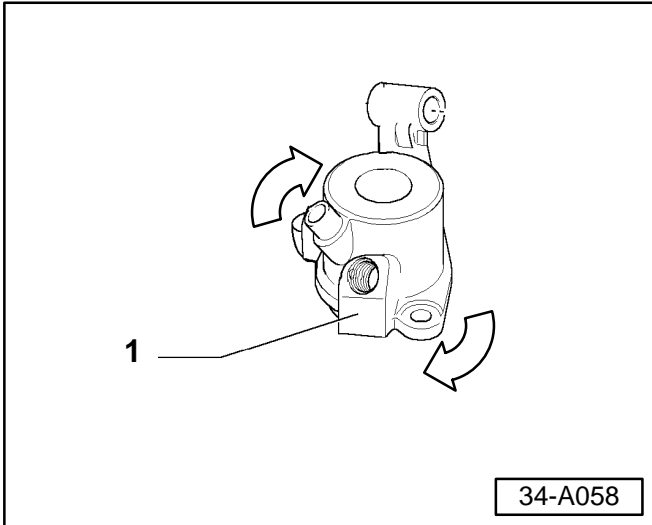
Vibration/knocking from 1st or 3rd gear:

- Loosen selector mechanism.

- ◀ - Turn housing -1- right (clockwise as far as possible).
- Tighten selector mechanism bolts to 25 Nm. (18 ft. lb.).

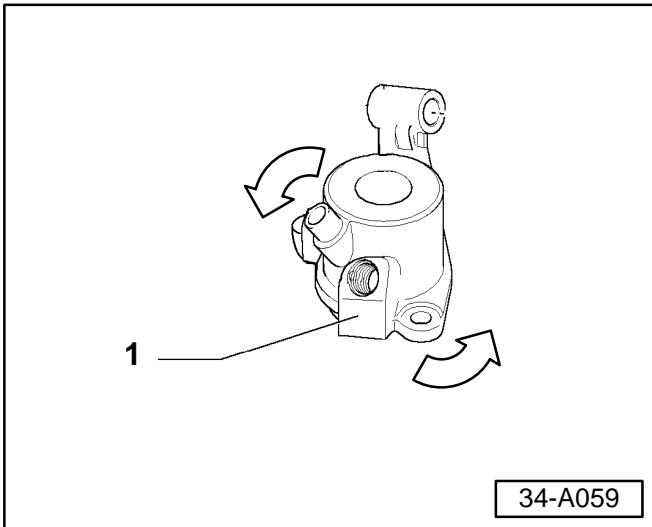
Vibration/knocking from 2nd or 4th gear:

- Loosen selector mechanism.

- ◀ - Turn housing -1- left (counter clockwise as far as possible).
- Tighten selector mechanism bolts to 25 Nm. (18 ft. lb.).
- Road test vehicle.
