Thread: HOW TO: Oil Separator R&R

I wrote this guide on how to replace your oil separator as this appears to be a persistent issue on 2013 S6/S7 cars, particularly ones that are just outside warranty, like mine (53k miles). The symptoms are described in TSB 2040644/8, detailed below from the erWin website:
Instructions for use

Technical Service Bulletin Transaction No.: 2040644/8

17 MIL on; whistling noises from engine compartment

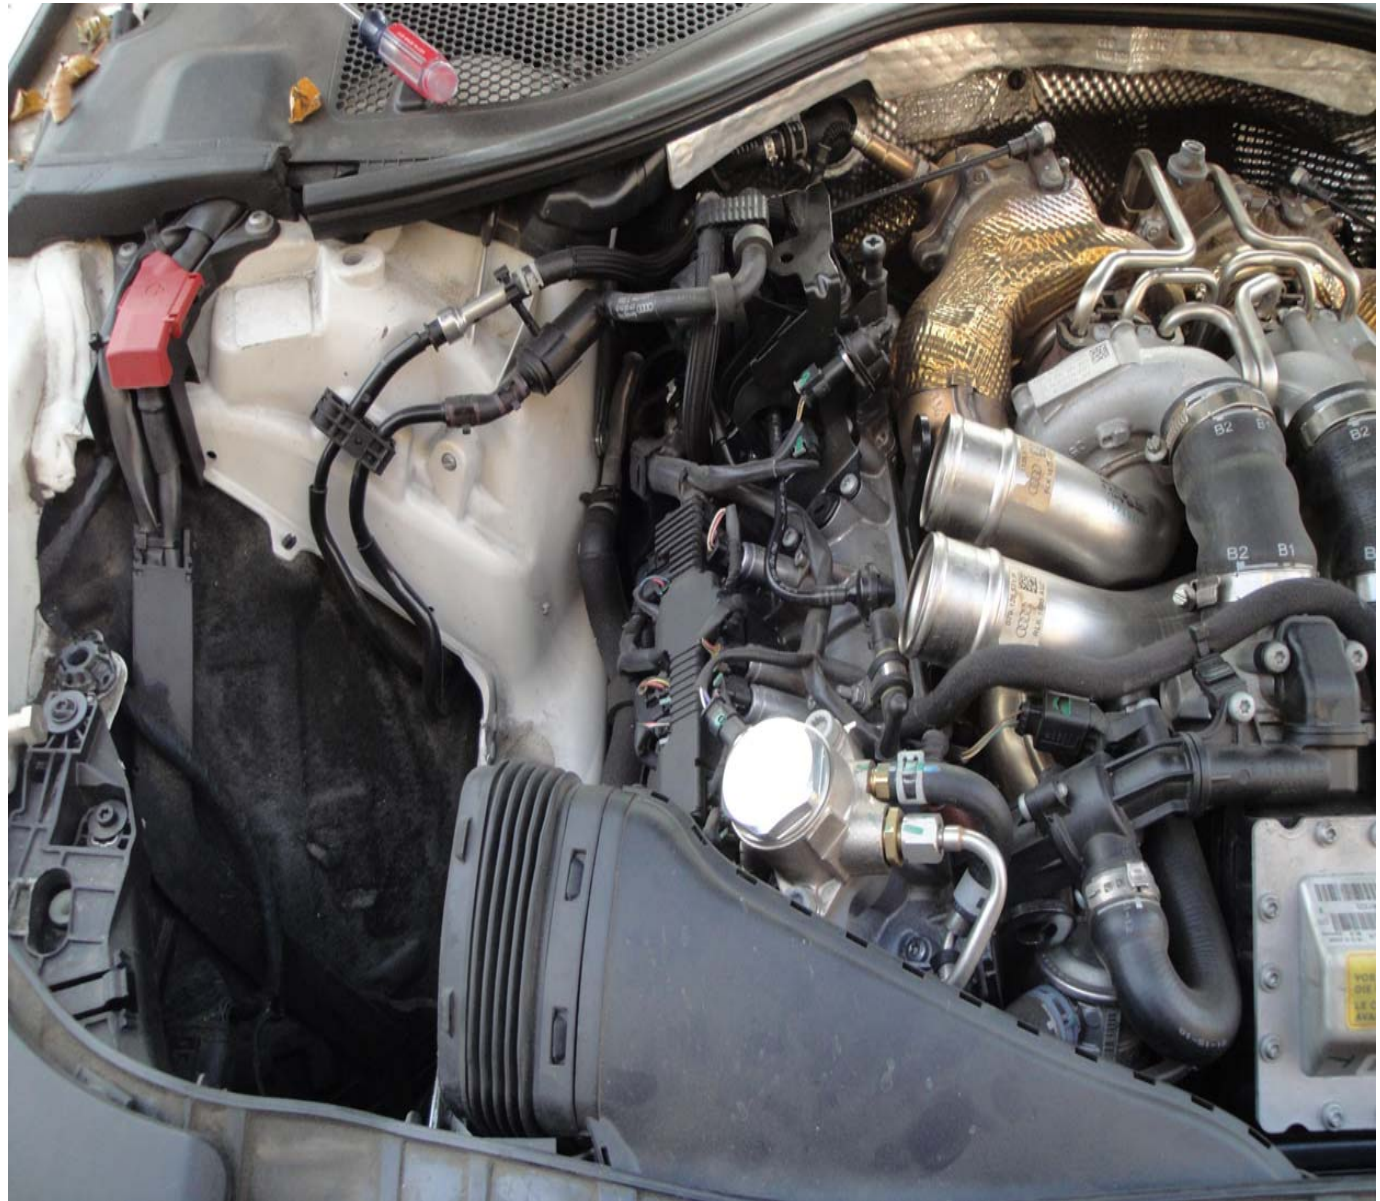
Step 1: Get your car on the ramps and remove the engine cover, airbox, and airbox-to-turbo inlet accordion hoses. Insert shop towels into turbo inlets to ensure no dirt/debris gets into them:

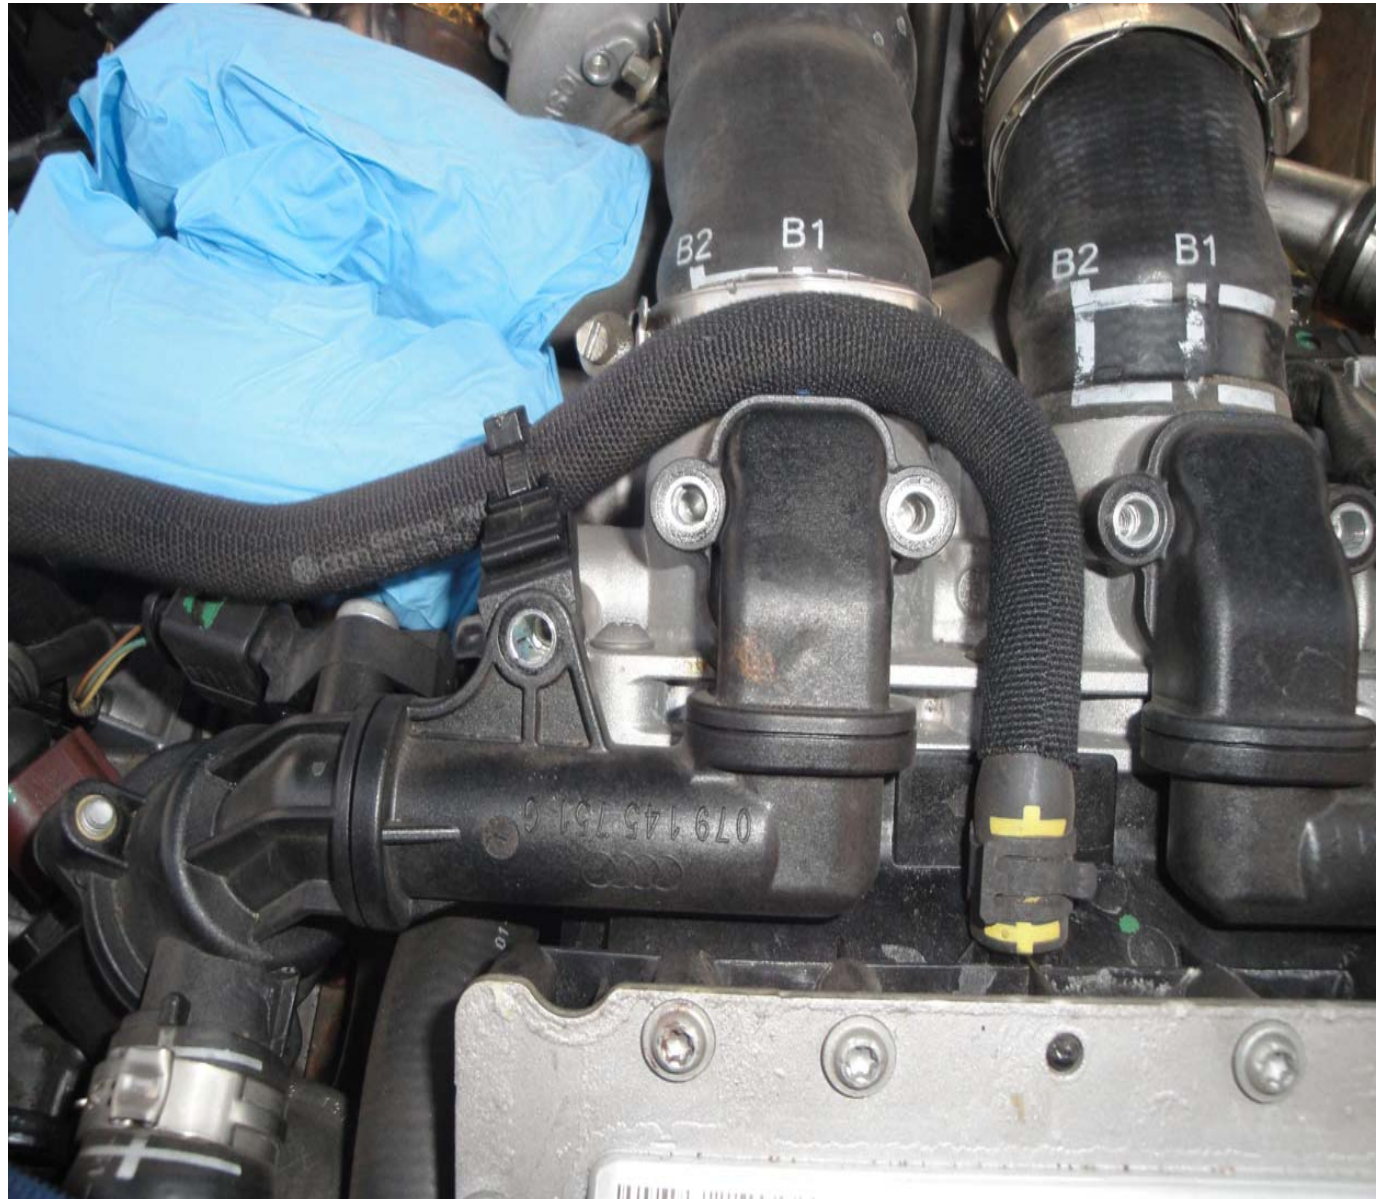
Step 2: Use compressed air to blow off the throttle body area of debris. Using a T30 Torx, remove the three bolts from the driver's side bypass valve-to-throttle body connection (The longer bolt goes on the outside):

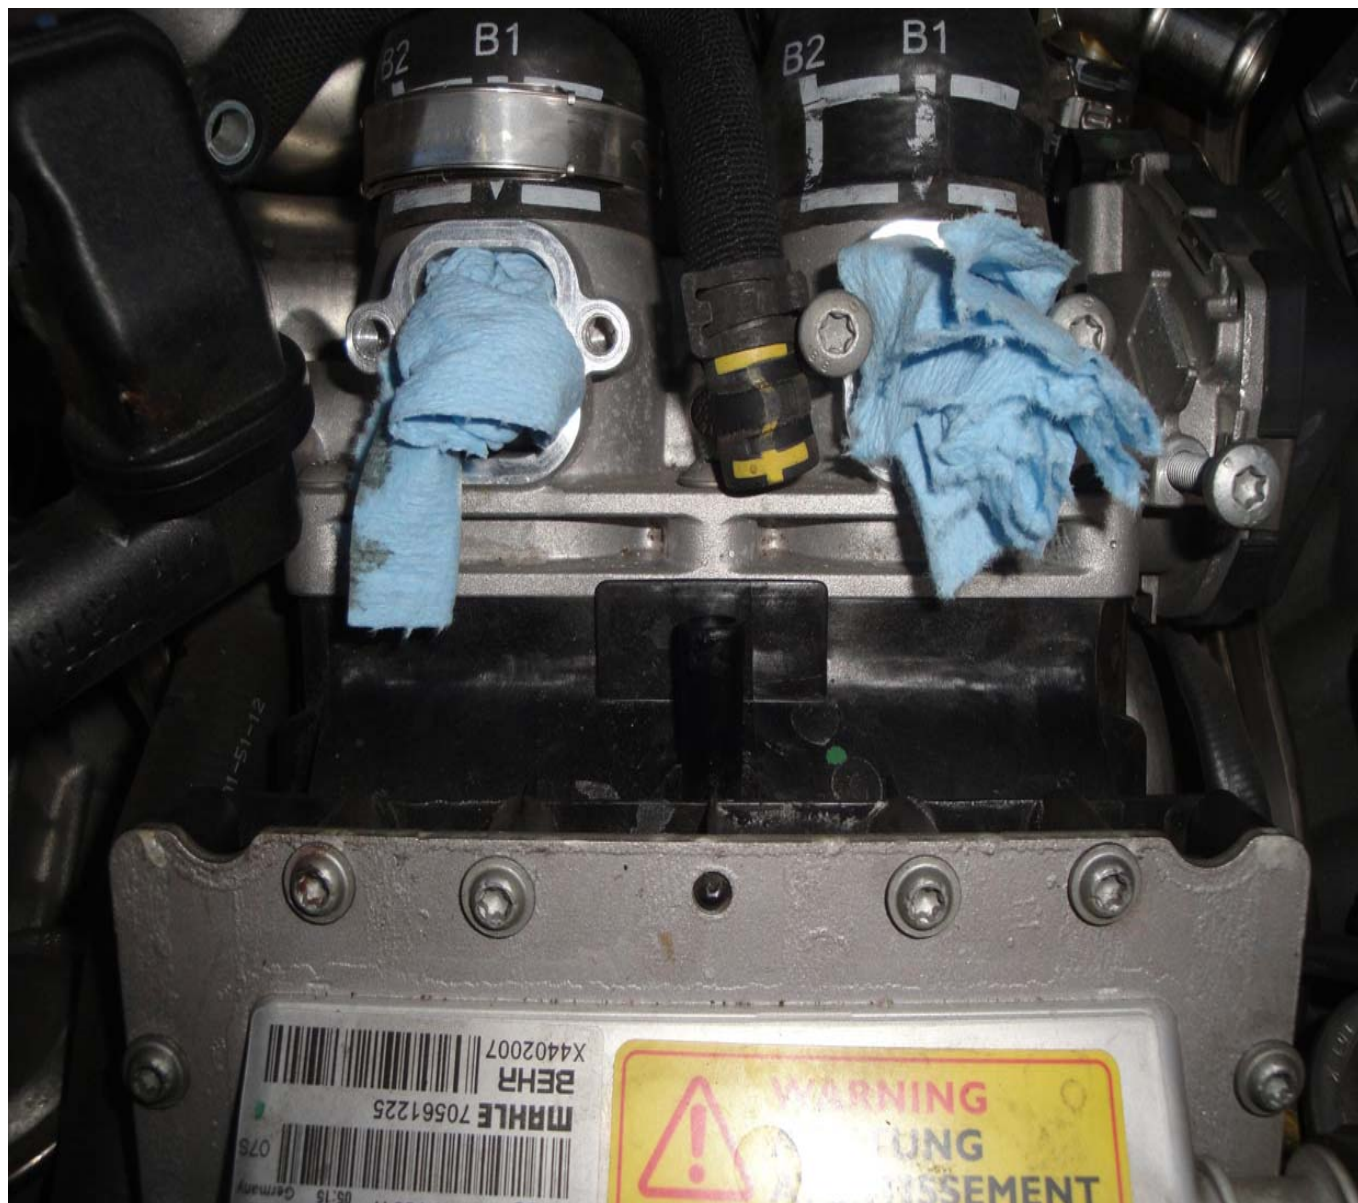
Step 3: Do the same for the passenger side. Insert shop towel to ensure no debris goes into the holes:

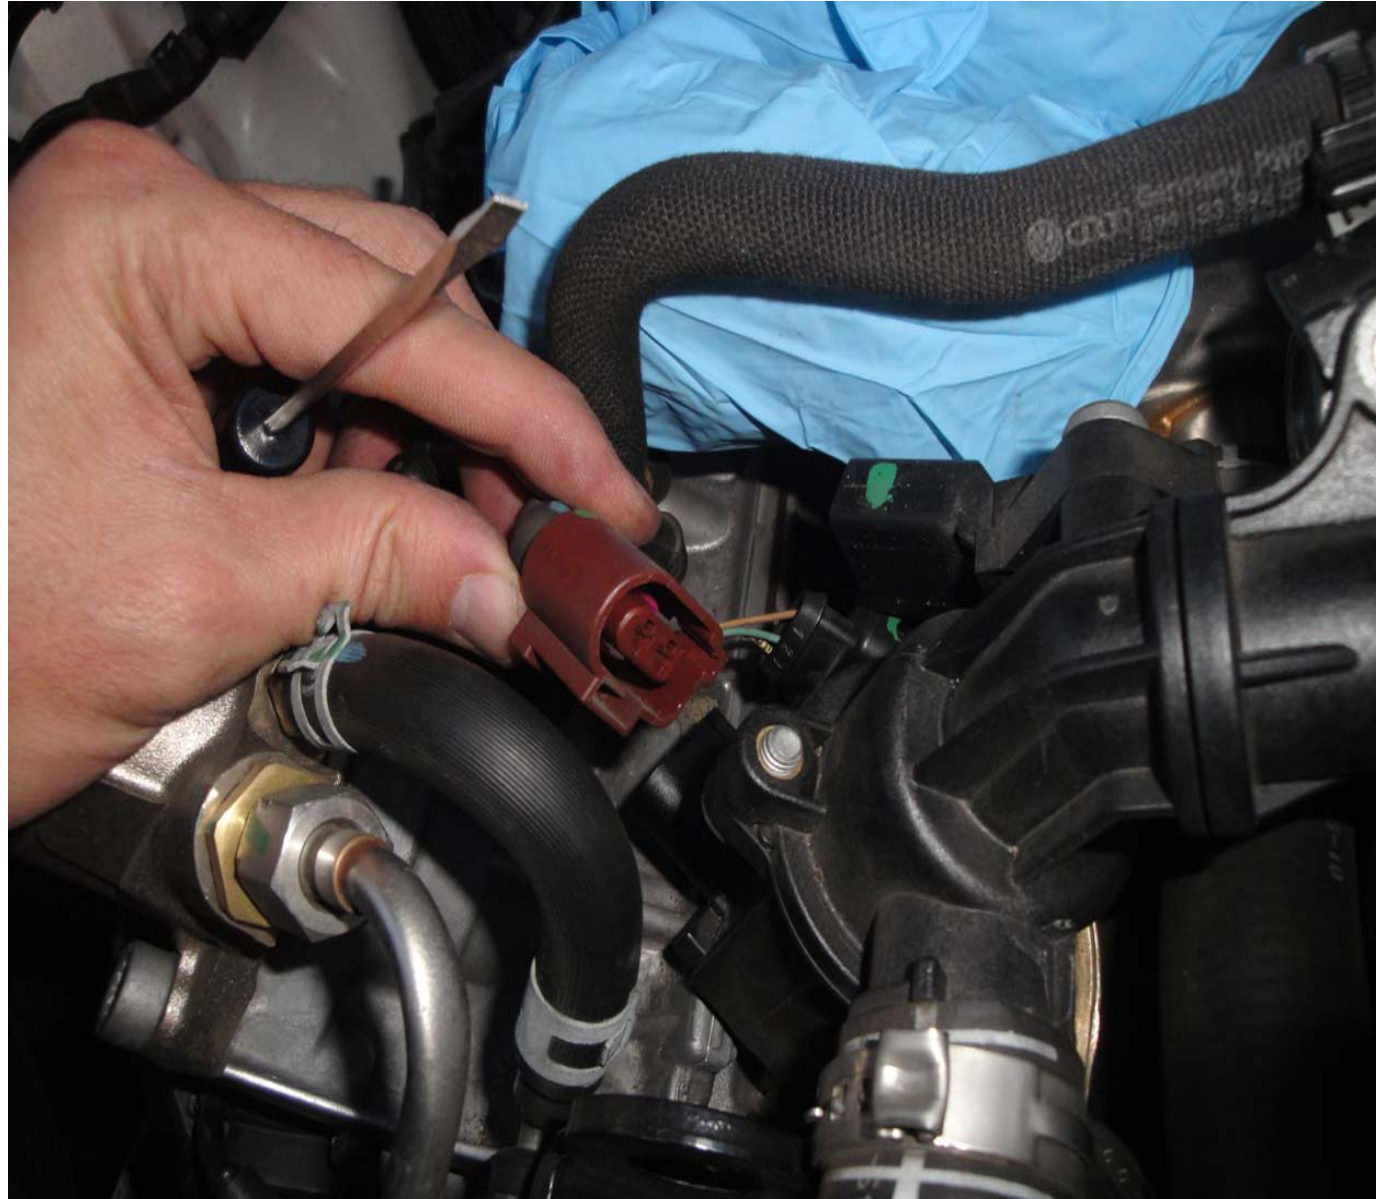
Step 5: Disconnect the black and brown connectors from the bypass valve assembly on each side:

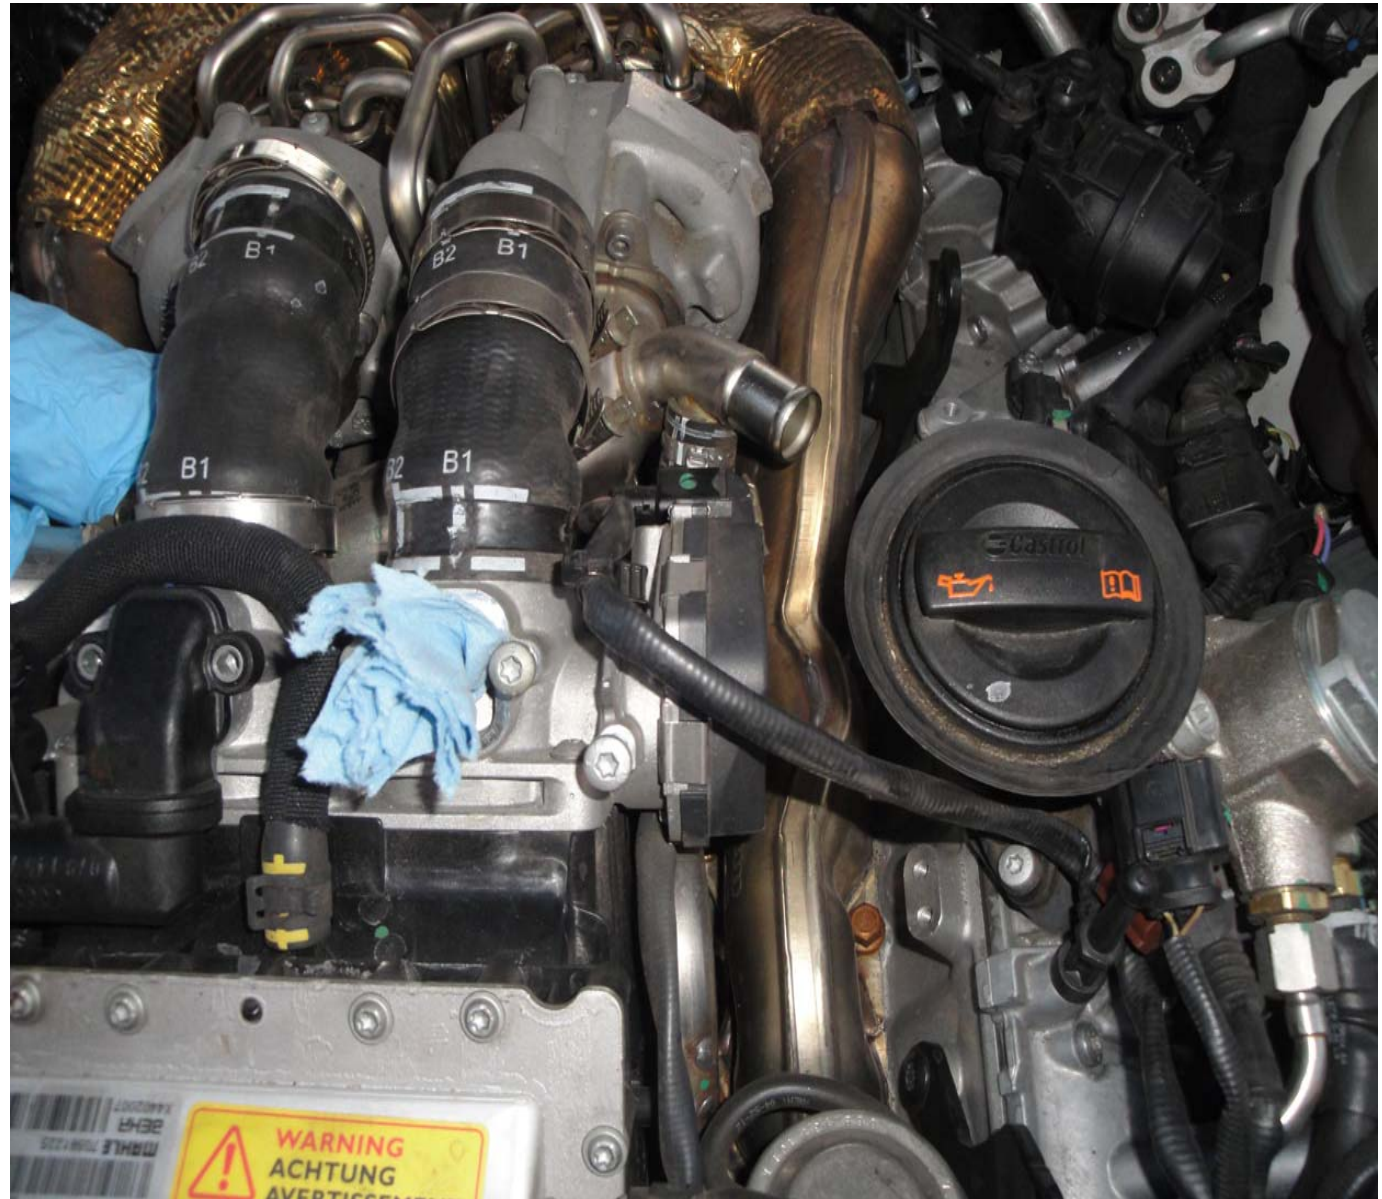
Step 6: Using a screwdriver and some anger, remove the clamp from the turbo inlet-to-bypass valve on the driver's side. Then, remove the bypass valve assembly from the driver's side:

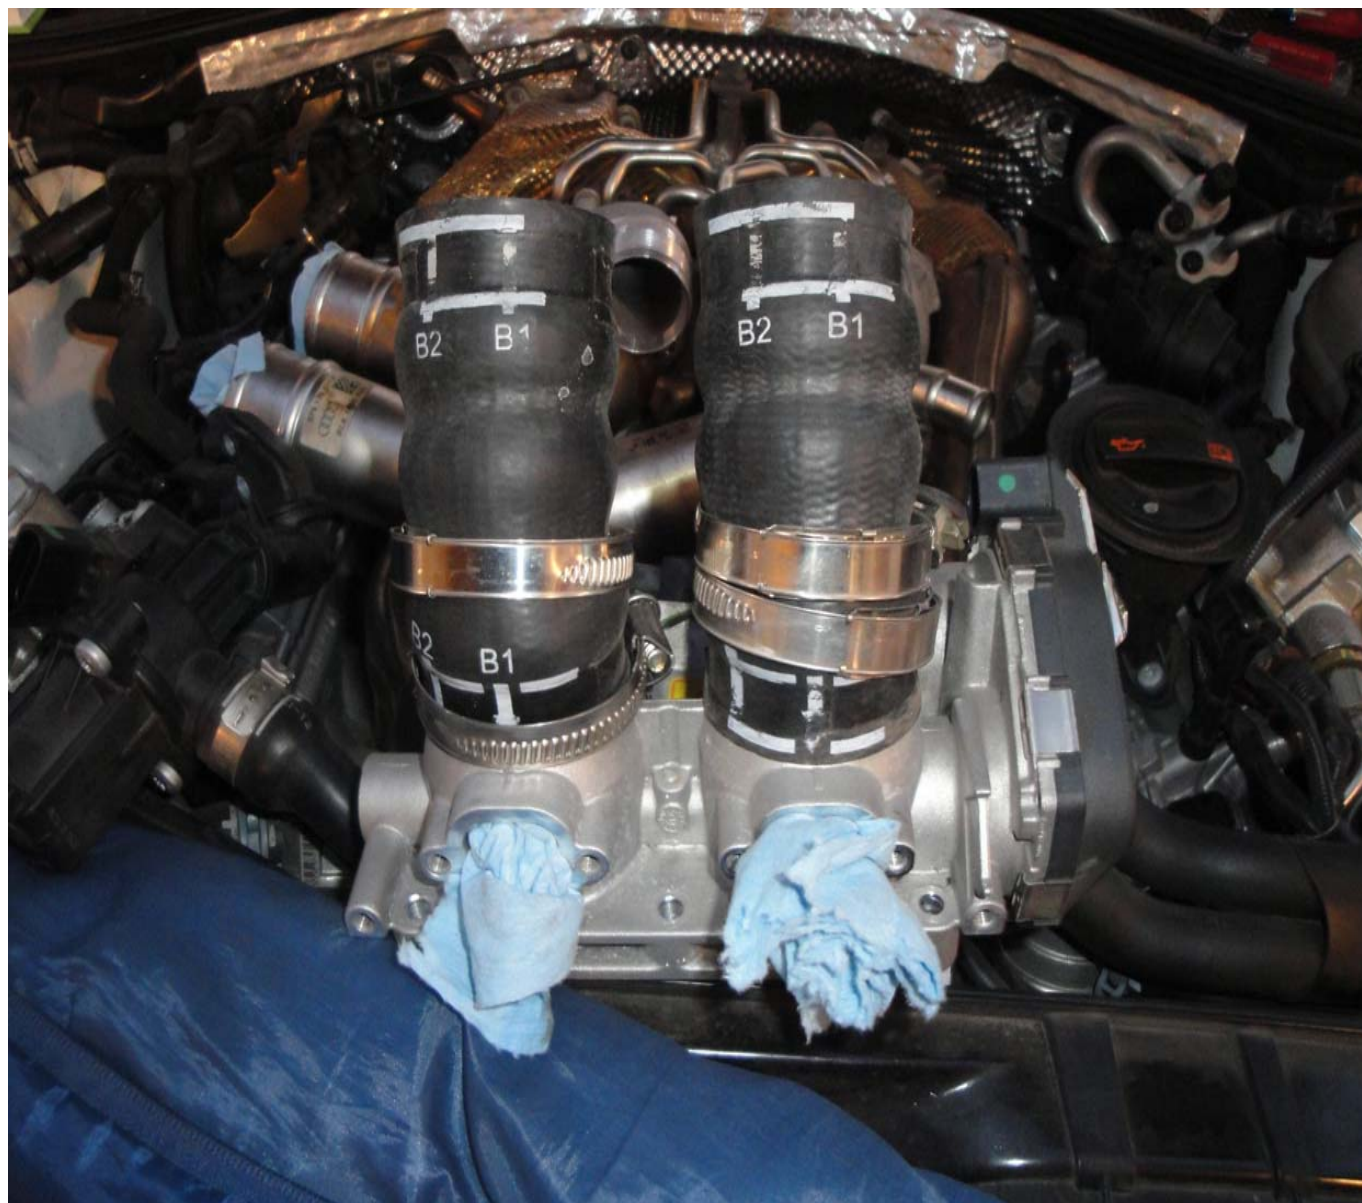
Step 8: Using a T30 Torx bit and extension, remove the 6 screws holding the throttle body to the intercooler:

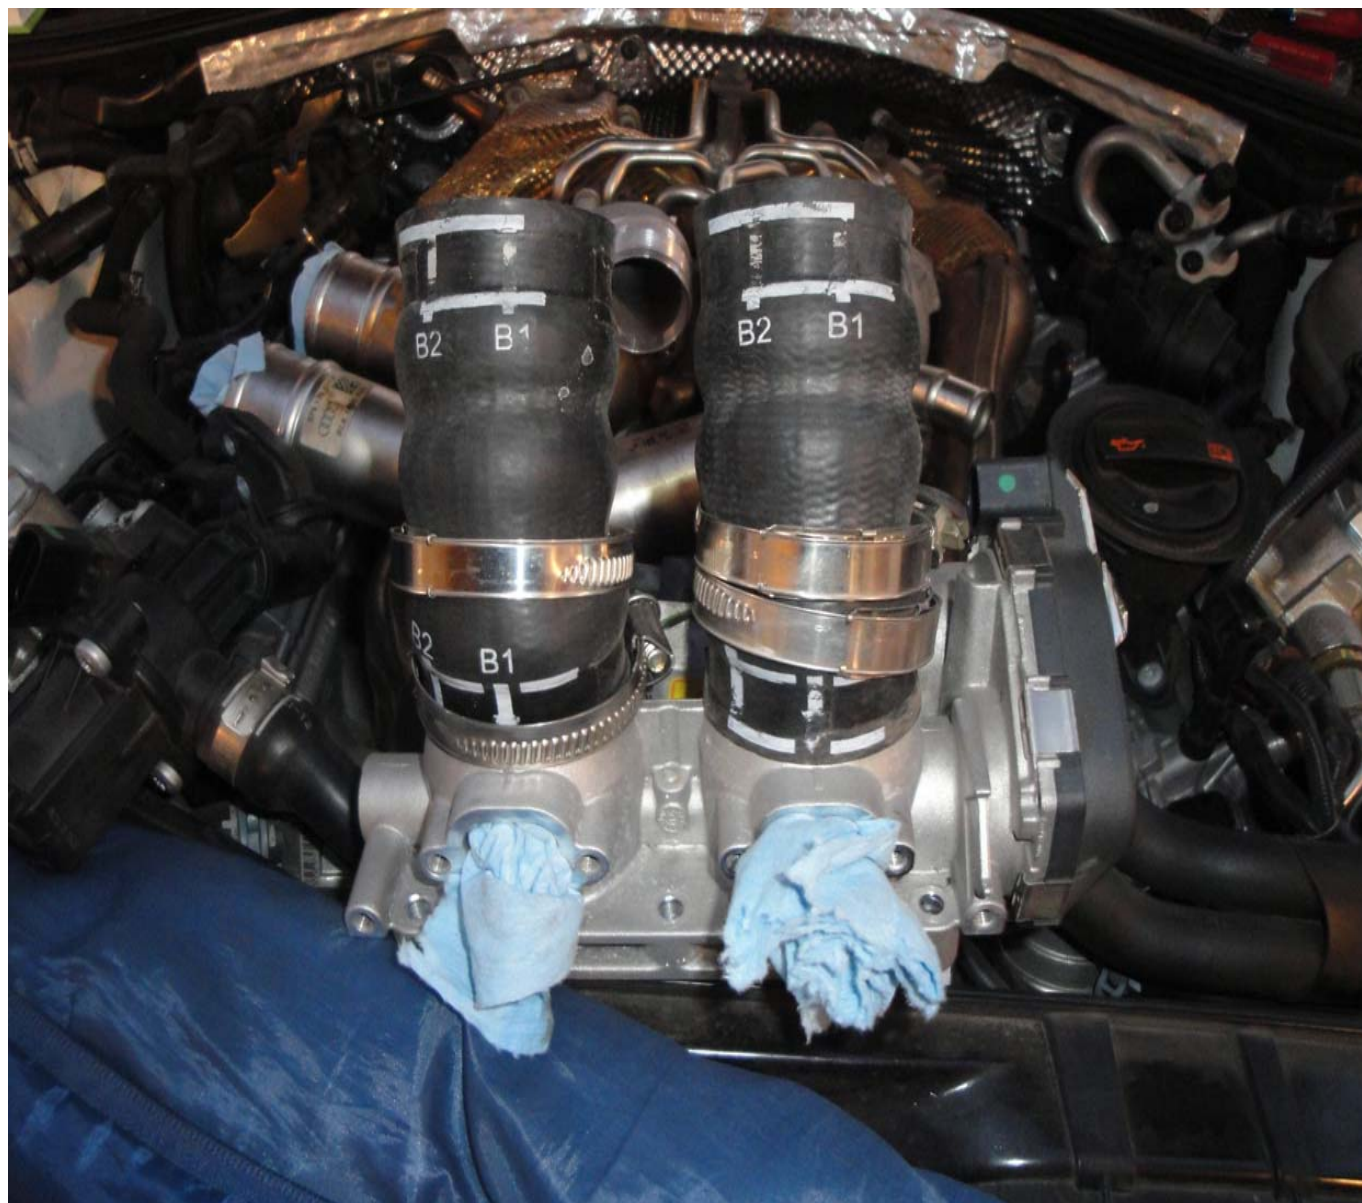
Step 9: Using a hose tool to wedge under the hose, loosen the turbo-to-throttle body hoses. Push the throttle body aft a bit, then lift up over the little lip on the intercooler, then forward to remove the throttle body. Before you can remove the throttle body, there are two sensors on the underside. Pull the grey tabs up, then push in to release both connections. The one with the green wire goes on the passenger side, brown wire on the driver's side):

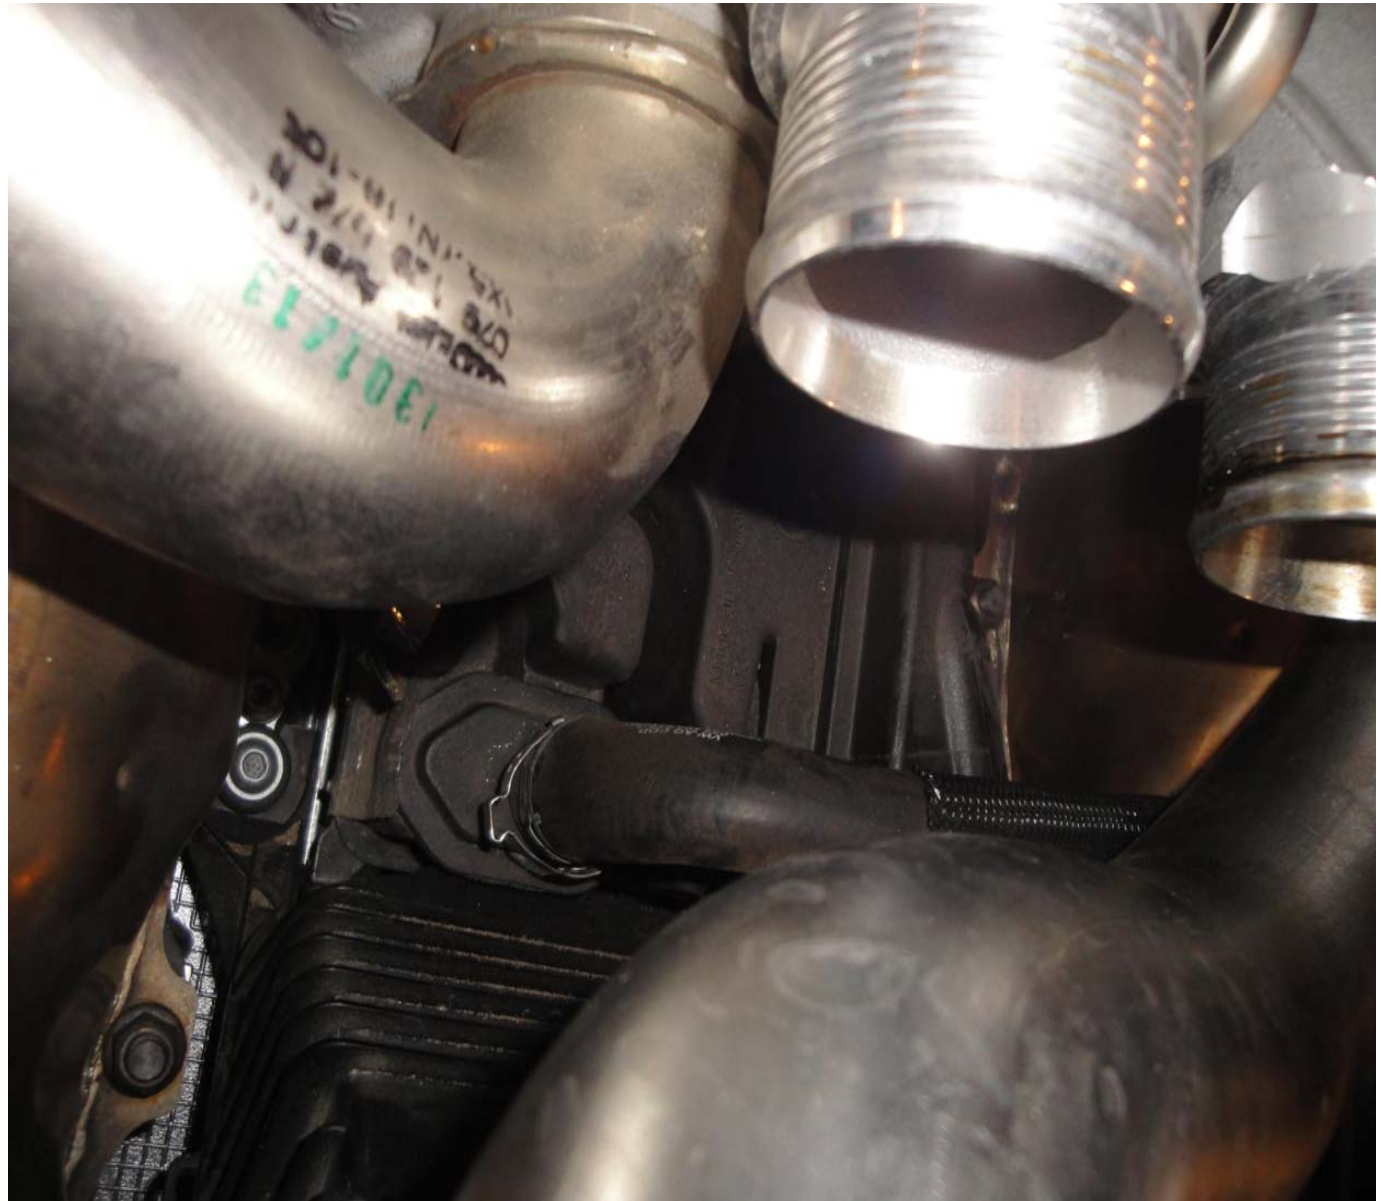
Step 11: Using a screwdriver and a bit more anger, loosen the tube connecting the driver's side turbo inlet to the oil separator. Remove the tube and the entire bypass valve/turbo inlet assembly should be free:

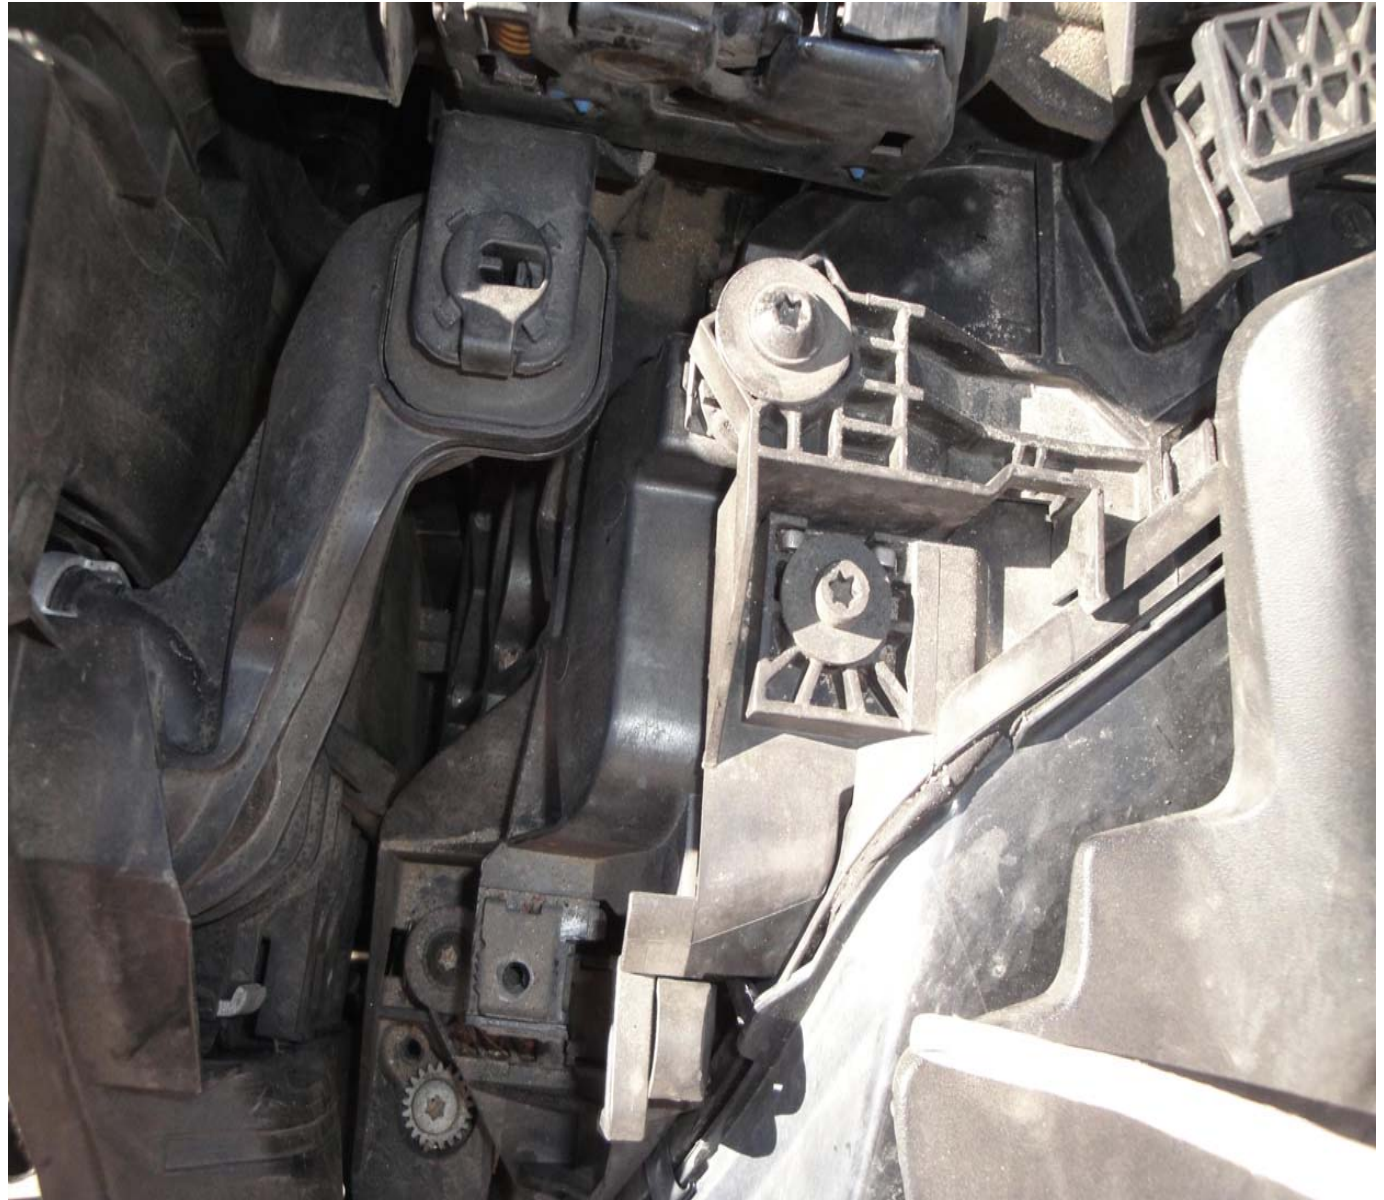
Step 15: Remove the bolts that hold the bumper to the lock carrier between the grill and headlight. One on each side:

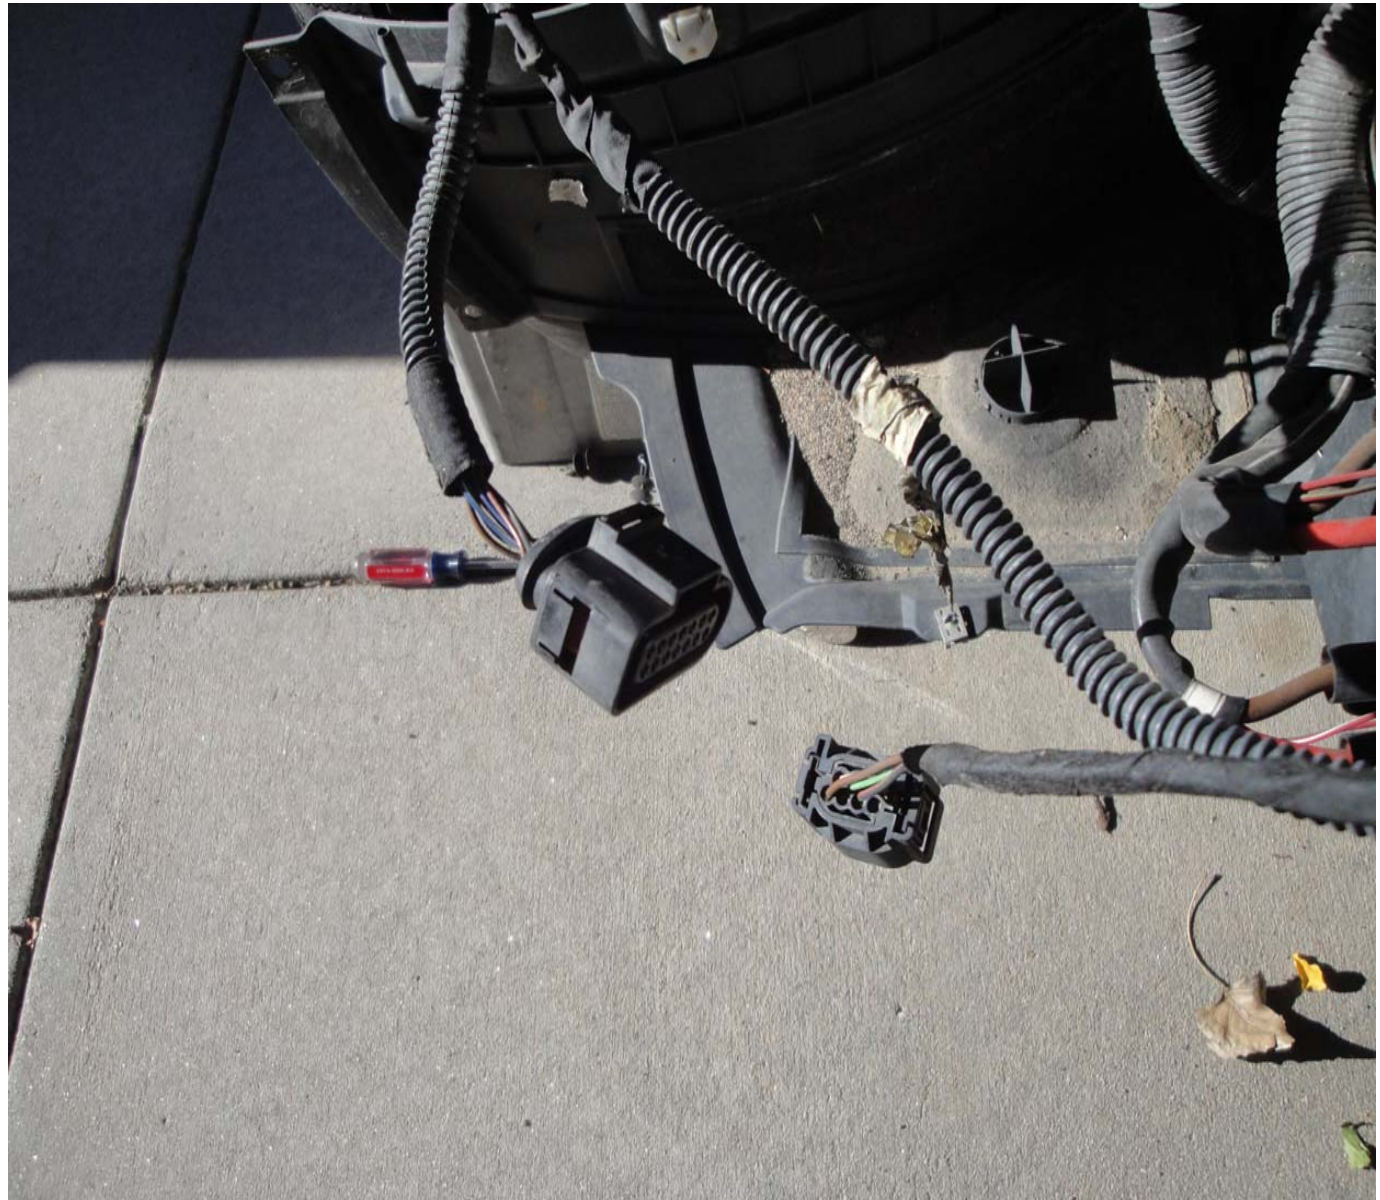
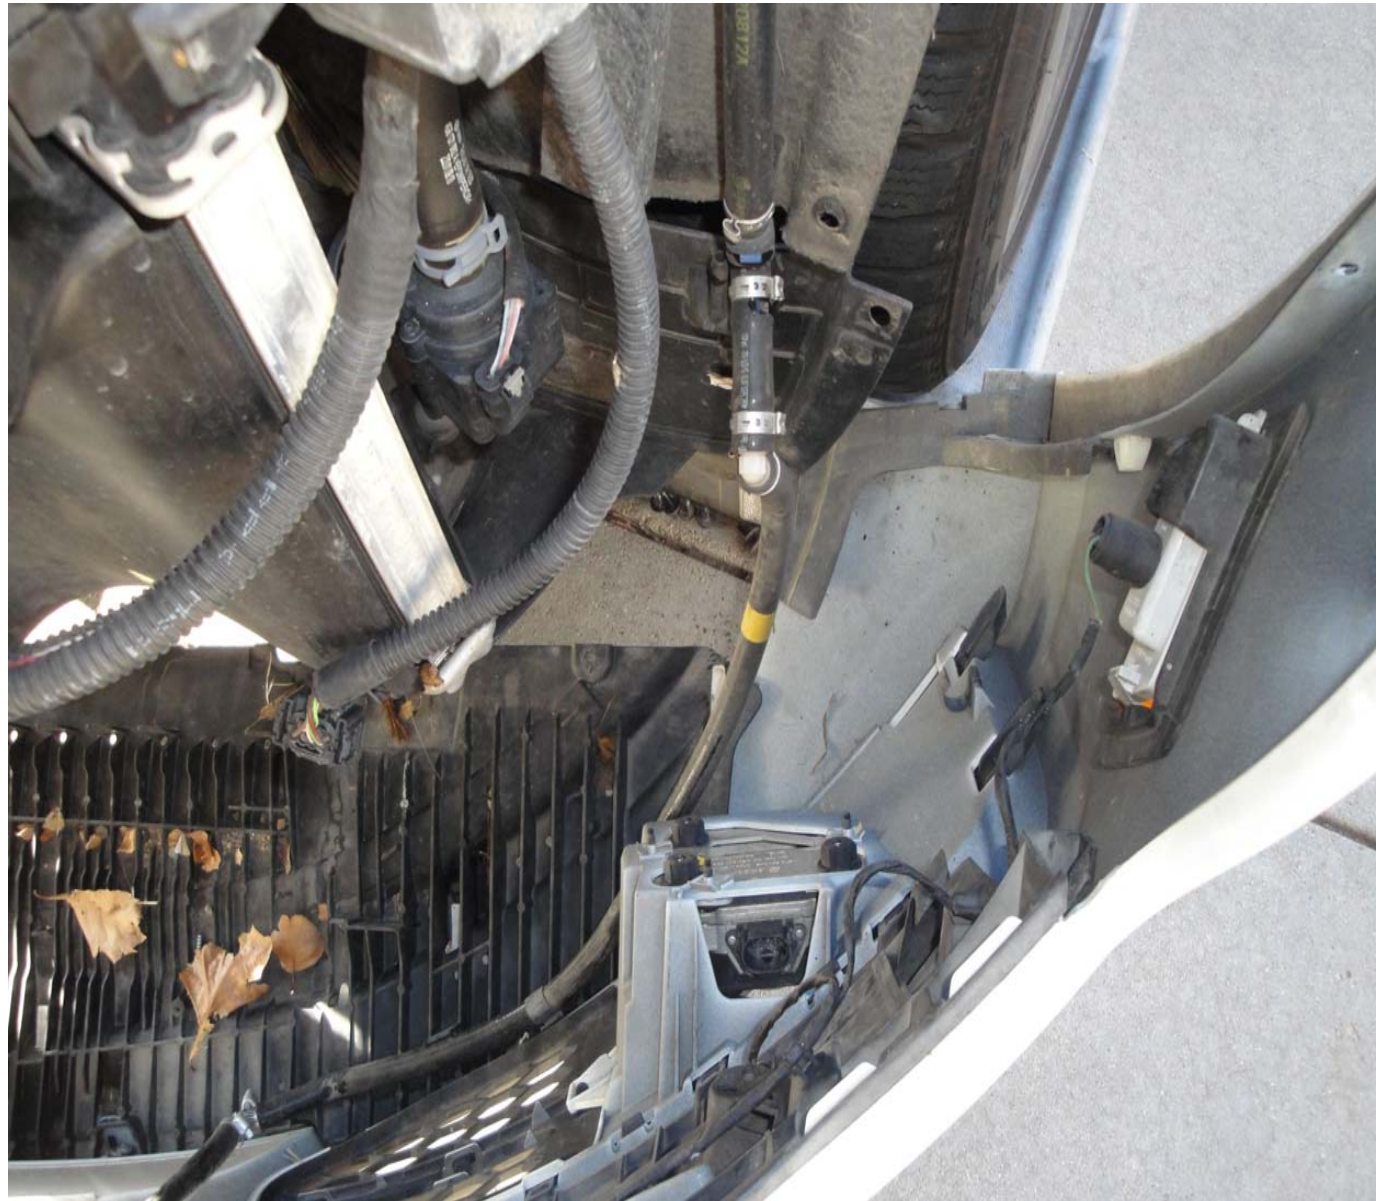
Step 18: Disconnect the front camera, night vision, and some electronics box from behind the Audi emblem. Slowly lift and pull forward the bumper. Exposing a gap between the bumper and headlights, reach down and disconnect the ACC sensors on each side, as well as a connector below where the passenger headlight was. Finally, with the help of a friend, remove the blue clip from the headlight and night vision washers, then unplug the hose, attempting poorly to cap off the torrent of washer fluid going onto your shoe. Remove the bumper:
