Thread: HOW TO: Oil Separator R&R

I wrote this guide on how to replace your oil separator as this appears to be a persistent issue on 2013 S6/S7 cars, particularly ones that are just outside warranty, like mine (53k miles). The symptoms are described in TSB 2040644/8, detailed below from the erWin website:
Instructions for use

Technical Service Bulletin Transaction No.: 2040644/8

17 MIL on; whistling noises from engine compartment

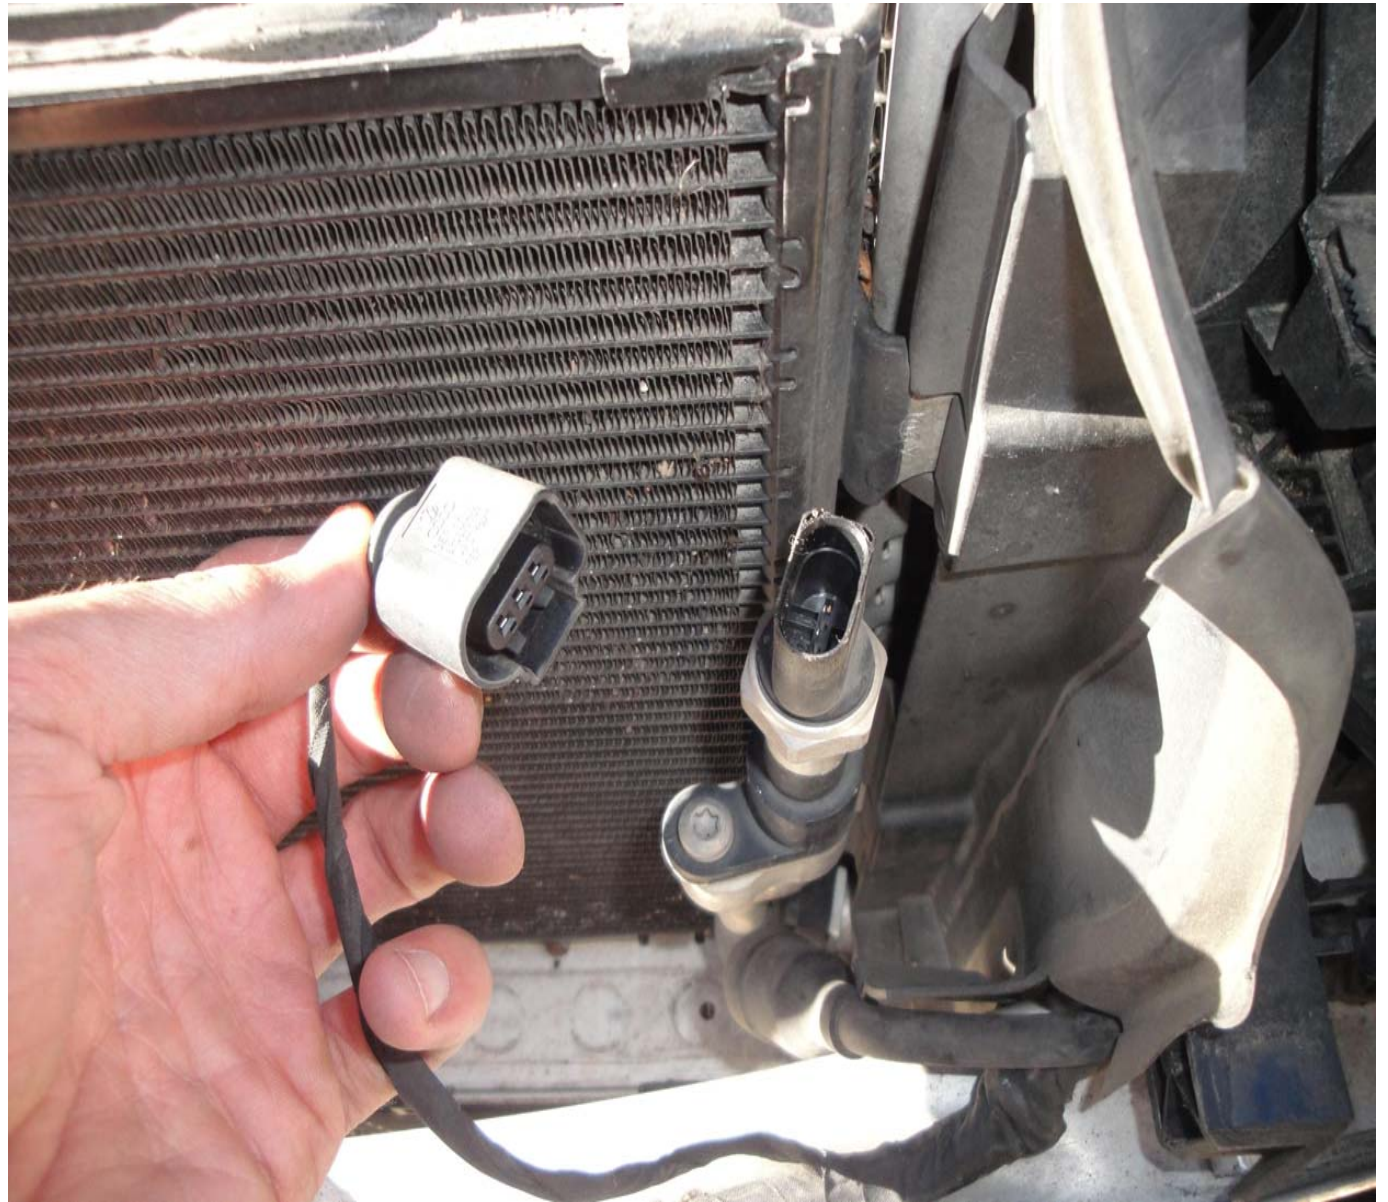
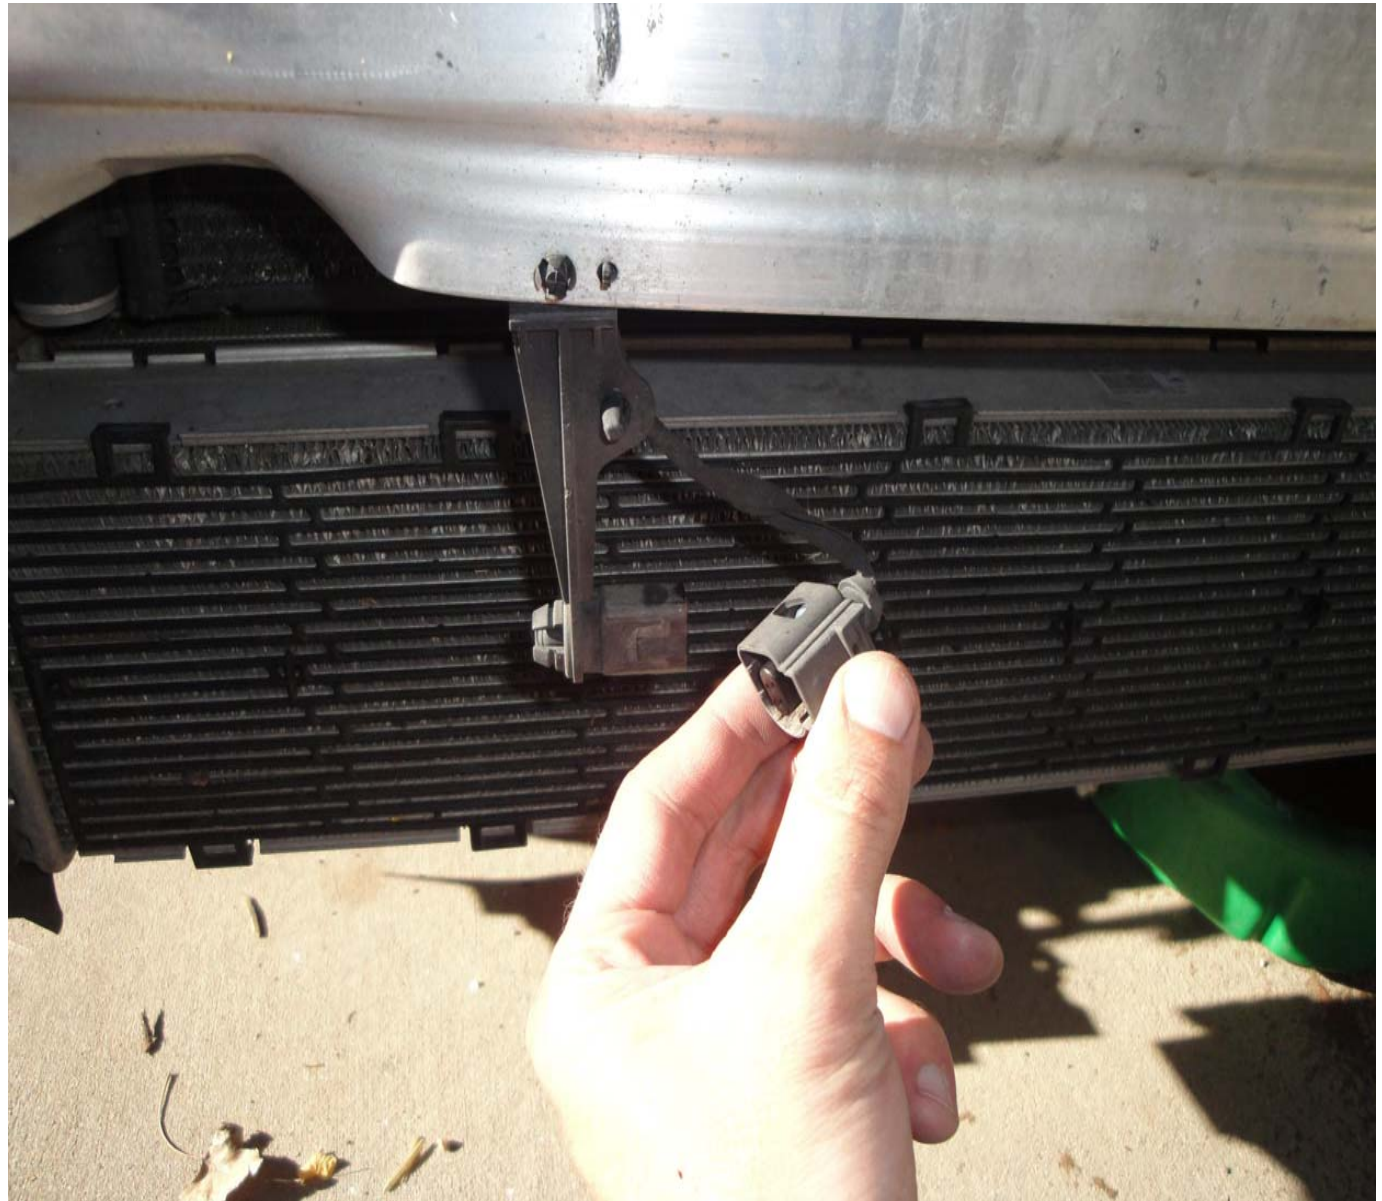
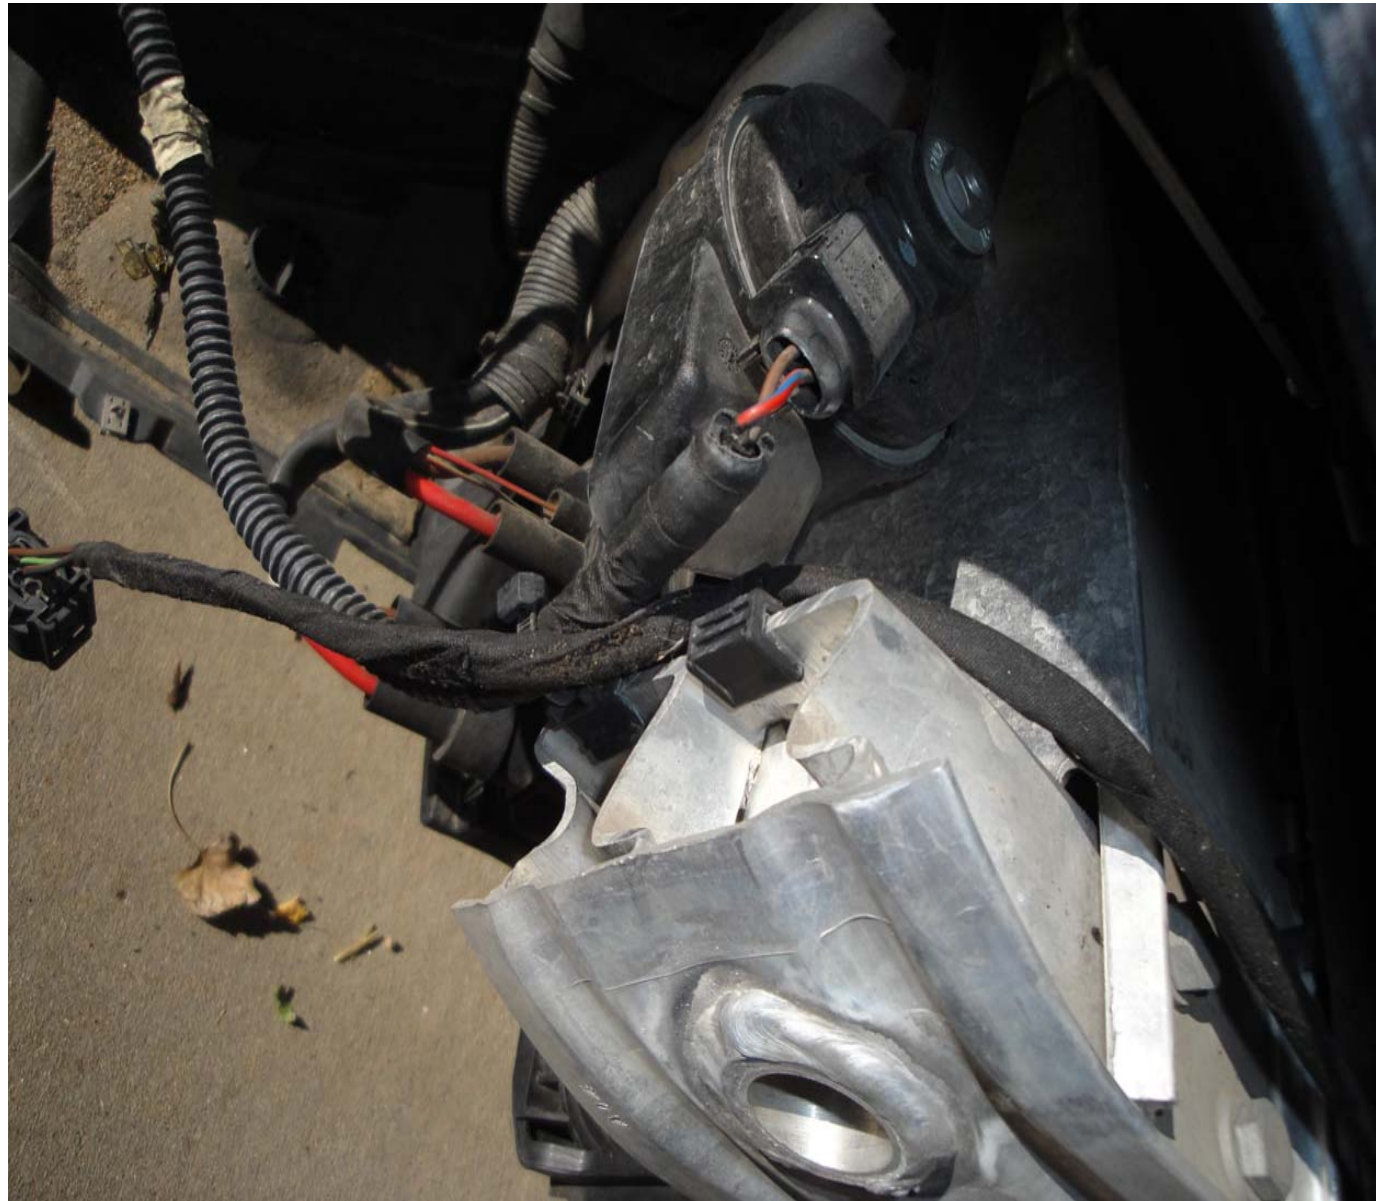
Step 19: Disconnect the A/C pressure sensor, ambient air temp sensor, and both horns (one per side). Dislodge the retaining clips from the crash beam and ensure that the front wiring harness is free from the crash beam. Loop it up the driver's side fender and out of the way:

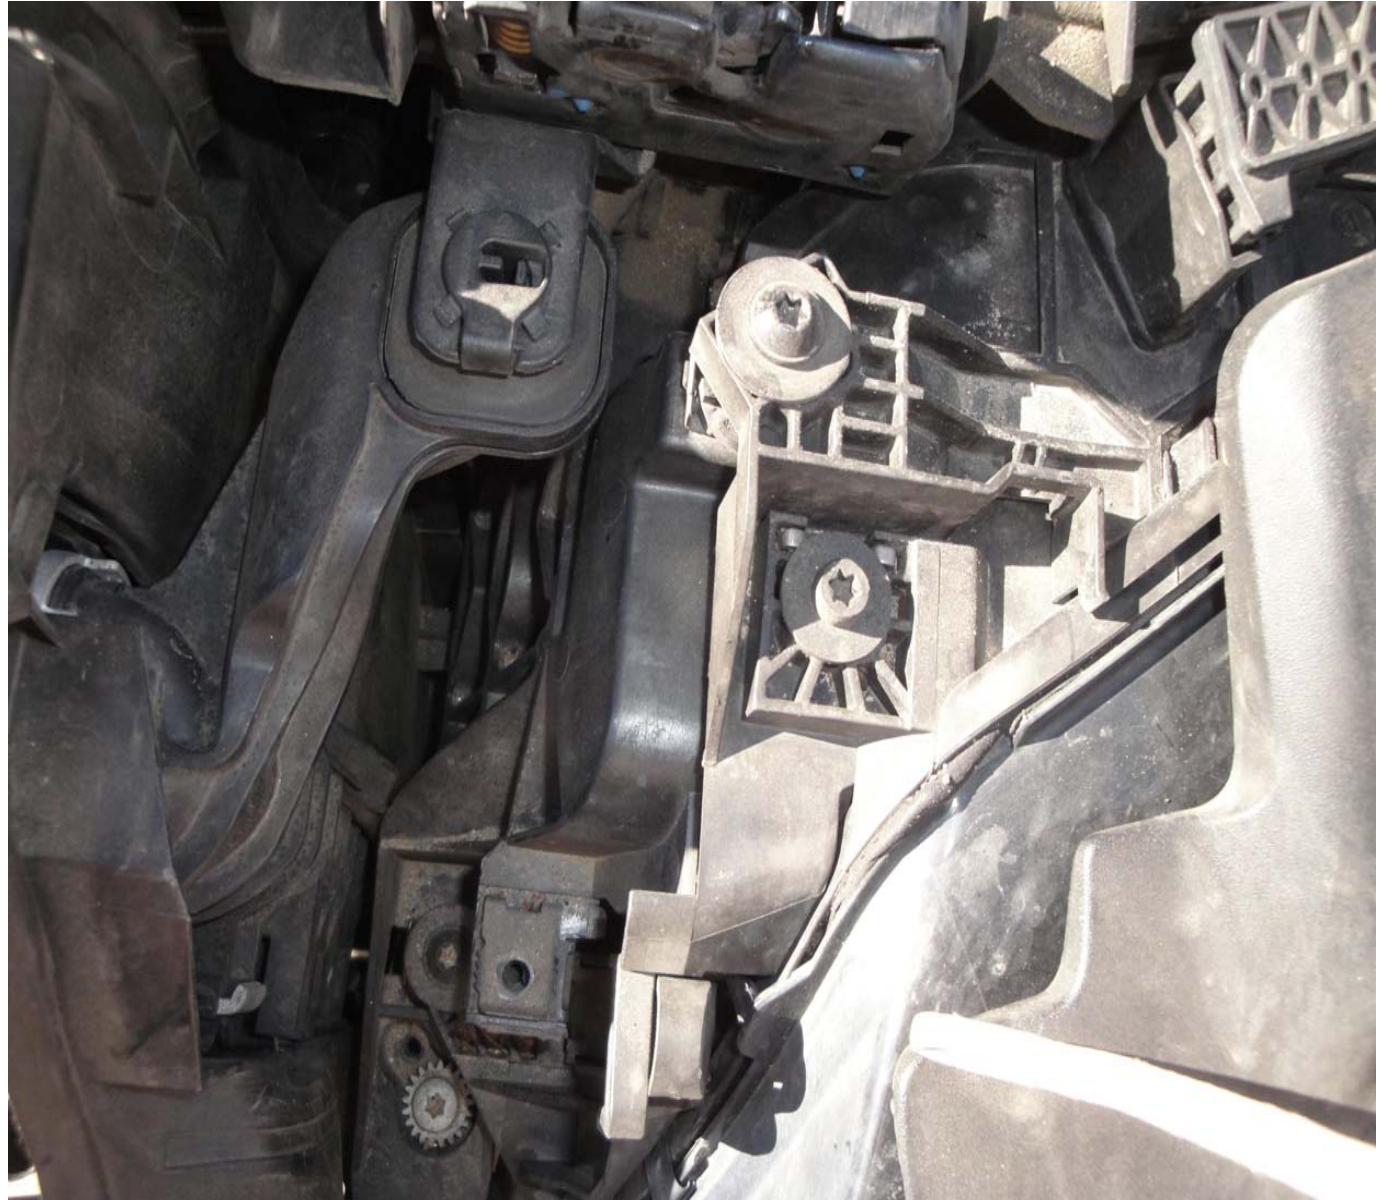
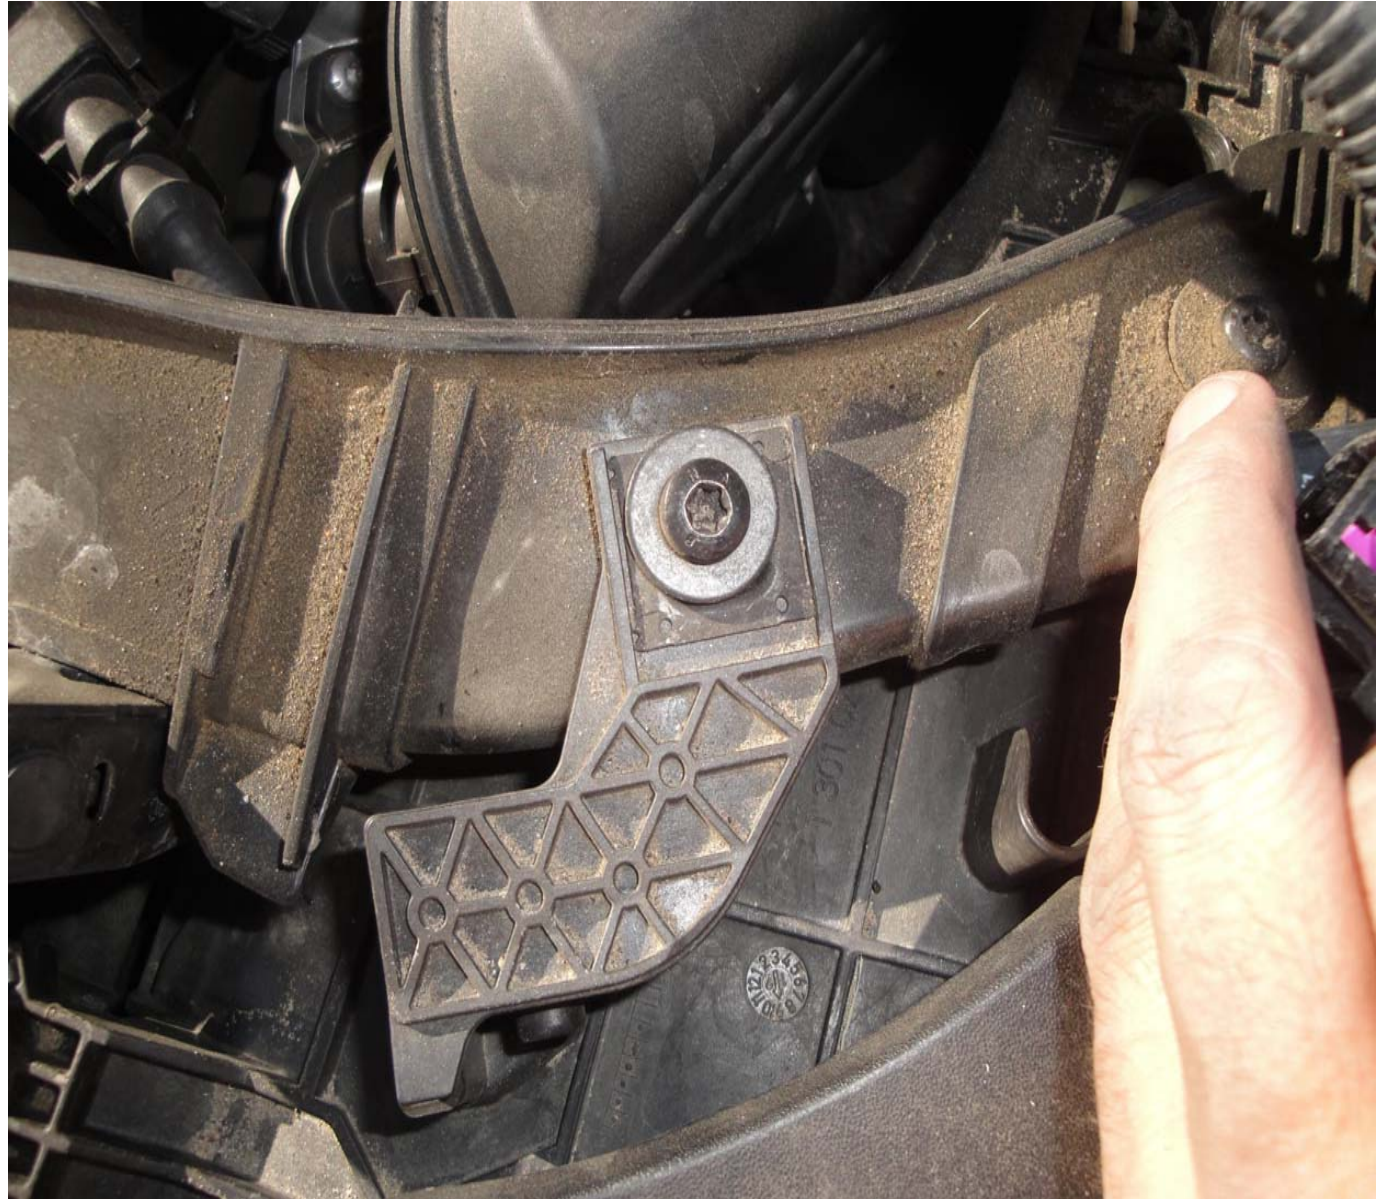
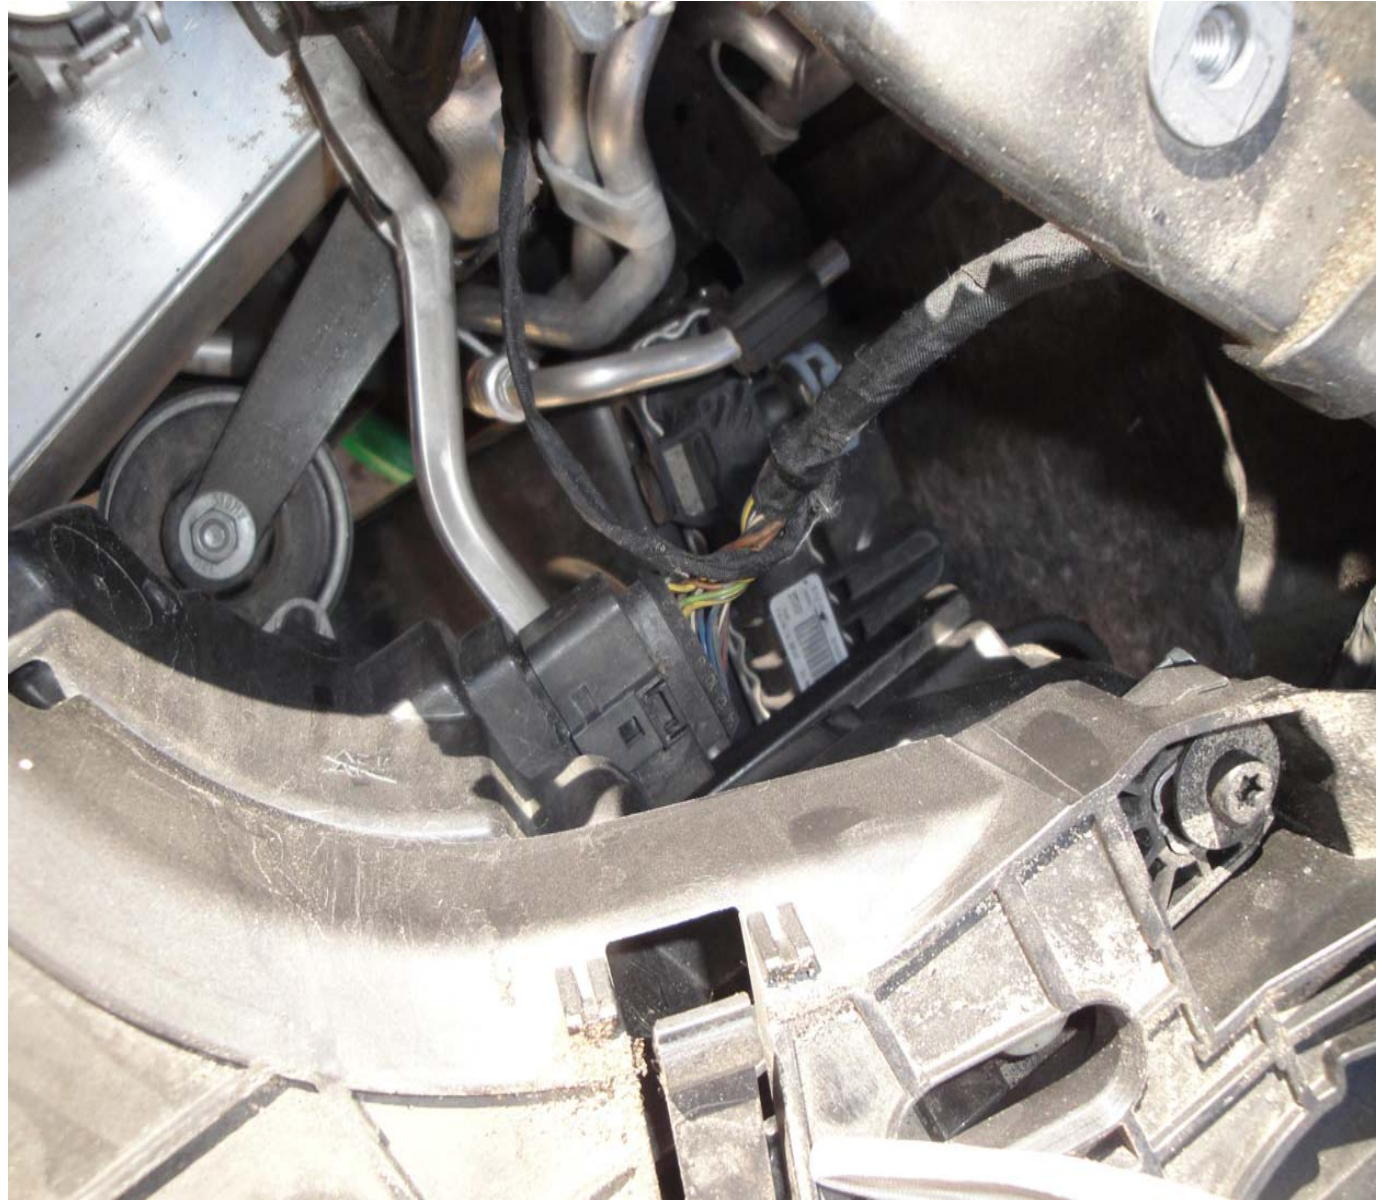
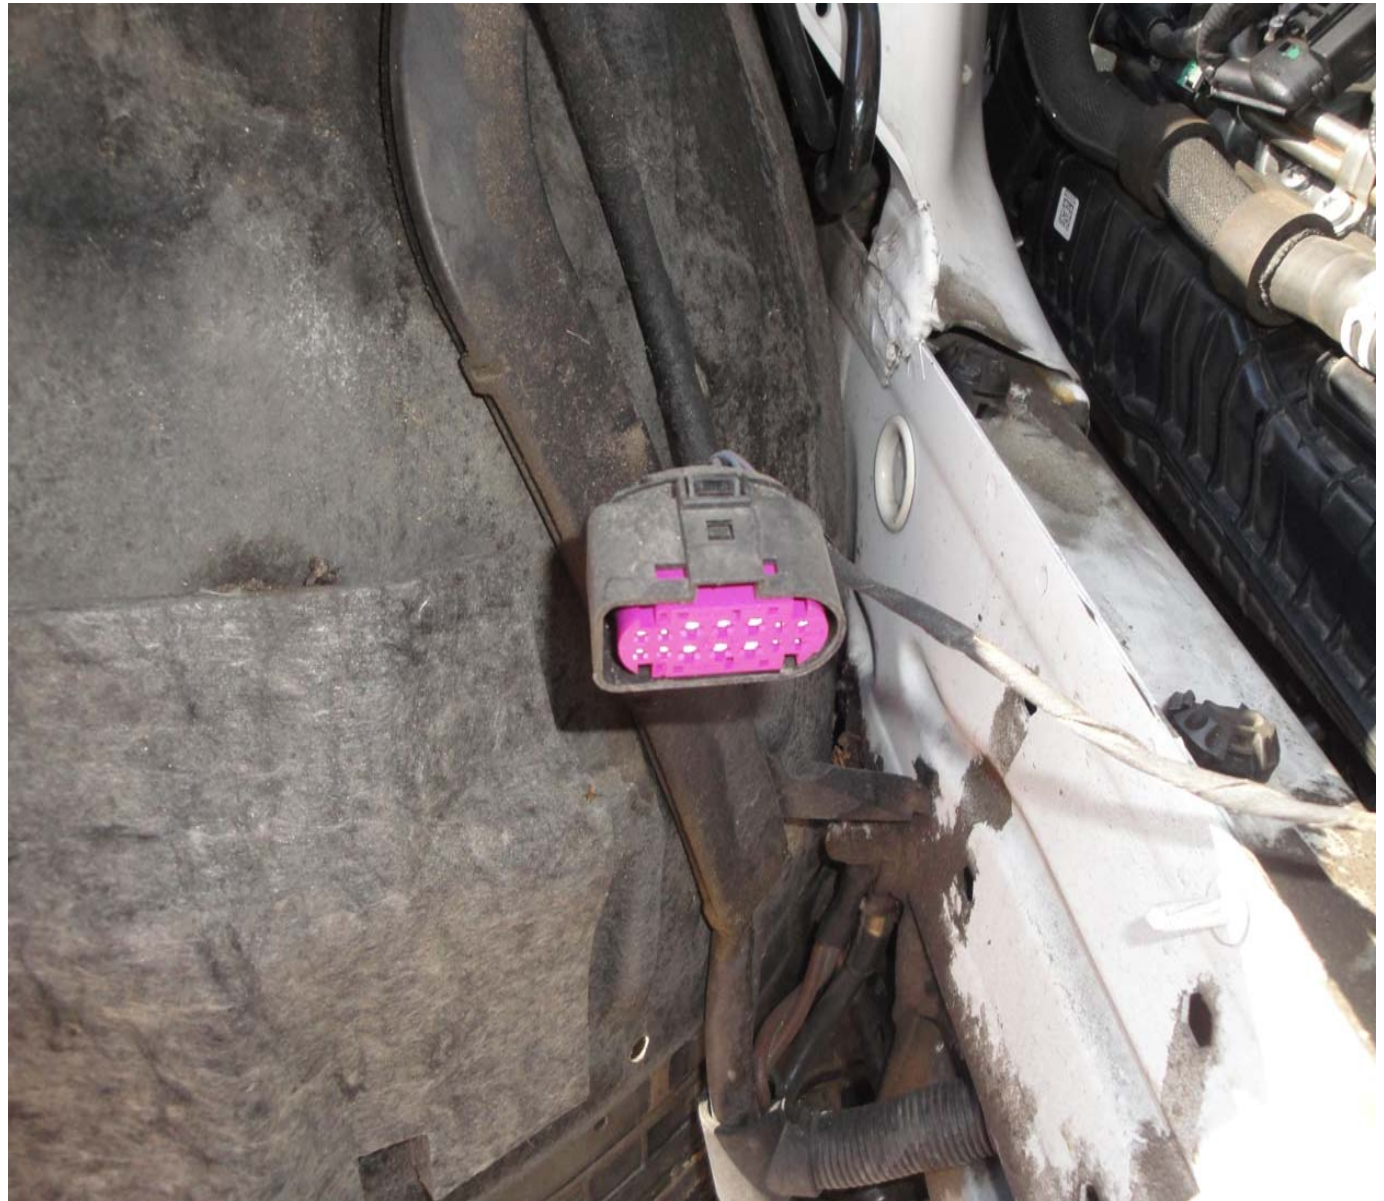
Step 20: Using a T30 Torx, loosen the 4 bolts holding the driver's side headlight to the chassis, removing the 5th screw completely in the middle. The headlight retainers have level adjusters built into them, so minimizing the bolt turning will ensure you don't need to have your headlights realigned. Finally, unclip the headlights and remove them.

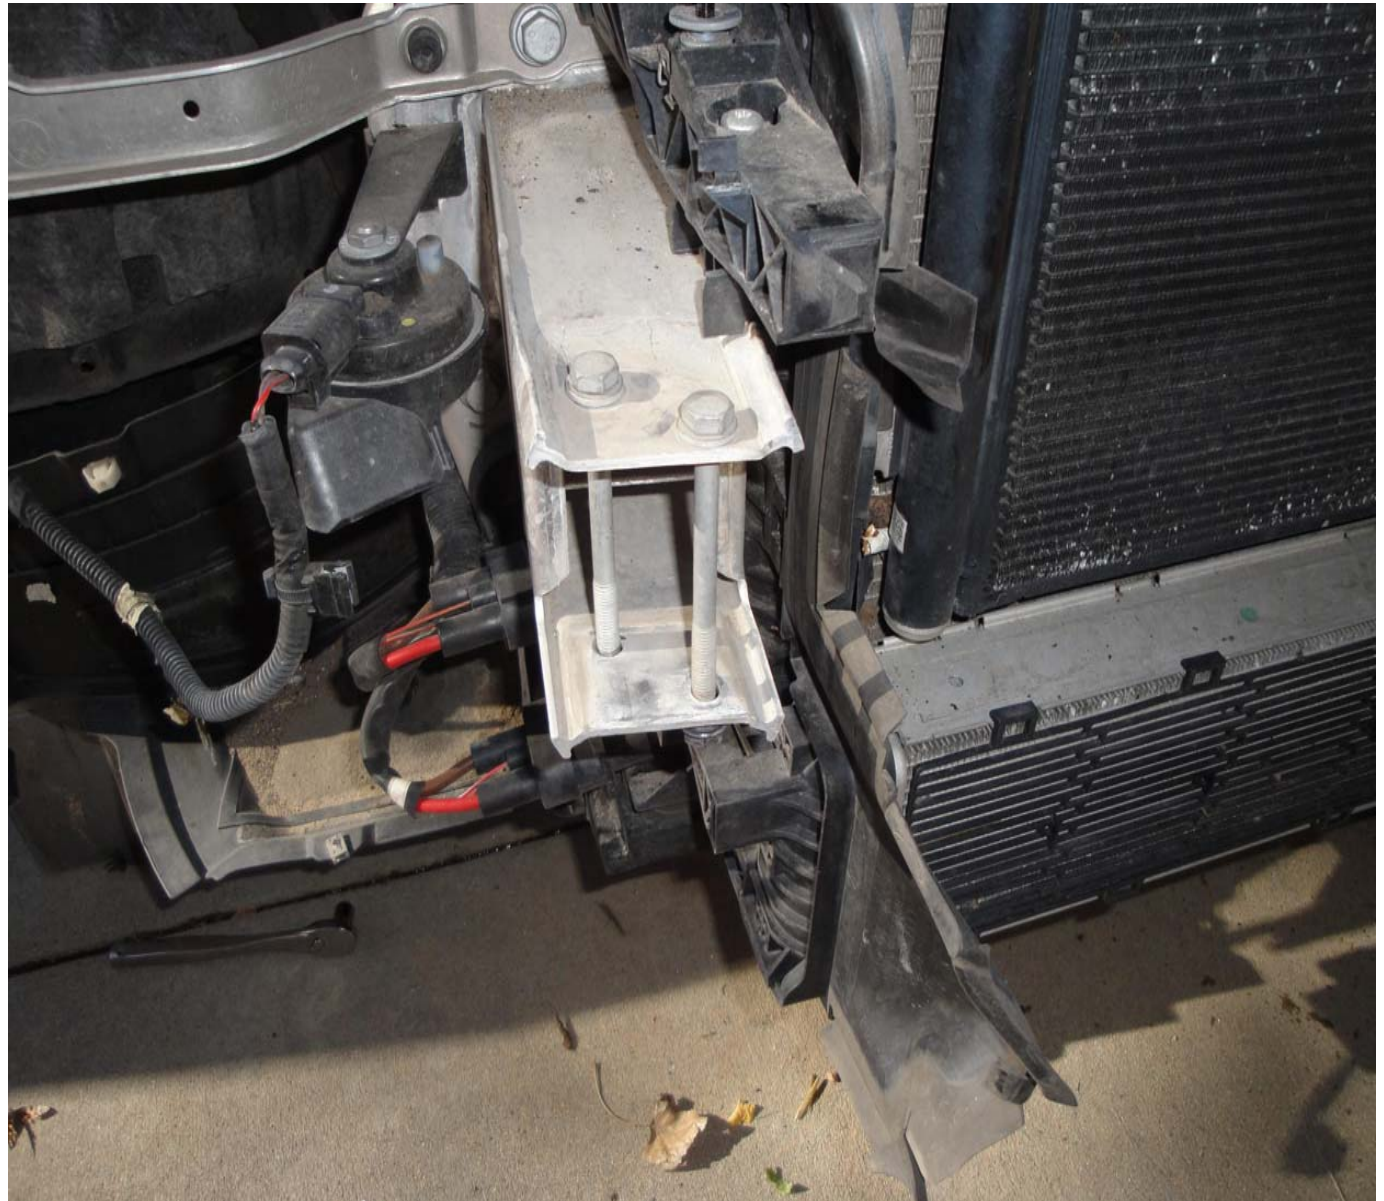
Step 21: Using a 13mm socket and wrench, loosen the four bolts holding the crash beam to the frame rails. Use a dead blow hammer to punch out the beam.

- Intercooler runners to intake manifolds - 9 Nm
- Intercooler to block - 9 Nm
- Hard coolant crossover pipe - 9 Nm
- Lock carrier frame to chassis - 55 Nm
- Lock carrier top to fender - 10 Nm
- Impact beam - 20 Nm (Tighten in this order, facing the beam from the front: 1-2-4-3)
- Throttle body to intercooler - 5 Nm
- Bypass valve bolts - 9 Nm

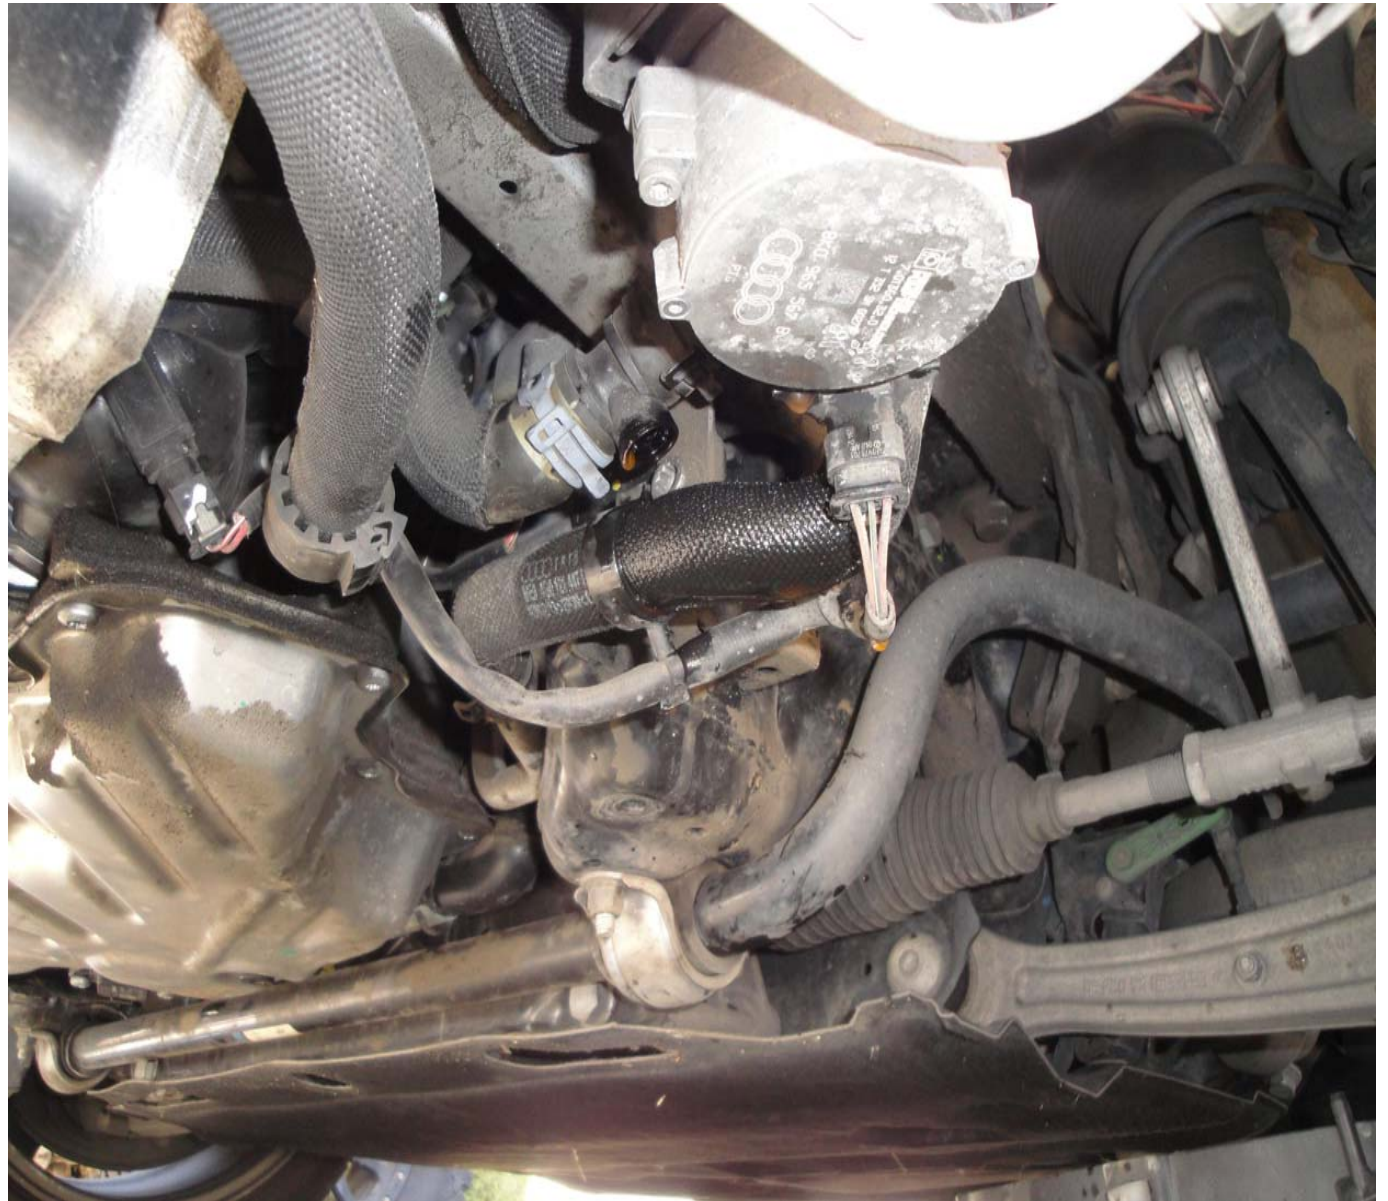
Step 22: Drain the coolant. Look for the drain plug in-line with one of the coolant hoses in front of the driver's side wheel. About 2 gallons will come out. Be sure to completely remove the plug for faster draining and open the expansion tank lid for venting:

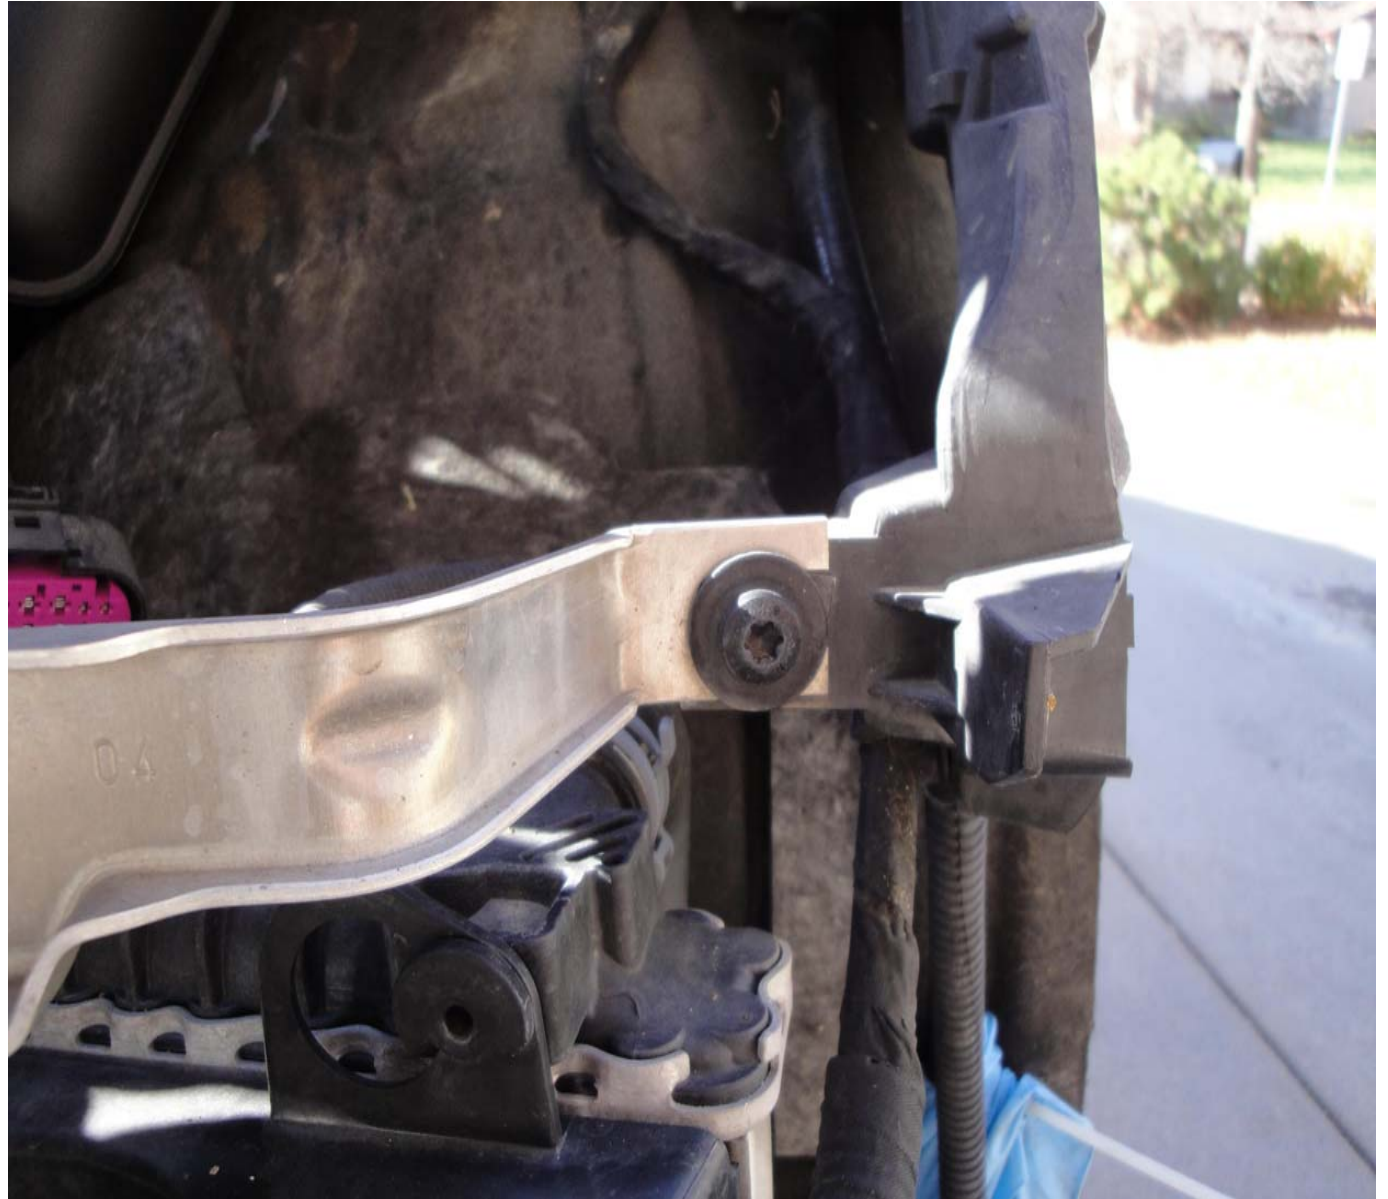
Step 23: Loosen the outer brackets from the lock carrier to the fender support thing on each side:

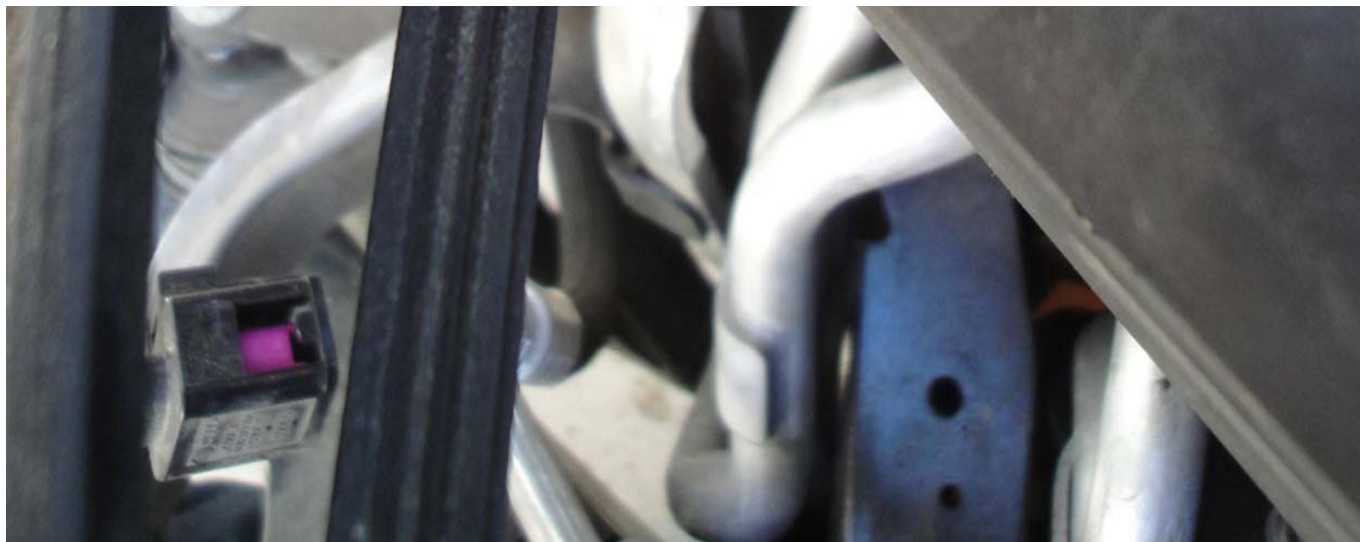
Step 25: Use a small flatblade screwdriver and pop off the two clips that hold the hood release cable to the lock carrier:

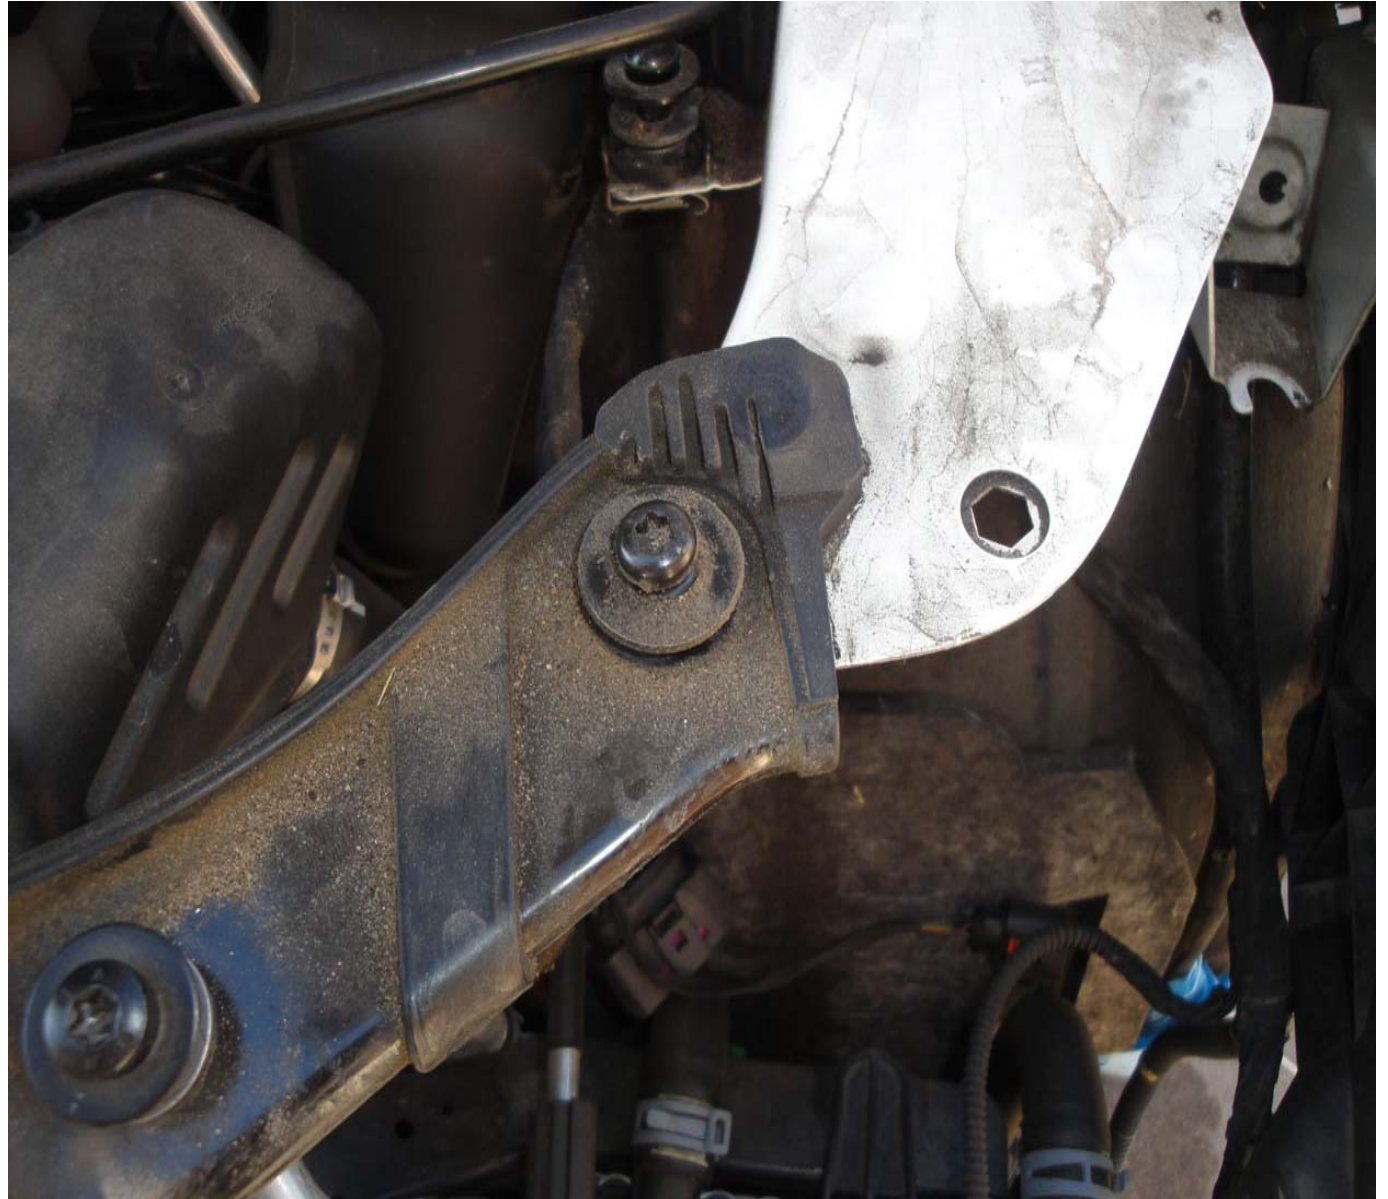
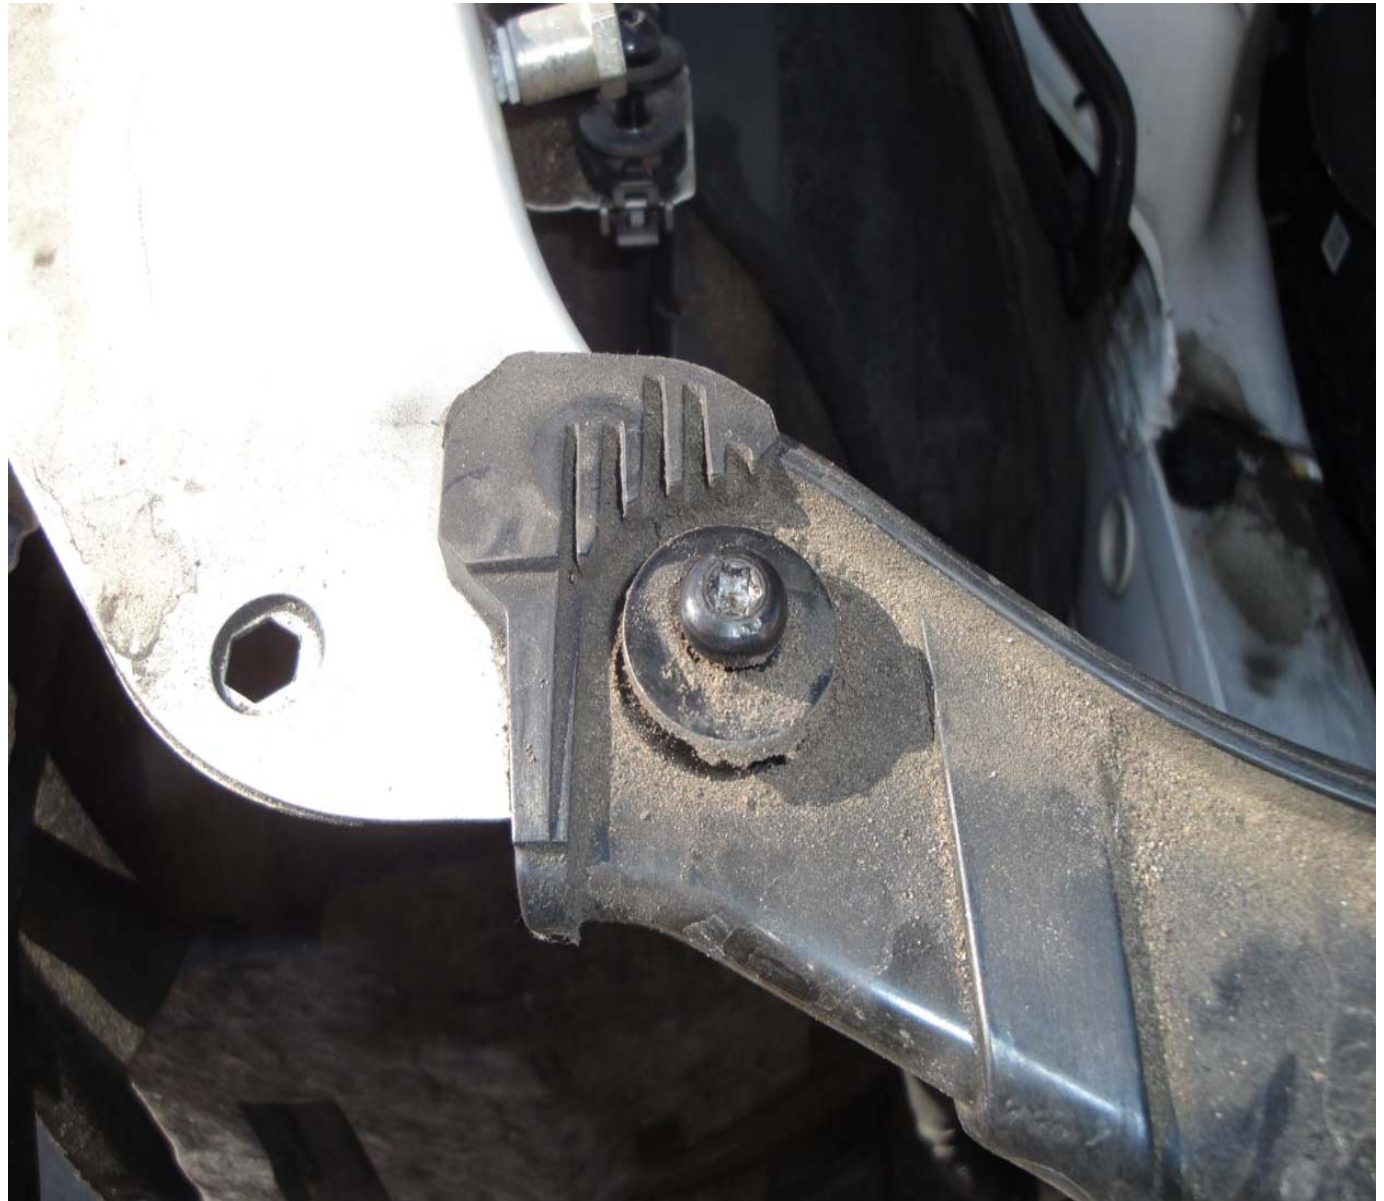
Step 26: Using a T30 Torx, remove the bolt that attaches the upper lock carrier to the fender support on each side:
