Thread: HOW TO: Oil Separator R&R

I wrote this guide on how to replace your oil separator as this appears to be a persistent issue on 2013 S6/S7 cars, particularly ones that are just outside warranty, like mine (53k miles). The symptoms are described in TSB 2040644/8, detailed below from the erWin website:
Instructions for use

Technical Service Bulletin Transaction No.: 2040644/8

17 MIL on; whistling noises from engine compartment

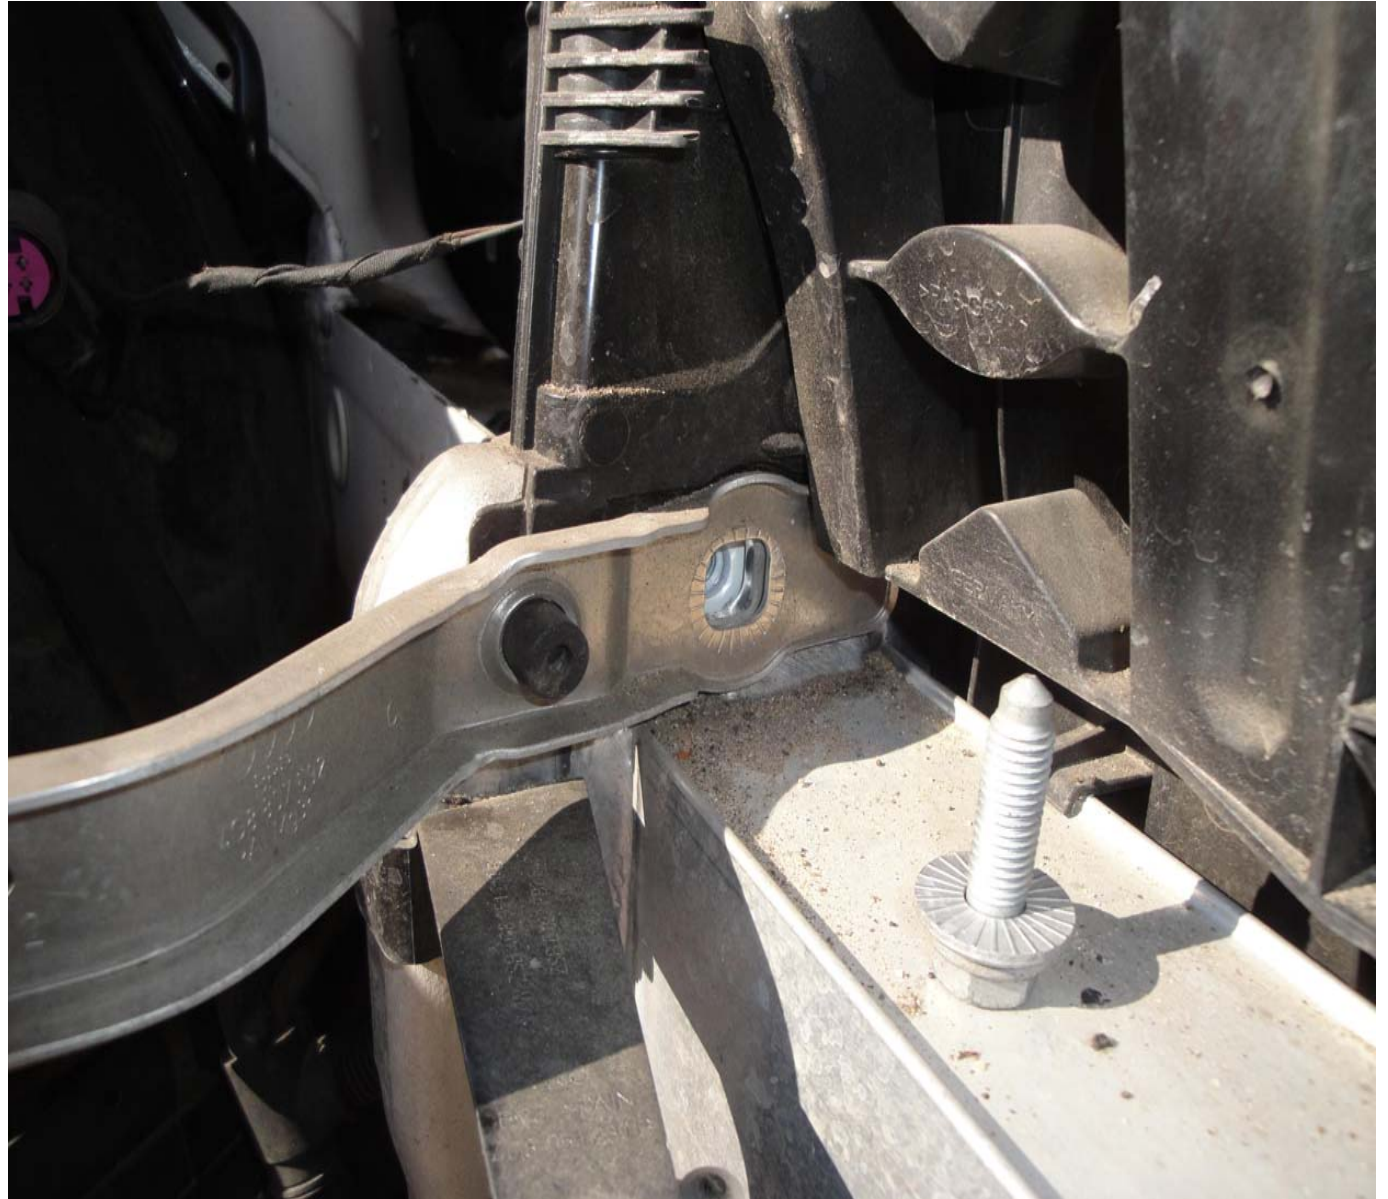
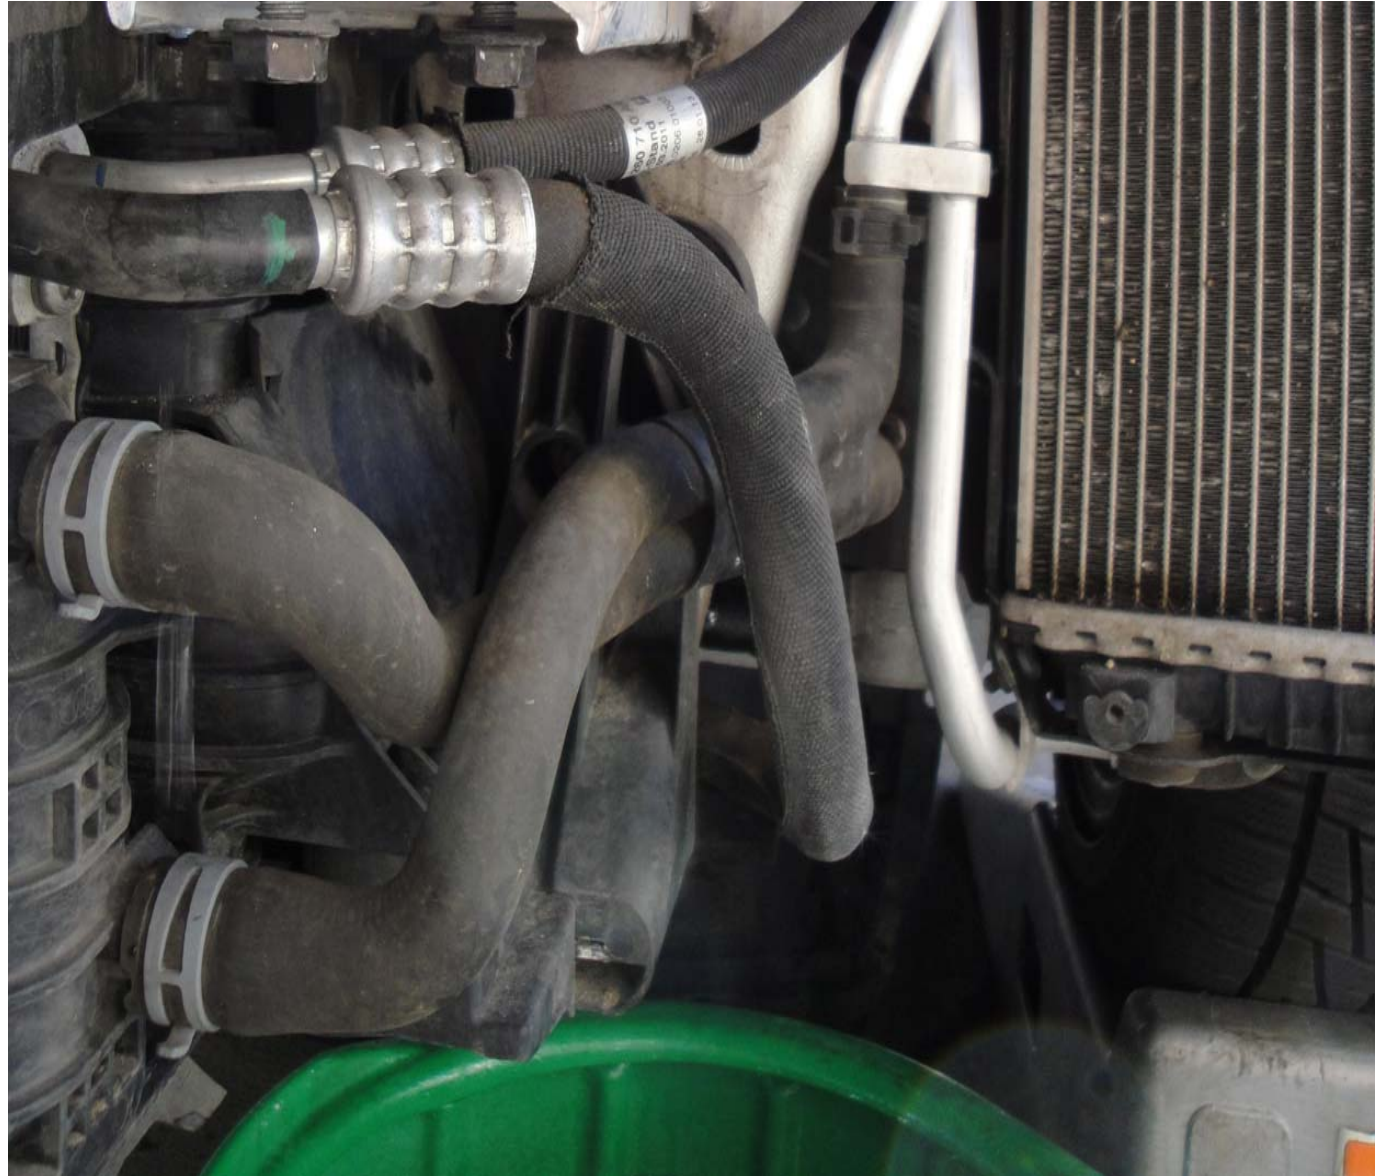
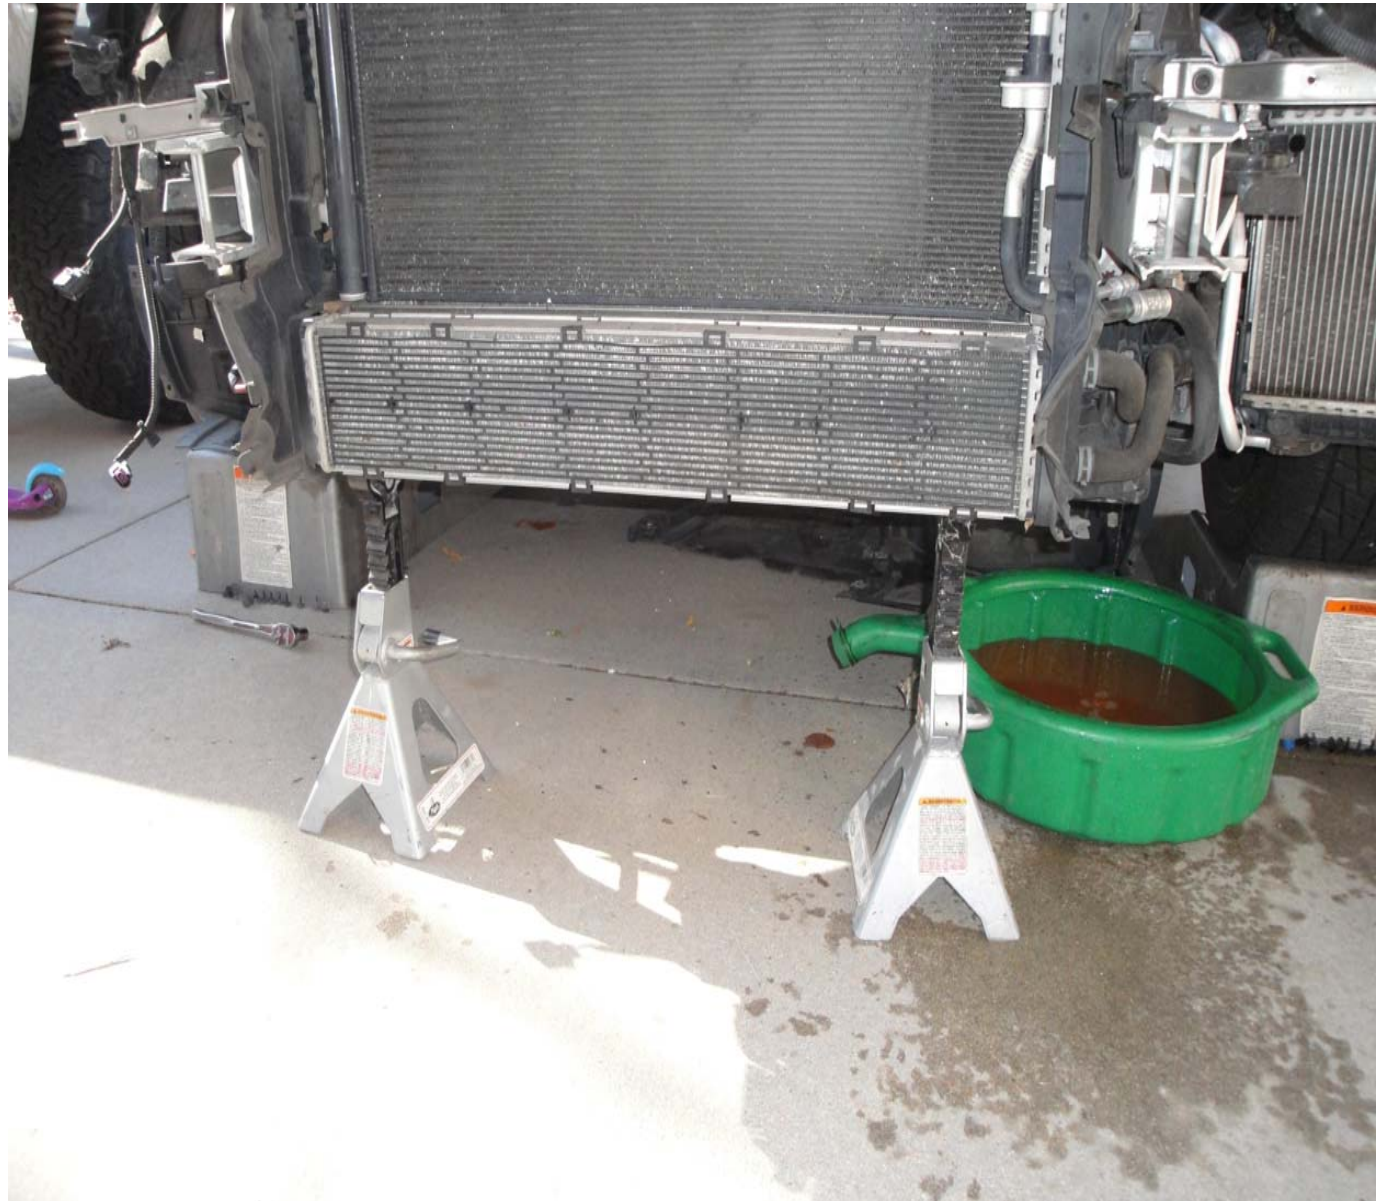
Step 27: Using a 16mm socket with extension bar, remove the 3 bolts on each side that attach the lock carrier to the frame rails. While the lock carrier won't fall forward due to the radiator hoses still being attached, I wanted to make sure it was supported and not dangling from any hoses/wires. Use a jack stand or two to support it and slide it forward:

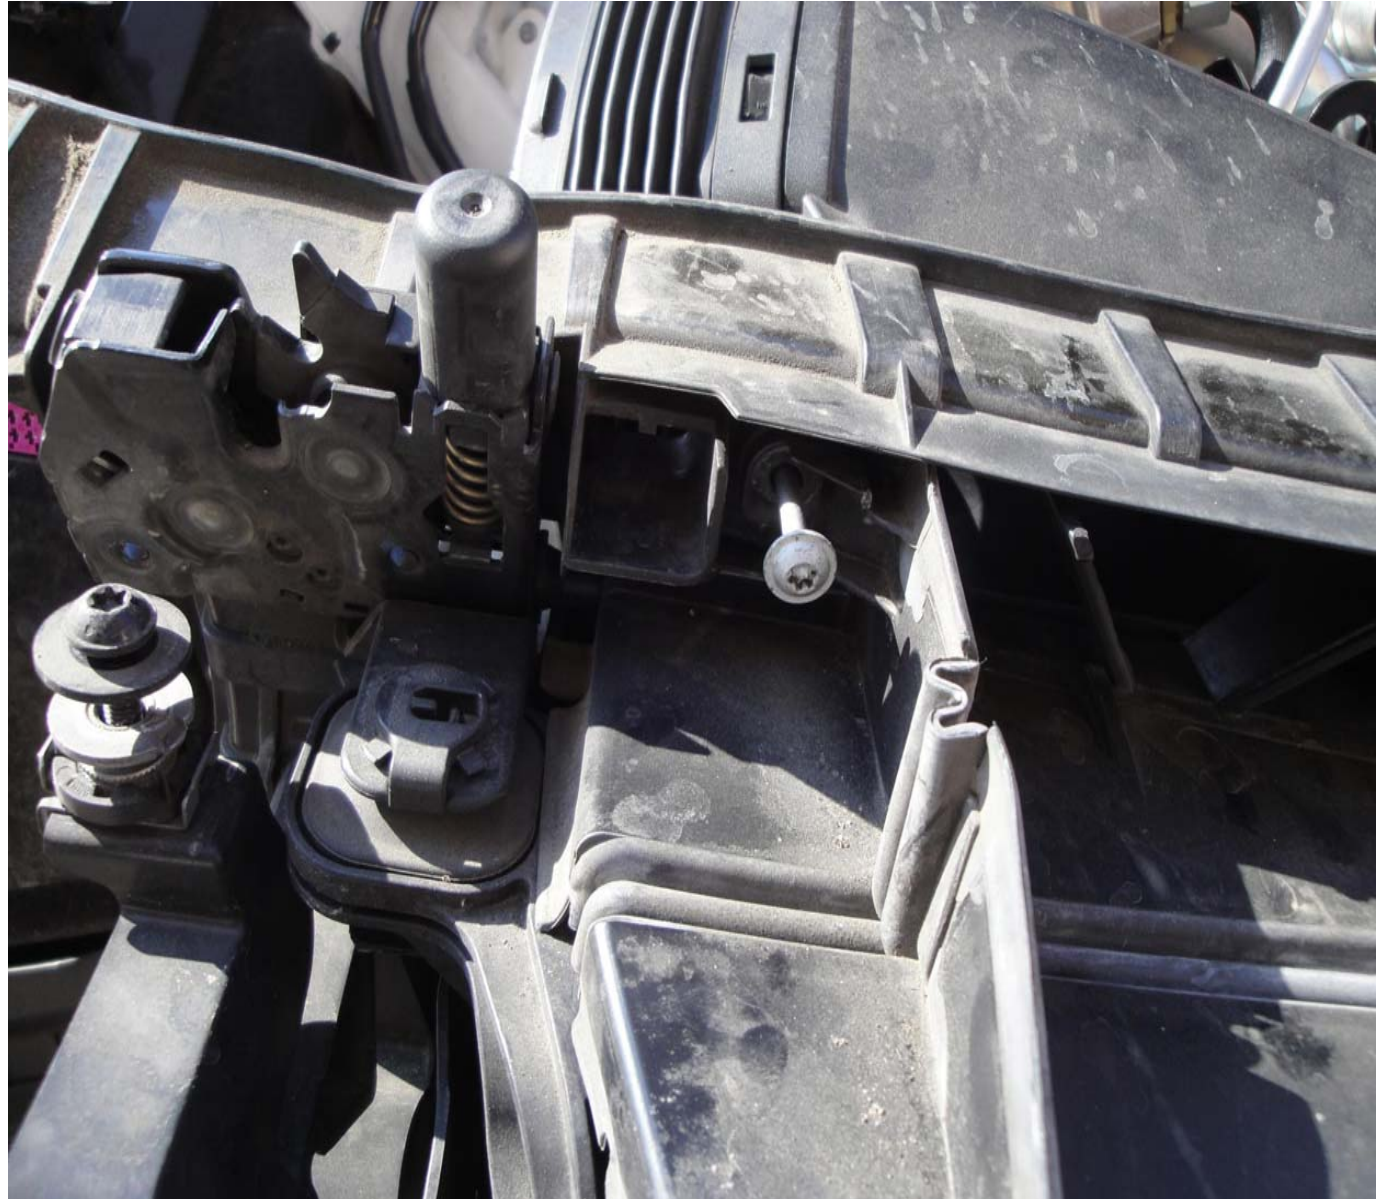
Step 29: Using a T20 Torx, remove the air intake scoop. One screw is hidden behind the radiator deflector:

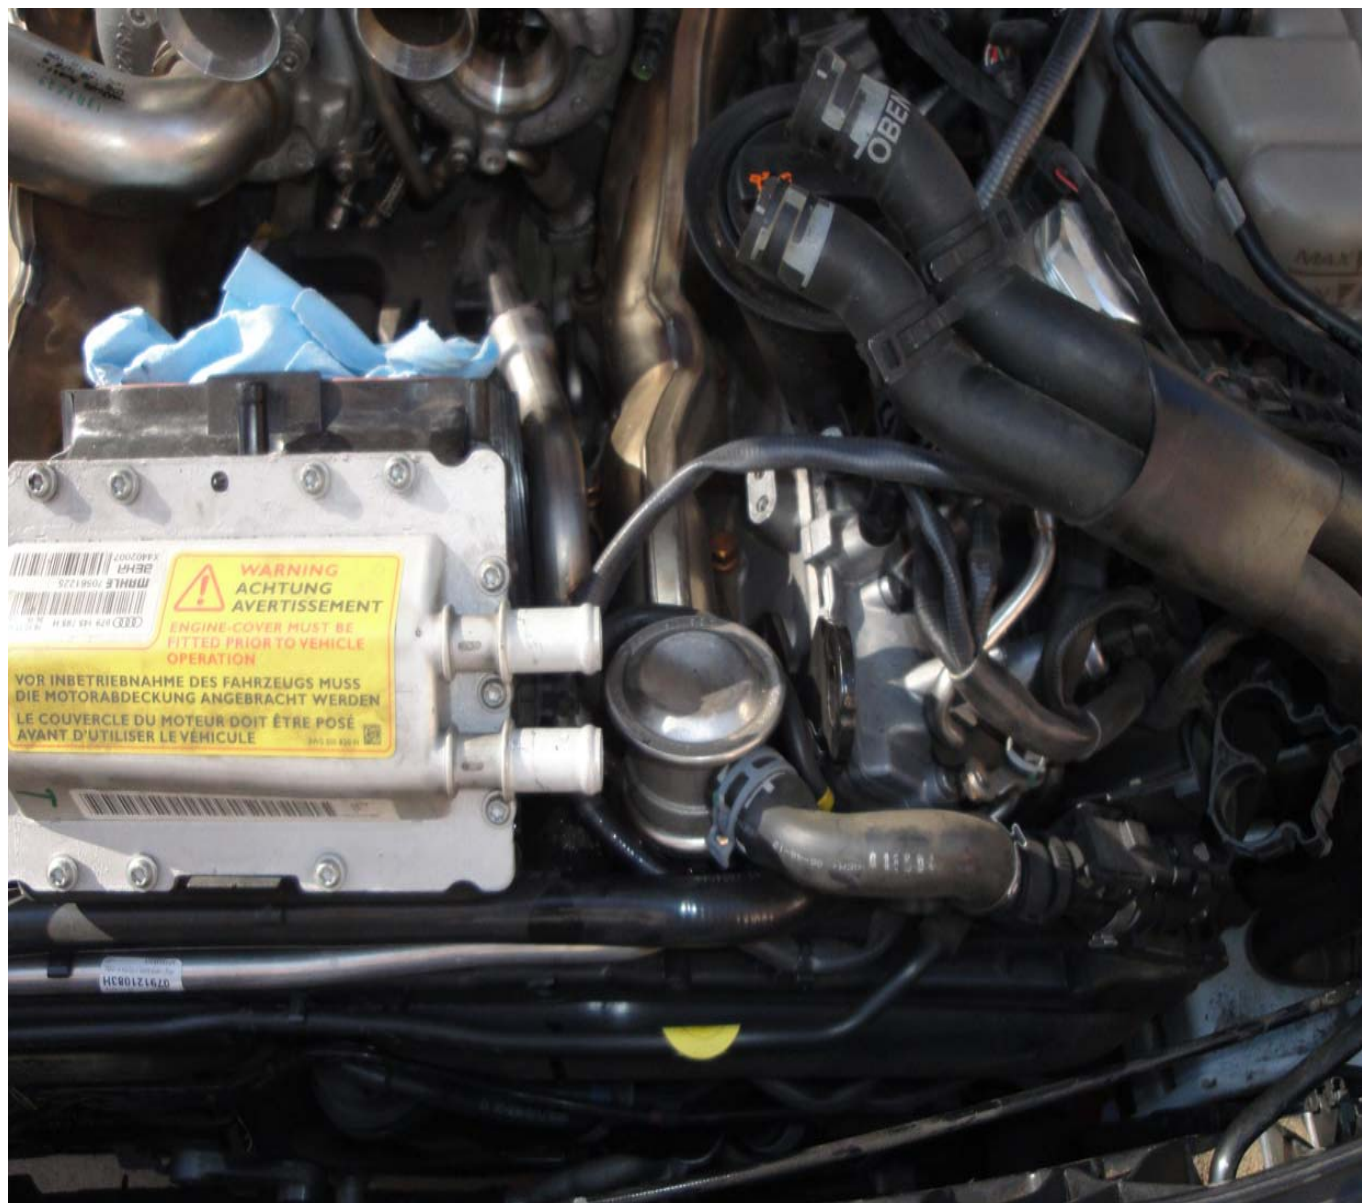
Step 30: Remove the coolant hose clamps on the intercooler. Disconnect the hoses and push them off to the side:

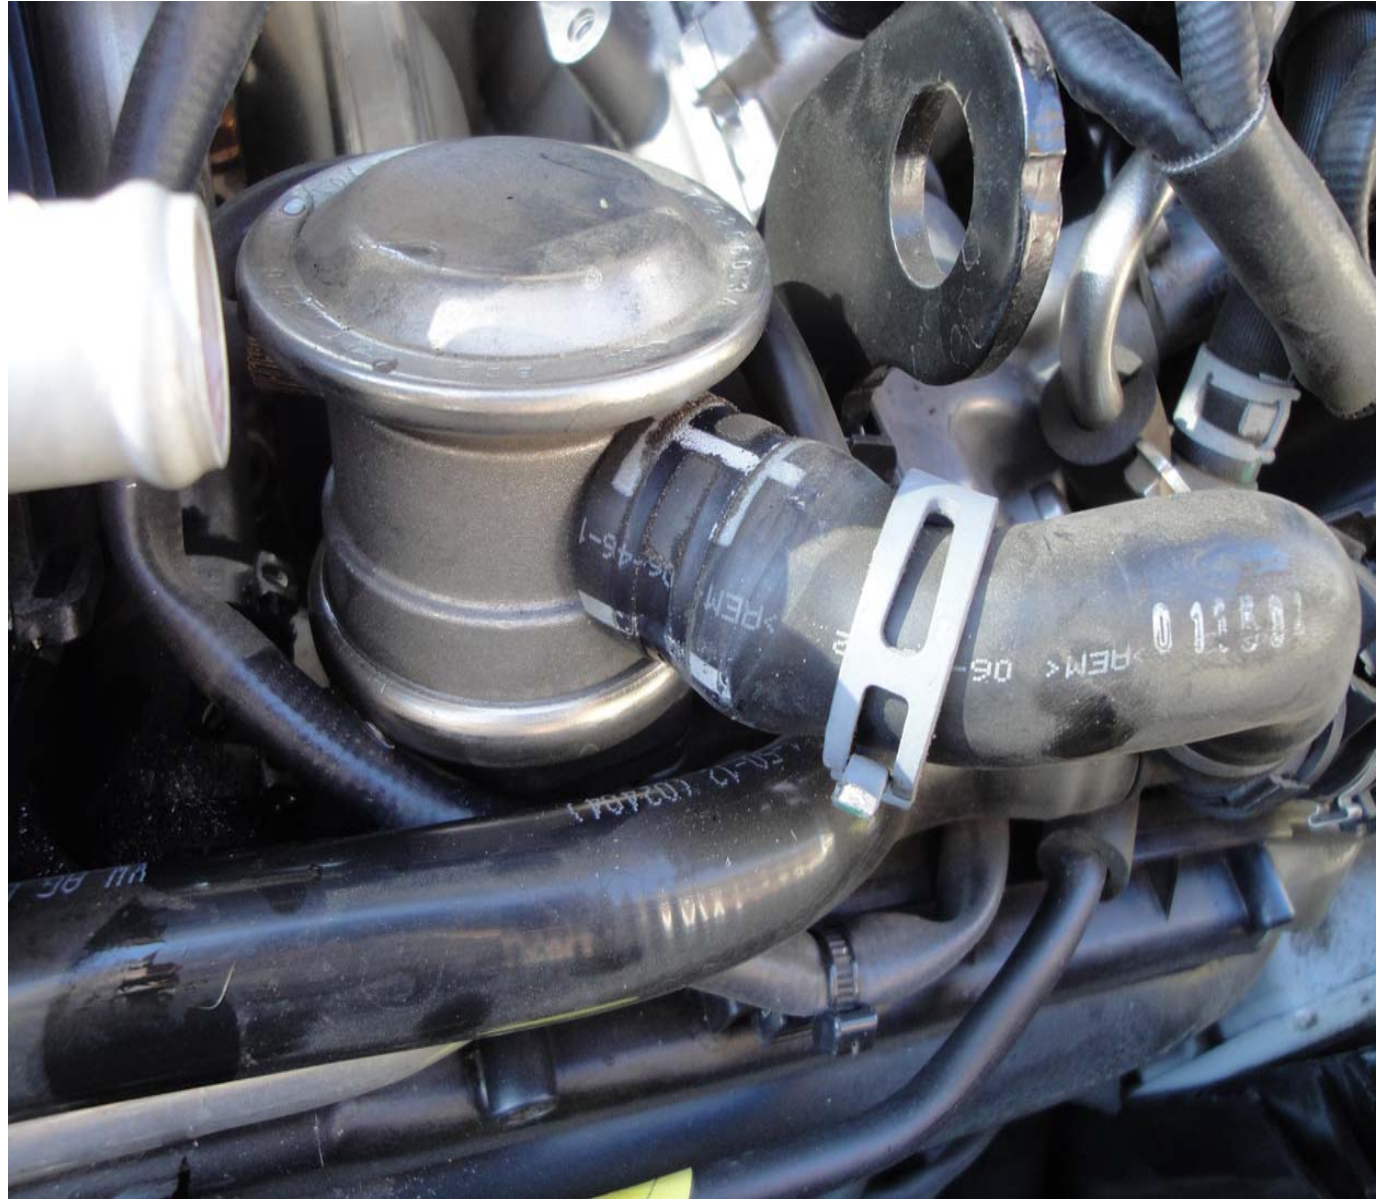
Step 32: Remove the clamps holding the second air injection system actuators hoses and remove the hose. The piece that connects to the air pump is disconnected by squeezing the top and bottom of the plastic coupler:

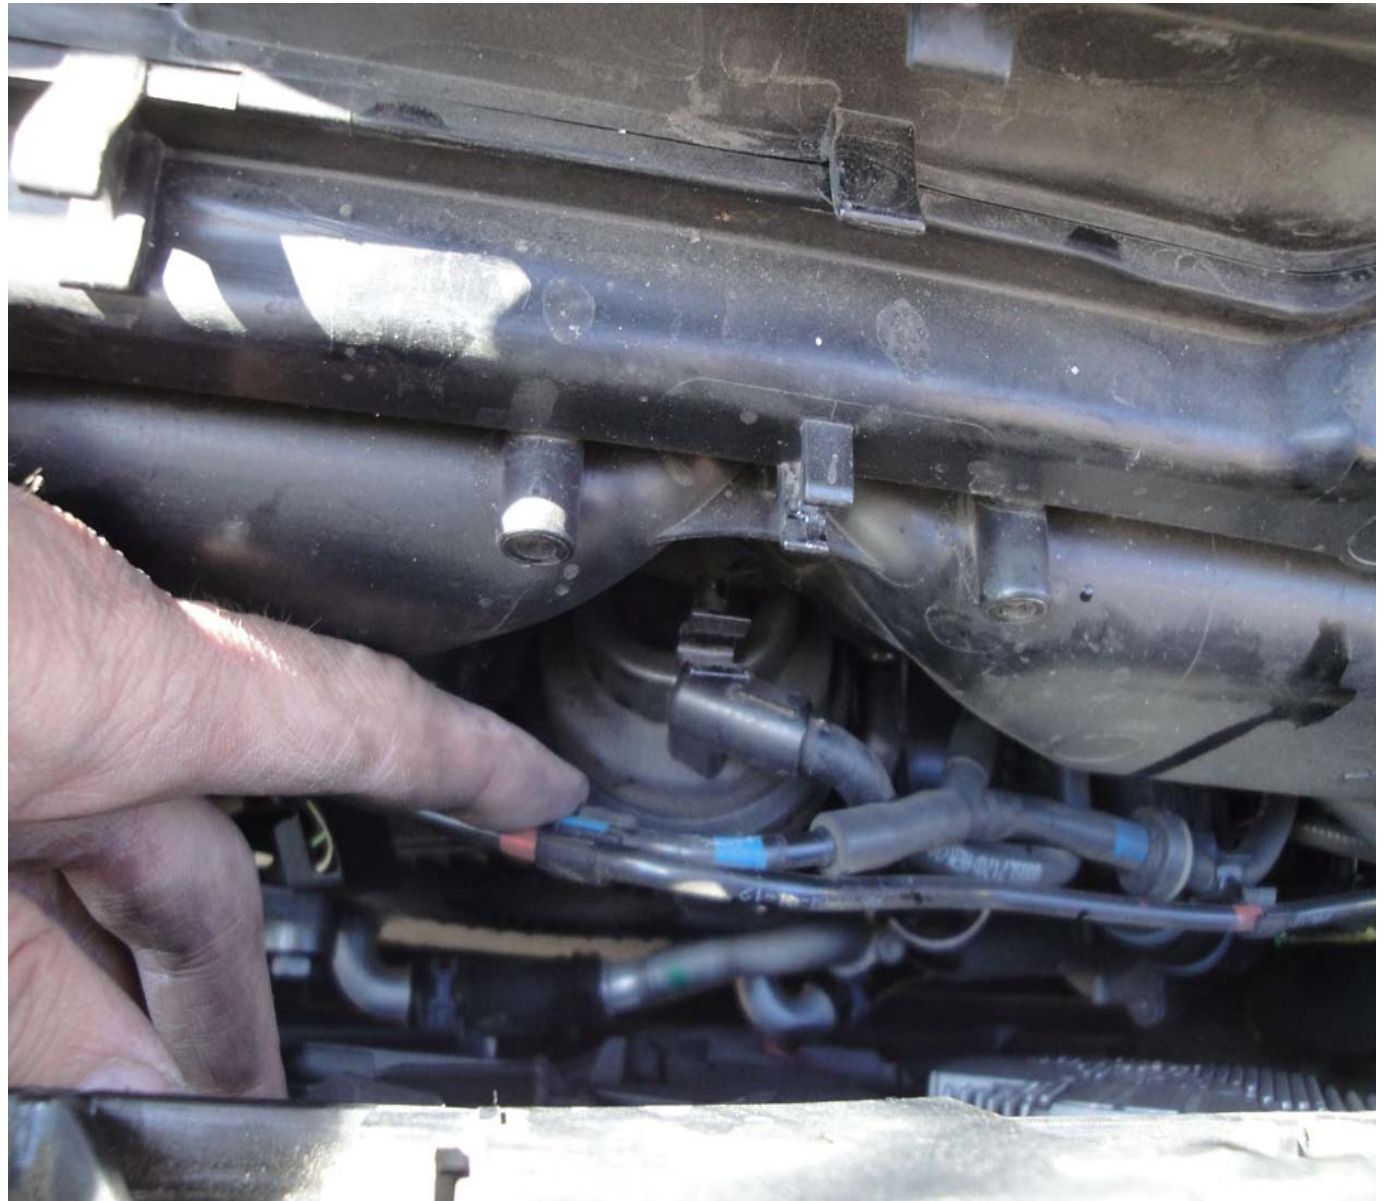
Step 35: Dislodge some vacuum lines off of the intake runners right in front of the intercooler:

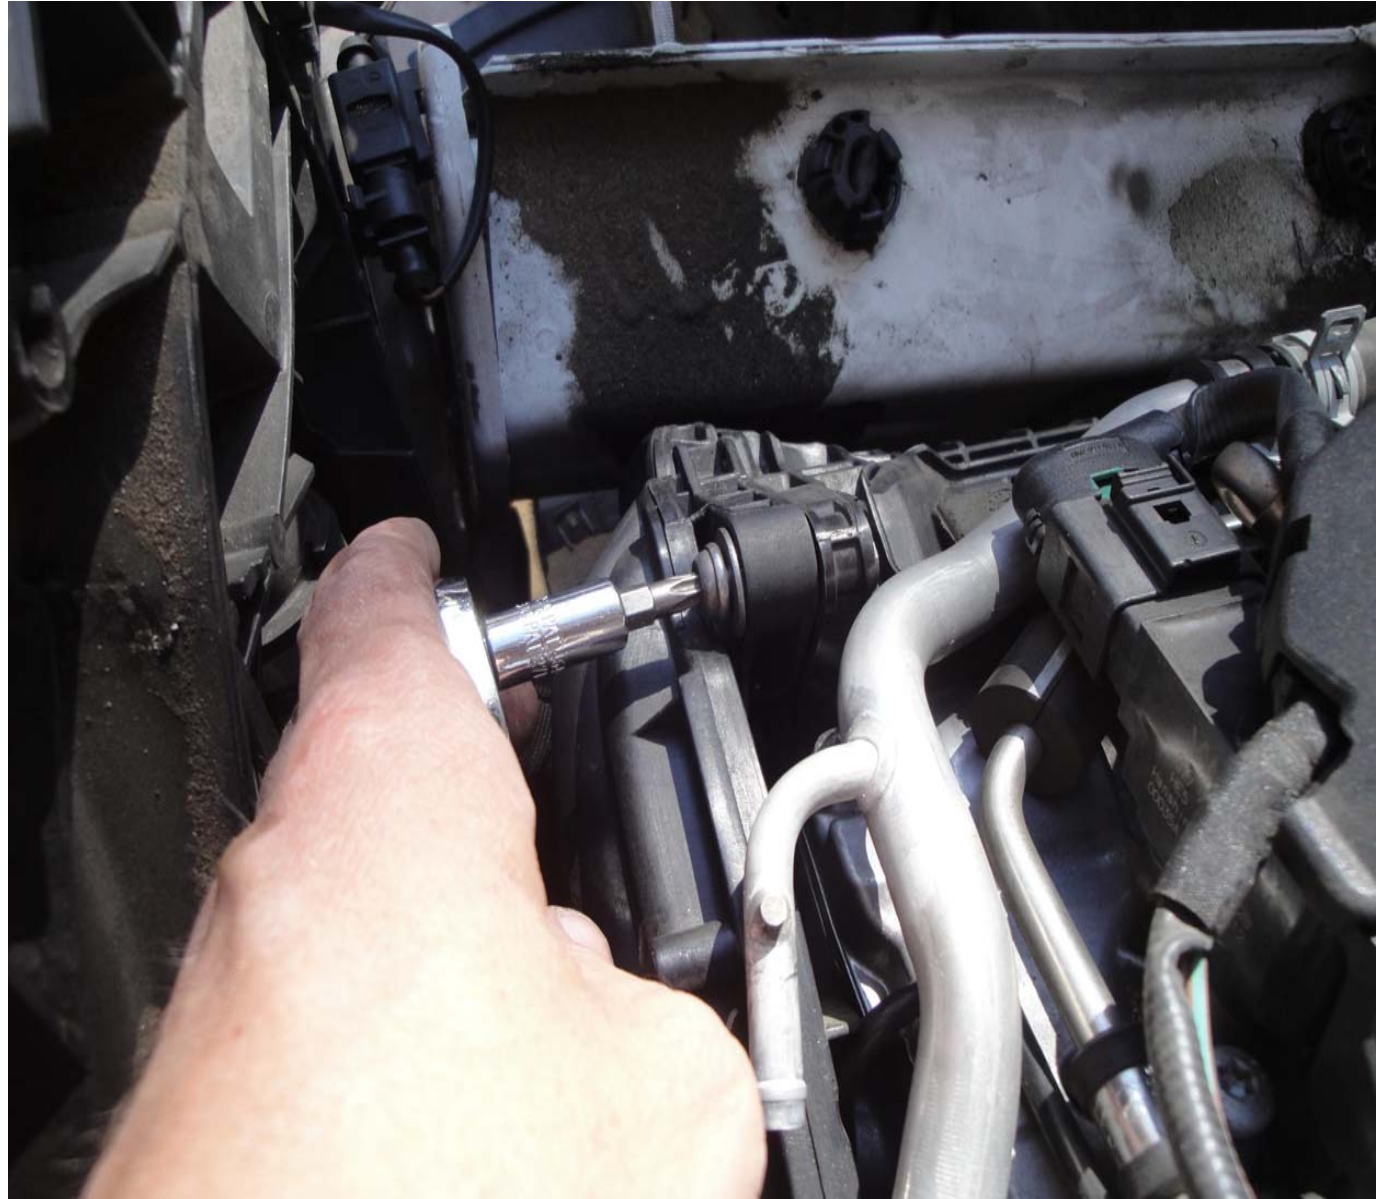
Step 37: Using a T30 Torx, remove the 6 bolts (3 per side) that connect the intercooler runners to the intake manifolds. One is on the top, another is on the outside bottom, and one is about 3 inches inward from the second bolt. A carrier will come out with the bolt, don't worry about it:

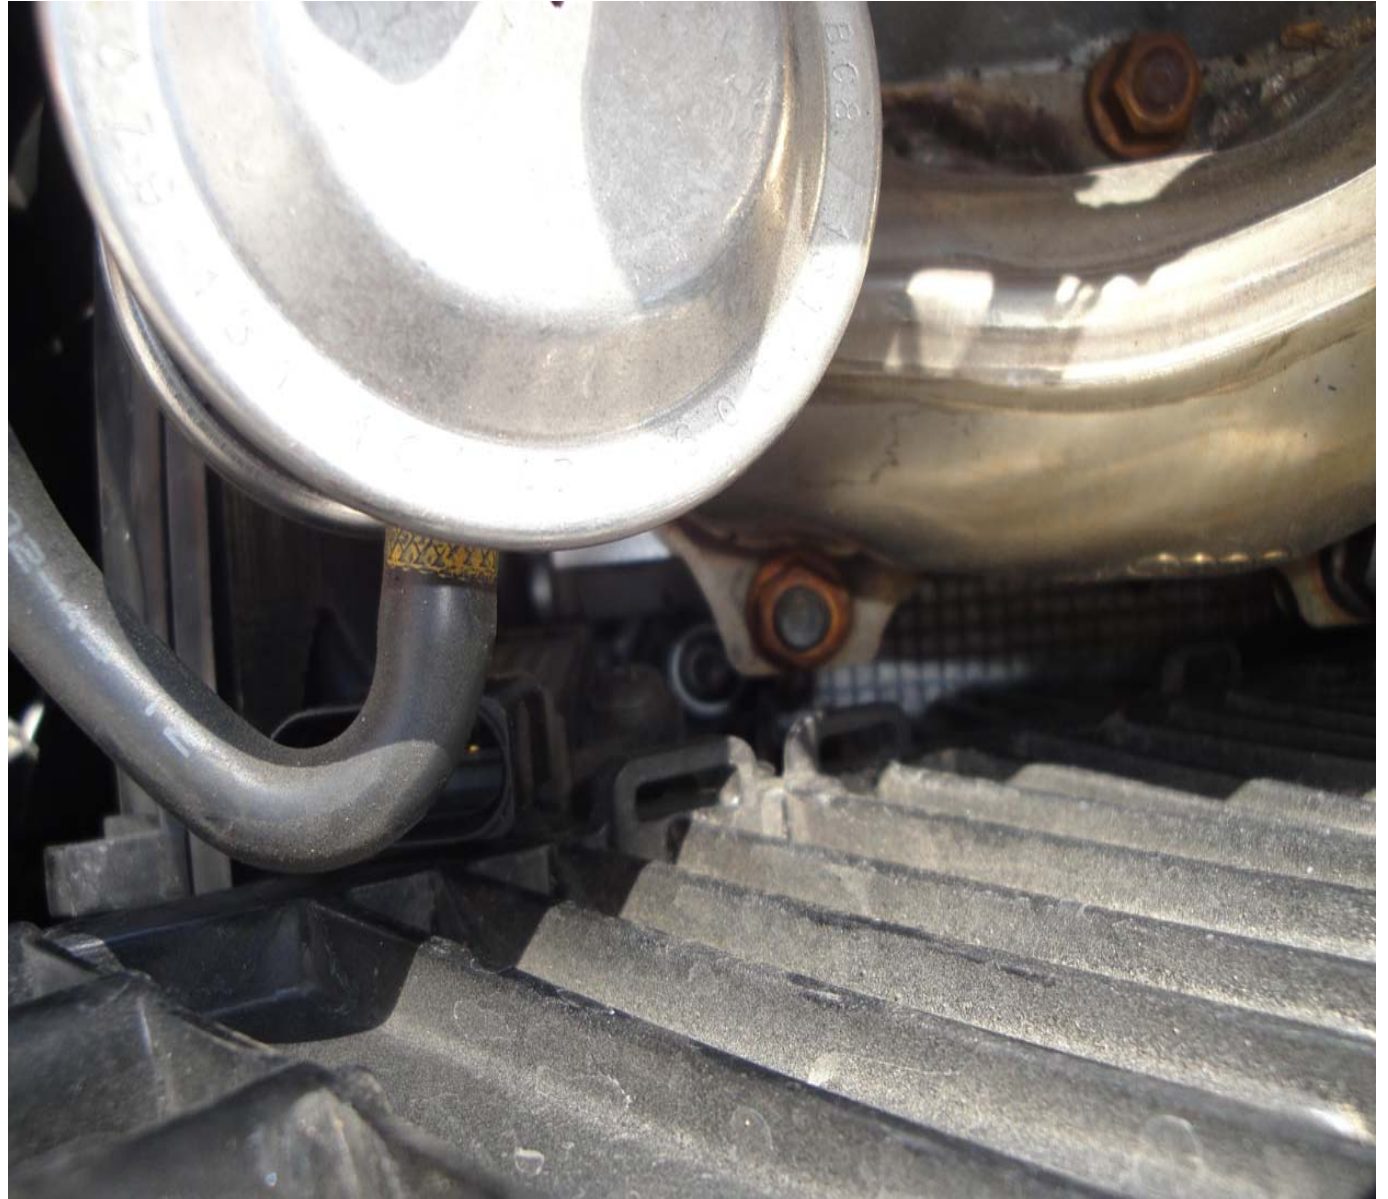
Step 38: Using a 5mm Allen with extension, remove the three bolts that hold the intercooler to the block on either side. It looked like there should be a 4th bolt on the driver's front, but there wasn't:
