REPLACING TIMING CHAINS, TENSIONERS AND GUIDES ON A MKIV 12v VR6

Written by: Dr. Gary Thompson (Vortex SN: VgRt6)

The following DIY outlines the procedure for replacing timing chain parts on a MKIV 12v VR6 engine.

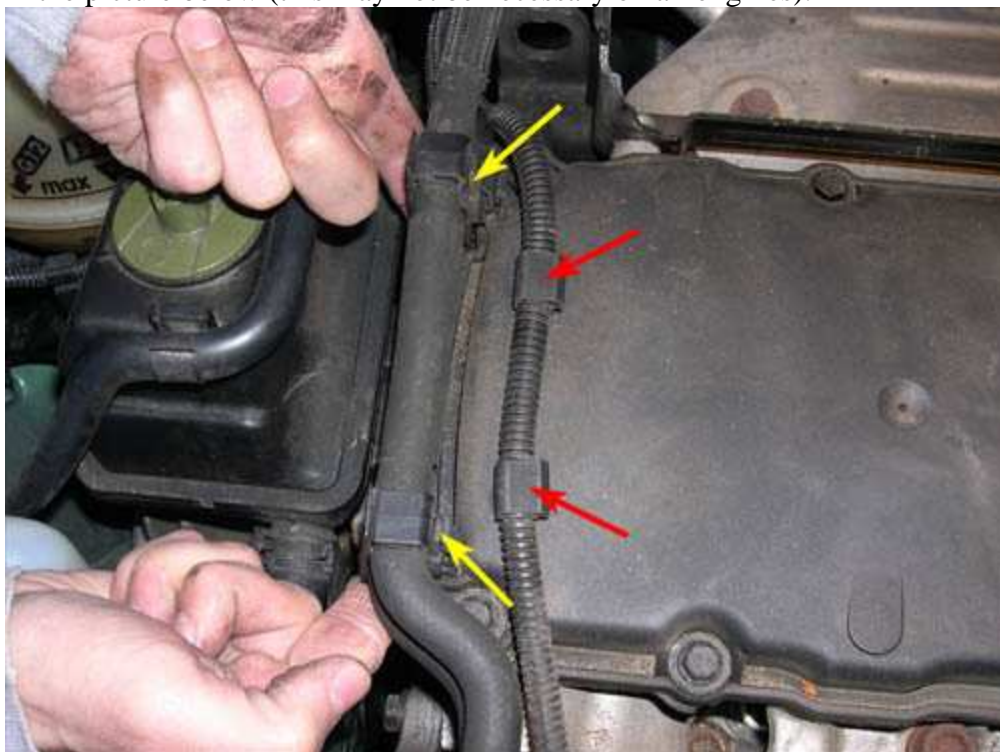
1. Unclip the fuel lines (yellow arrows) and rear knock sensor wire (red arrows) from the top of the valve cover, as shown in the picture below (this may not be necessary on all engines).

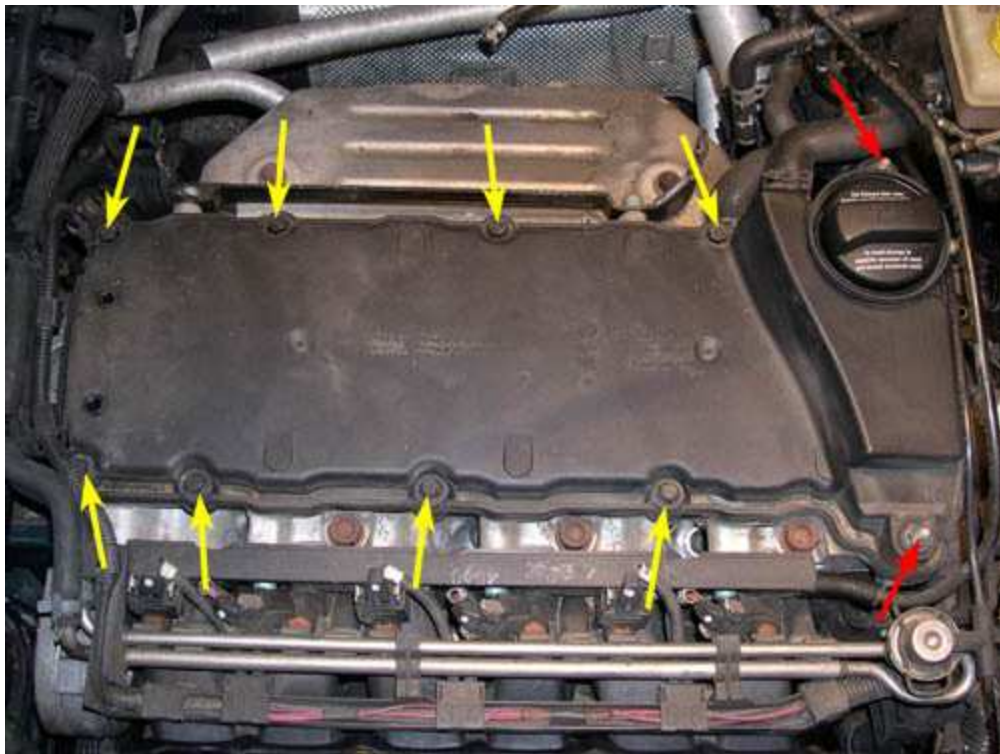
2. Loosen and/or remove the ten (10) 10mm bolts/nuts that secure the valve cover. On a MKIV, there are 8 captured bolts (yellow arrows in picture below) and 2 nuts on posts (red arrows in picture below). I believe that all ten are nuts on posts on other VR6 engines, but I may be wrong. Once the valve cover is unsecured, pull it up and off of the head, being careful not to damage the cover gasket (it will be reused).

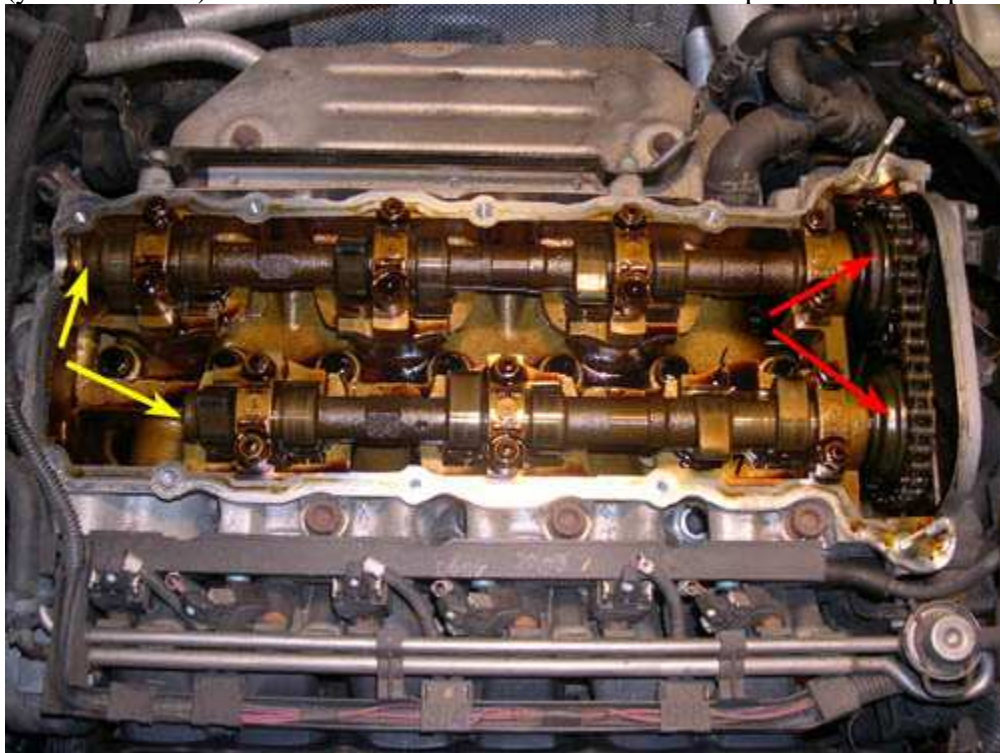
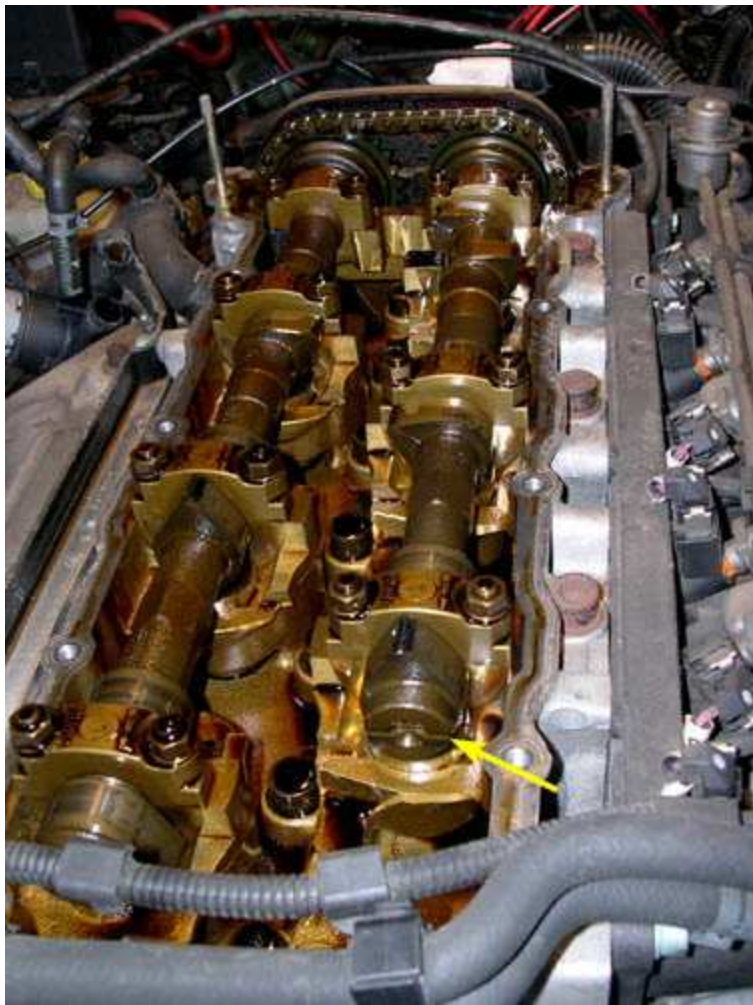
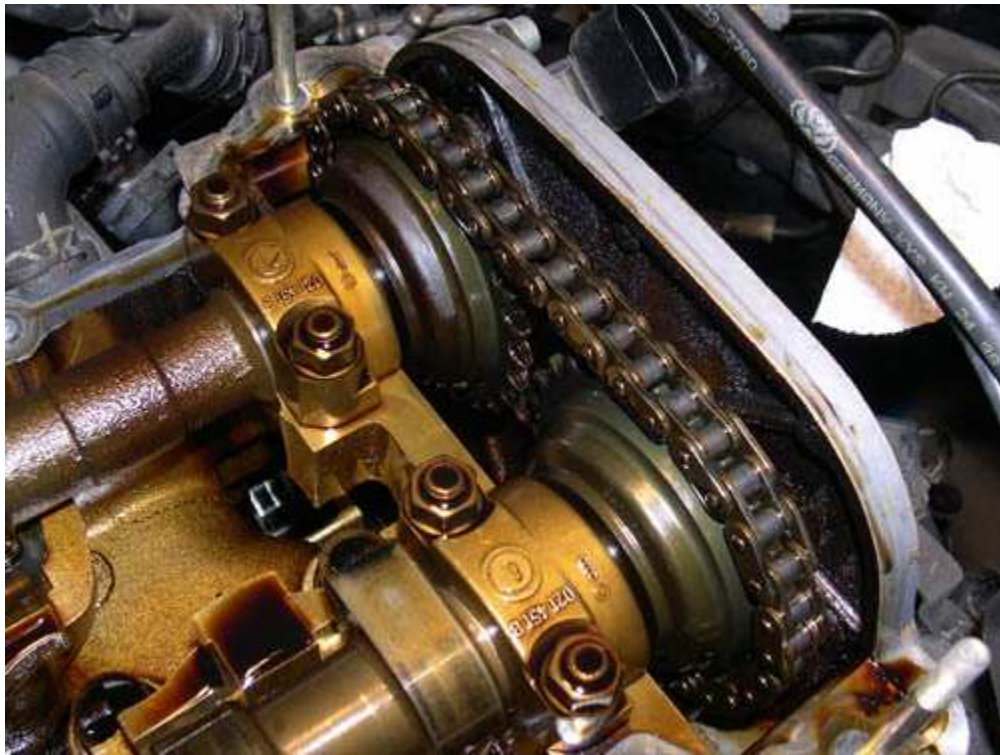
3. The images below show the two camshafts. On the passenger's end are grooves that are used for timing the engine (yellow arrows) and on the driver's end are the camshaft sprockets and upper timing chain.

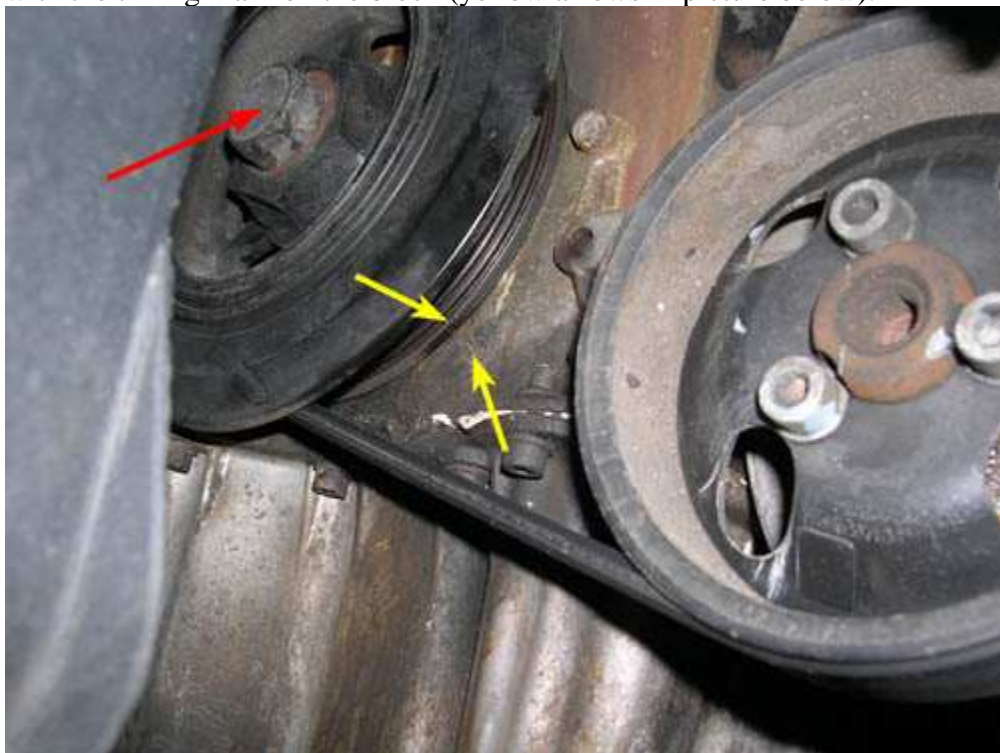
5. Crank the engine to Cylinder #1 TDC (top dead center) by slowly hand-turning the crankshaft pulley (red arrow in

picture below) clockwise with a 27mm wrench or socket until the little notch on the inner flange of the pulley lines up with the timing mark on the block (yellow arrows in picture below).

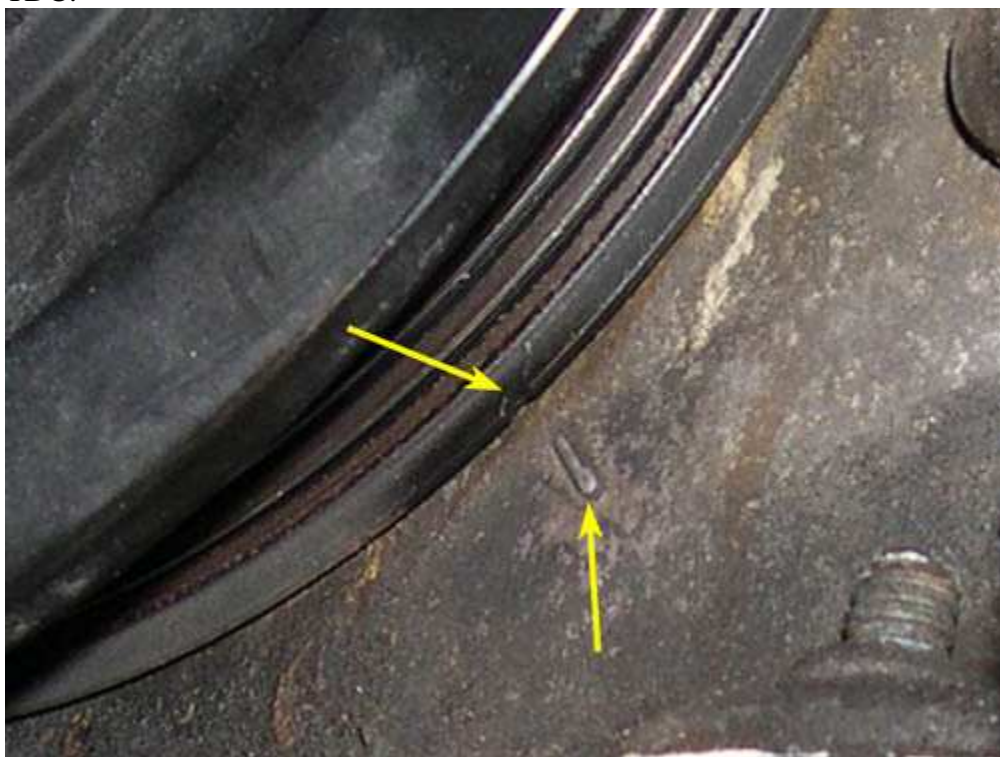
6. The picture below shows a close-up of the notch and timing mark that need to be lined up to set the engine at Cyl. #1 TDC.

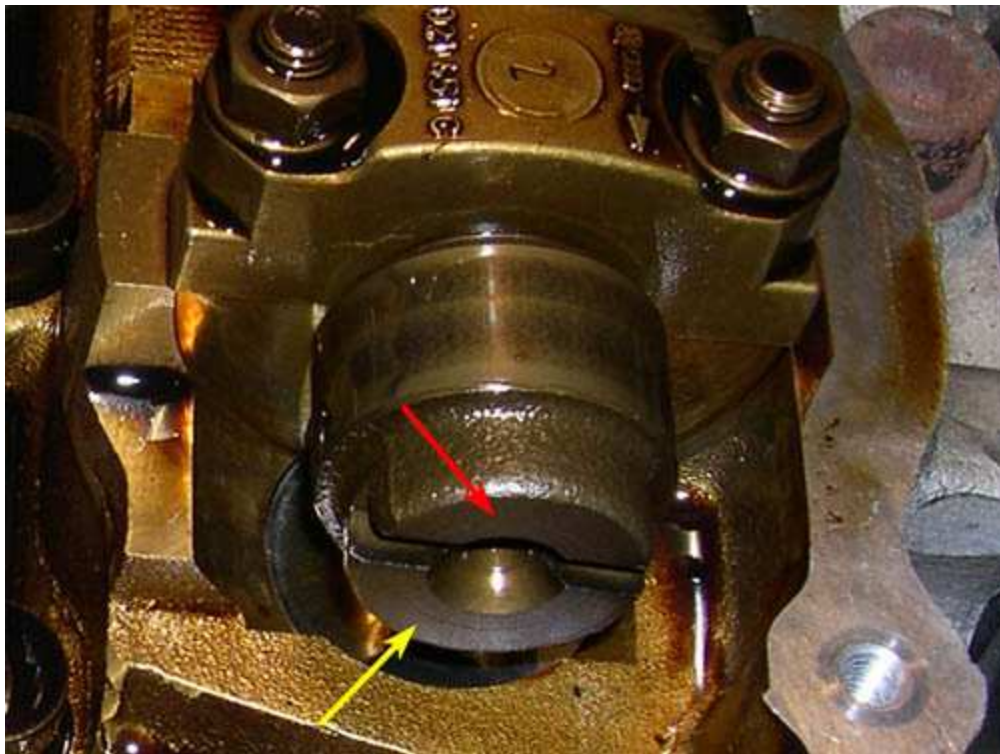
7. Once the notch and timing mark are lined up, check the groove on the end of one of the camshafts. The groove should be above the centerline of the shaft - i.e., there should be more material below the groove (yellow arrow in the picture below) than above the groove (red arrow in picture below). If the opposite is true, then the camshafts are 180° out of phase. Rotate the crankshaft one full revolution and line up the notch and timing mark again to set the camshafts for Cyl. #1 TDC (remember, two rotations of the crankshaft equals one rotation of the camshafts).

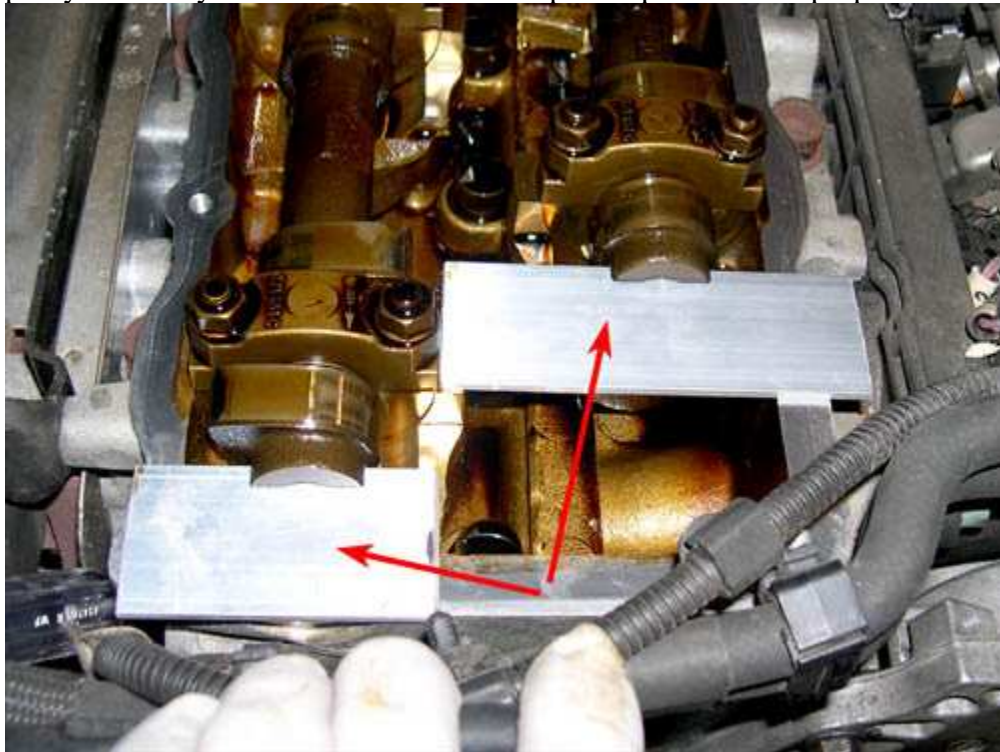
8. If everything is lined up properly and the engine is at Cyl. #1 TDC, you should be able to slide the camshaft locking tool (VW tool #3268) into the grooves. Instead of using the VW tool, I just used two 1/8" thick pieces of Al plate (purchased at Lowe's) to lock each camshaft individually, as shown by the red arrows in the picture below. You can use pretty much any 1/8" thick metal or dense plastic plate for this purpose.

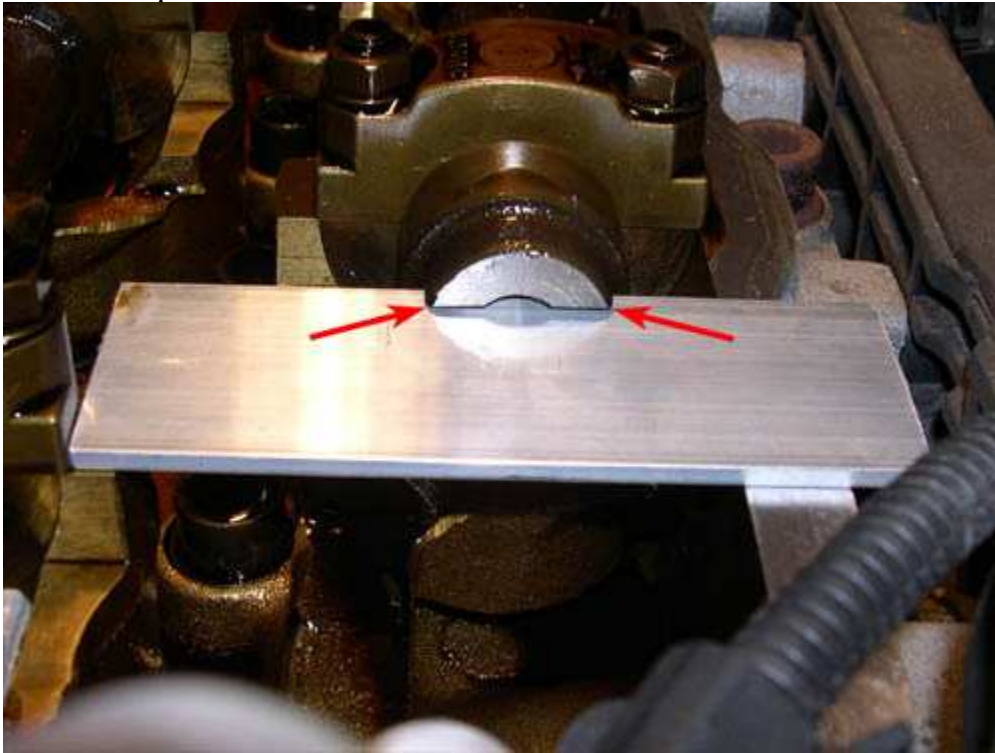
9. If the engine is timed correctly, the camshaft tool(s) (VW or improvised) should slide into the groove easily and should

be exactly parallel to it. The picture below shows that the gaps between the groove and tool on either side of the camshaft should be equal.

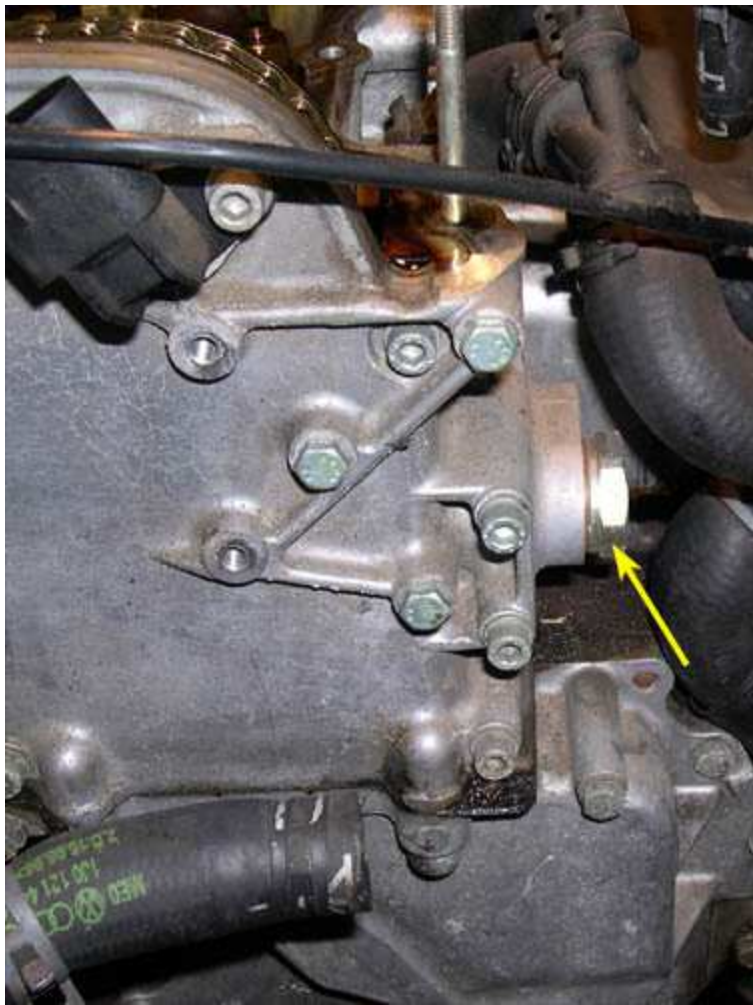
10. Remove the upper tensioner bolt (yellow arrow in the picture below) from the back edge of the upper timing chain cover using a 27mm wrench or socket.

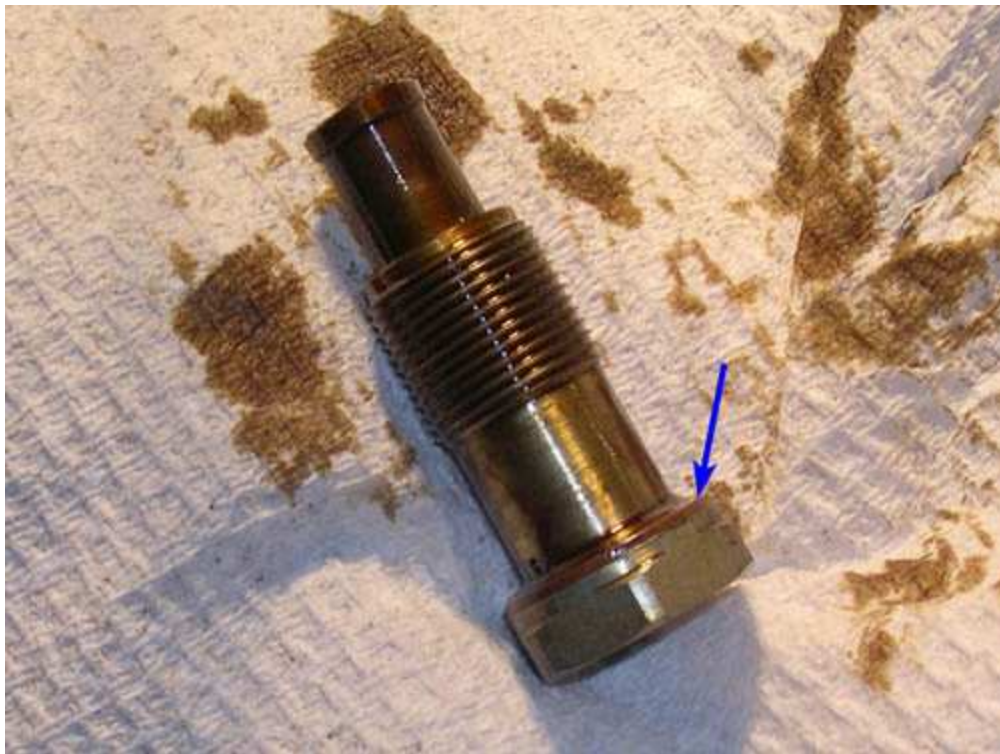
11. The picture below shows the newer style upper tensioner bolt. There should be a copper crush washer (blue arrow) present to seal the bolt against an oil leak. (Note: Even though the tensioner bolt and crush washer have separate VW part #s, the parts are one piece on the newer style tensioner.)

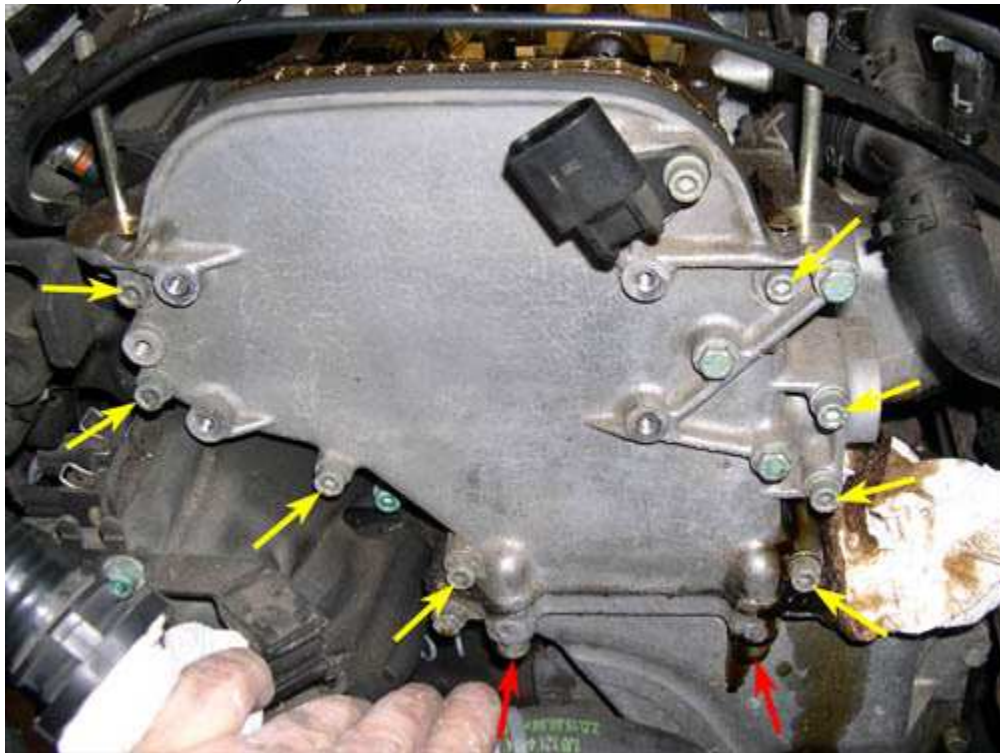
12. Remove the bolts that secure the upper timing chain cover. There are eight (8) 5mm hex bolts (yellow arrows in picture below) that secure the cover to the head and two (2) 6mm hex bolts (red arrows in picture below) that secure the upper and lower timing chain covers to each other (with part of the headgasket between them - this will be covered in more detail below).

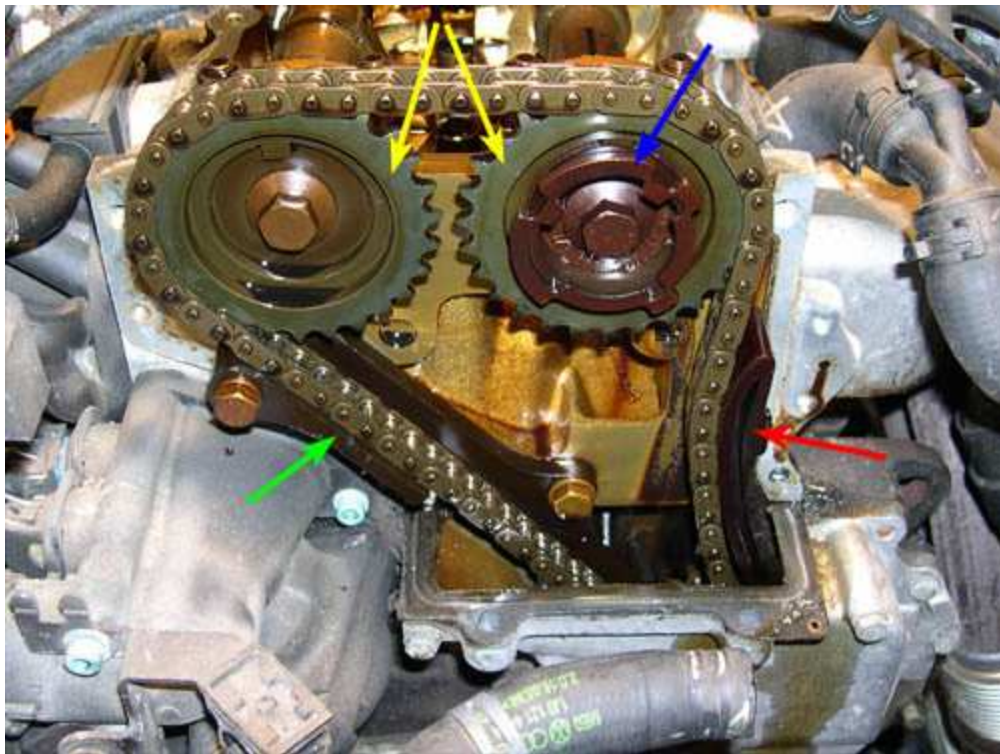
14. With the upper timing chain cover off, you should be able to see most of the upper timing chain parts, as shown in the picture below. The yellow arrows point to the two camshaft sprockets, which are secured to the camshafts with 15mm bolts. The blue arrow points to the shutter wheel on the rear sprocket that is used by the camshaft position sensor (this wheel may be slightly different on earlier model VR6s). The green arrow points to the upper guide rail and the red arrow points to the upper tensioner rail.

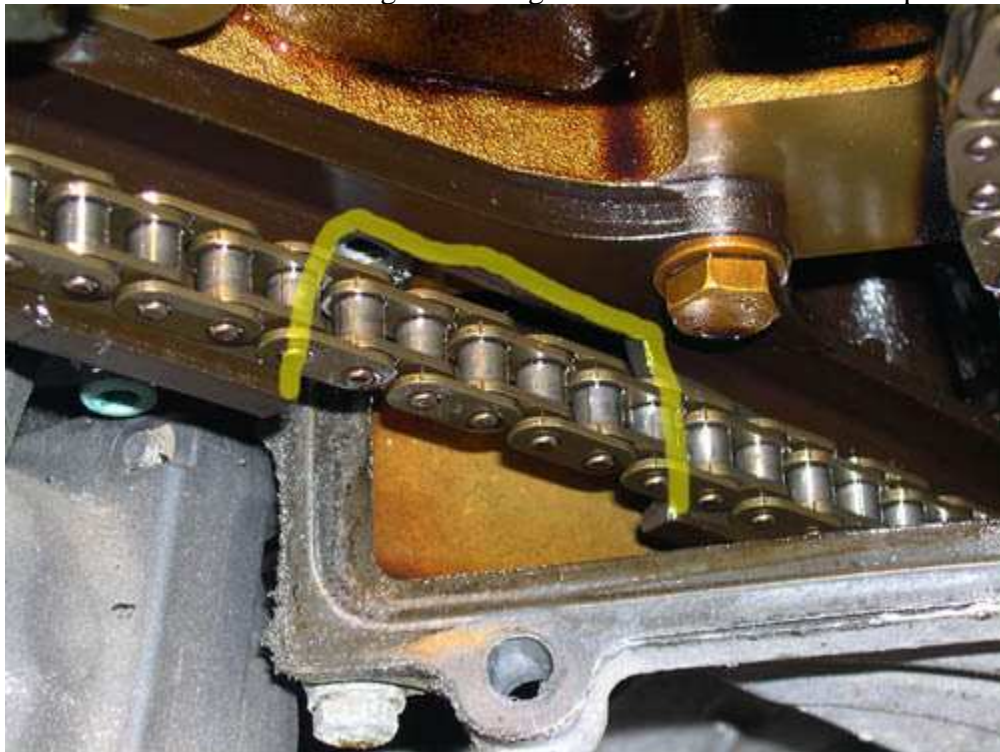
15. The picture below shows a close-up of my original upper guide rail. The yellow shading shows the location of a piece that broke off and was causing the rattling noise heard in the sound clip in the link above.

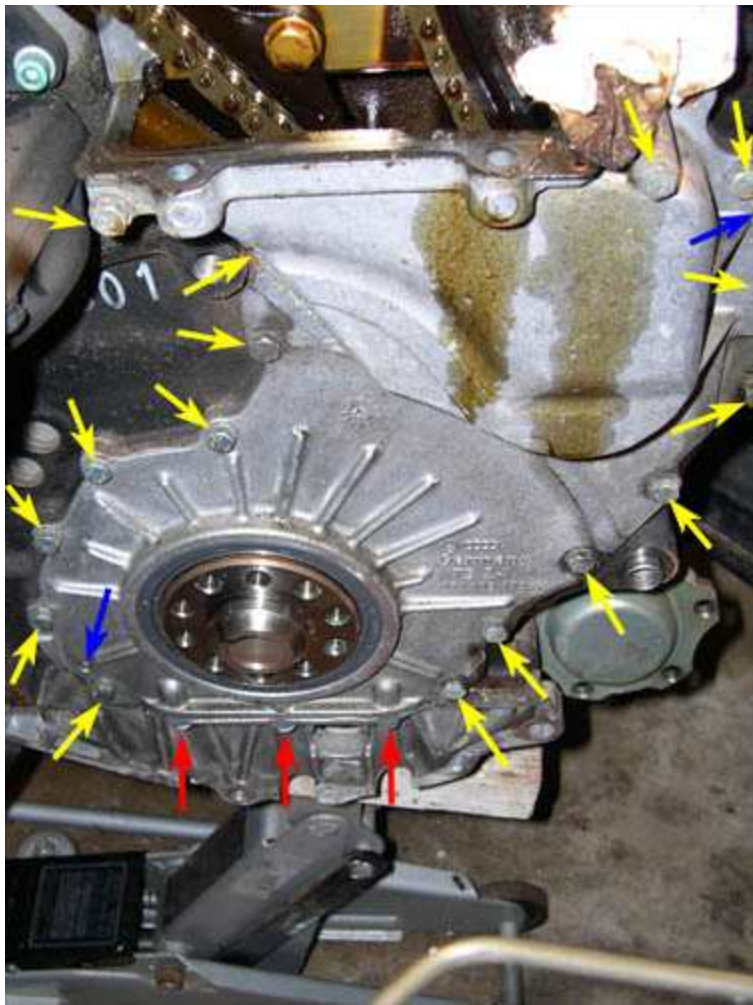
17. Remove the bolts that secure the lower timing chain cover. There are sixteen (16) 10mm bolts (yellow arrows in picture below) that secure the cover to the block and three (3) 5mm hex bolts (red arrows in picture below) that secure the lower timing chain cover to the oil pan. The blue arrows indicate the position of guide pins used to locate the cover when reinstalling it. NOTE: It has been pointed out by [uberacruzinvr6](#) that the lower part of the thermostat housing on pre-MKIV VR6s needs to be loosened/removed in order to remove the top front lower timing chain cover bolt (above the '01' in the picture below) - see pages 3 and 4 of this DIY thread and/or the DIY UPDATES section below for more info.

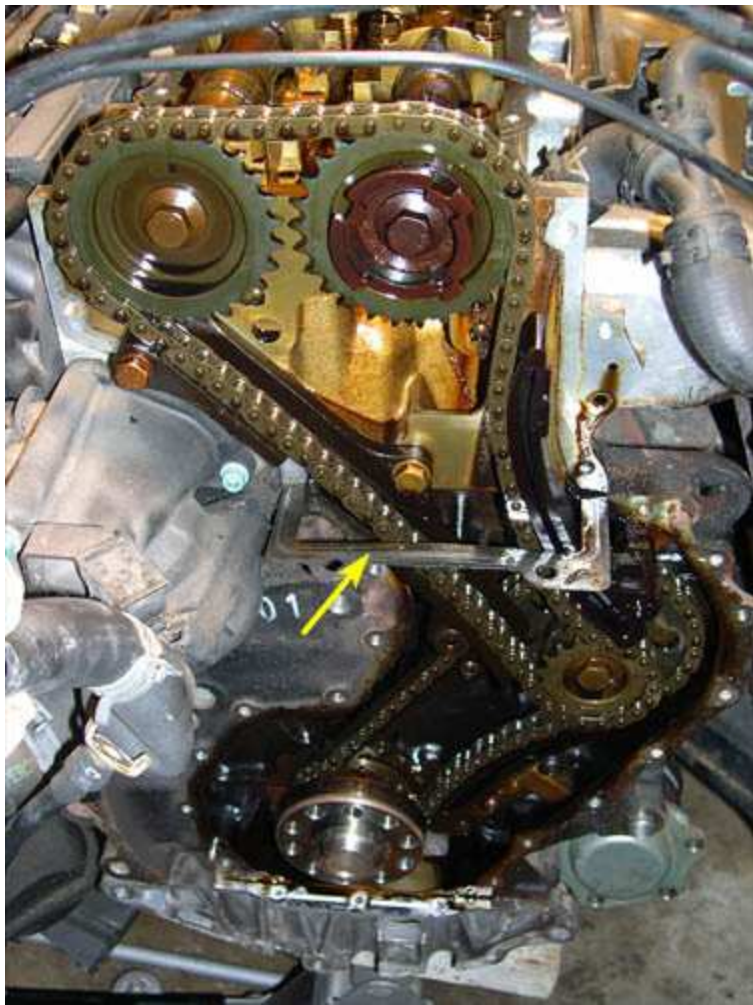
19. With the upper timing chain cover off, you should be able to see all timing chain parts, as shown in the picture below. The yellow arrow points to the part of the headgasket that normally resides between the two timing chain covers, but is now completely unprotected. Be extra careful not to damage/bend the gasket during the replacement procedure below.

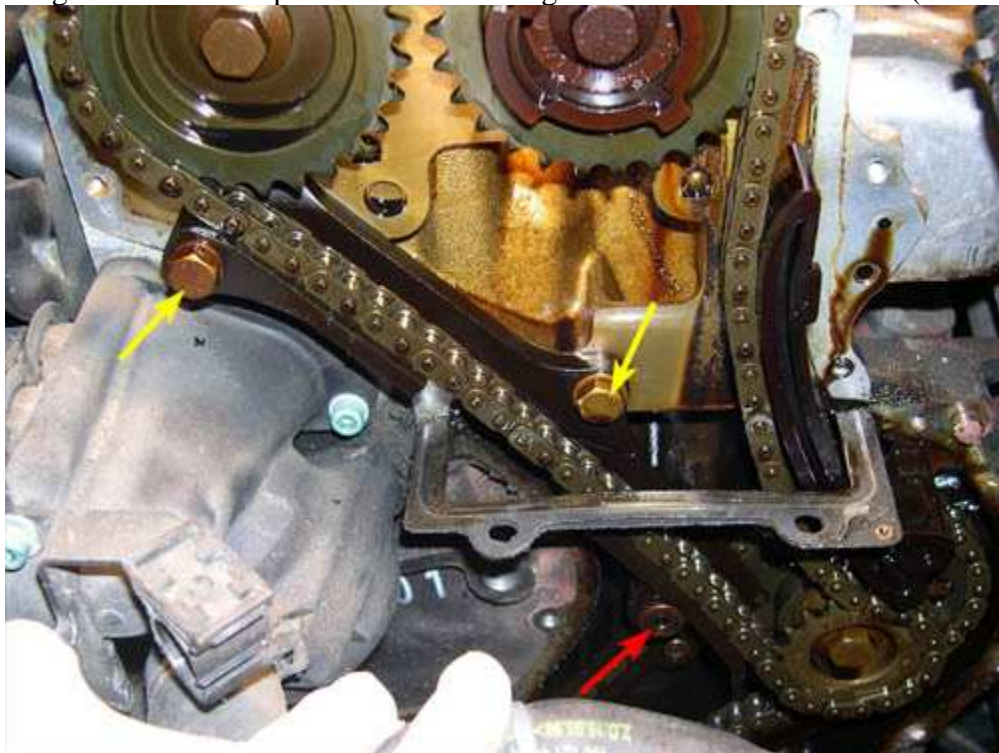
20. Remove the upper guide rail by removing the two (2) 13mm bolts (yellow arrows in picture below) and then sliding the rail up and off of the lower guide post (red arrow in picture below). You do not need to remove the guide pin. (Note that the guide pin resides behind the lower chain cover - I suspect that VW used a guide pin instead of a bolt here so that the guide could be replaced without having to remove the lower cover (and consequently, the tranny, clutch, etc).

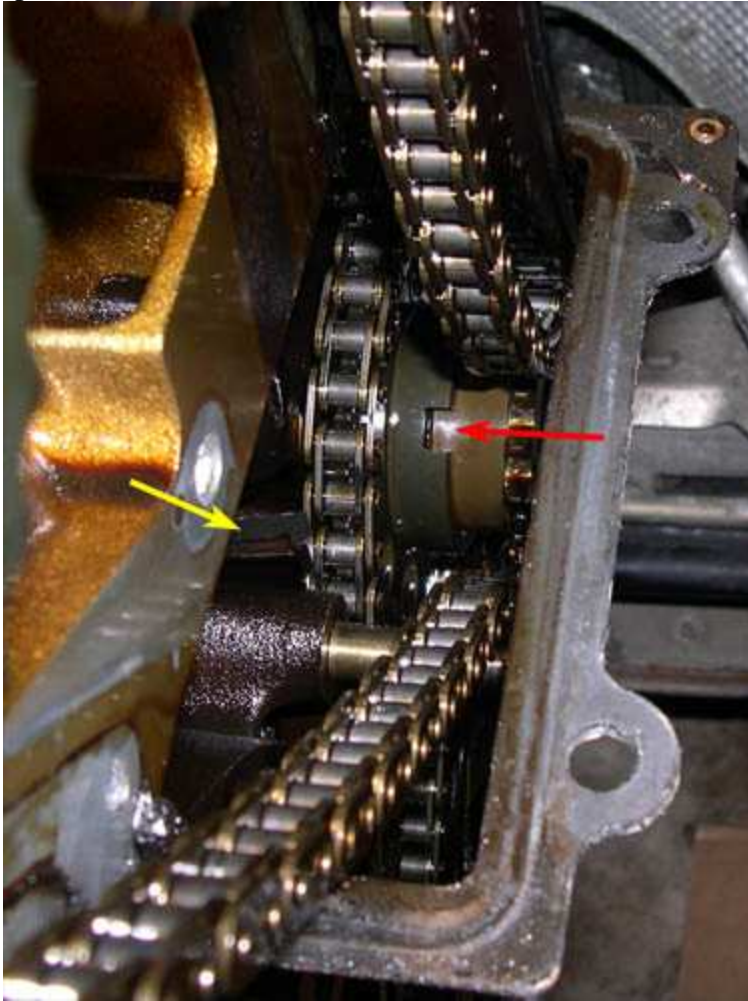
21. The picture below shows the notch in the inner intermediate sprocket (red arrow) that should be visible when the intermediate shaft is timed correctly (MKIV Bentley step #7 and Figure #21 on page 15d-16). Also, the yellow arrow points to the piece of my upper guide rail that broke off and was rattling in between the block and the inner intermediate sprocket.

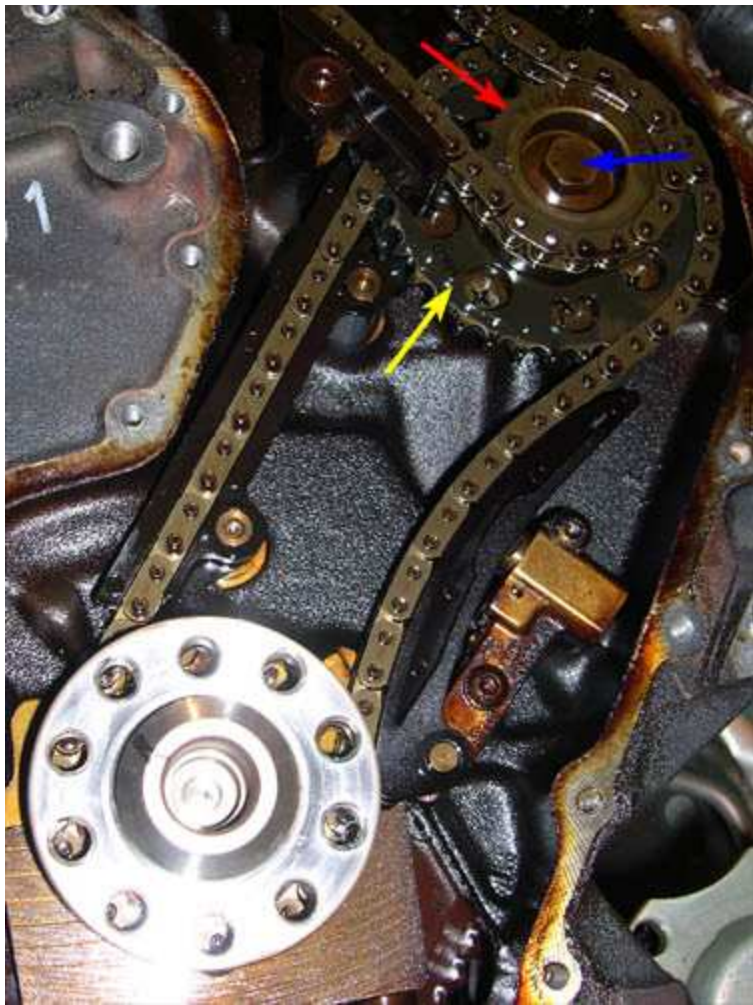
22. In order to remove both the upper and lower timing chains, it is necessary to create some slack in the chains. The easiest way to accomplish this in both chains is to remove the intermediate sprockets. In the picture below, the yellow arrow points to the inner intermediate sprocket and the red arrow points to the outer intermediate sprocket. To remove the sprockets, remove the 15mm bolt (blue arrow in picture below) that secures the sprockets to the intermediate shaft. In order to do this, it is necessary to counterhold the crankshaft to keep it at Cyl. #1 TDC. You can use one of the special VW tools to do this, or you can just have a friend counter hold the crankshaft pulley with the 27mm wrench or socket and a long breaker bar. The intermediate shaft bolt is torqued on fairly tight (74 ft-lbs or 100 N-m), so it will take a good amount of force to loosen it. If the crankshaft accidentally moves slightly while loosening the bolt, turn the crankshaft back to Cyl. #1 TDC BEFORE removing the intermediate bolt and sprockets. (Note: Leave the camshaft locking tool in place while loosening the intermediate shaft bolt. As long as the crankshaft does not move significantly, there is no harm in leaving the tool in the camshaft grooves.)

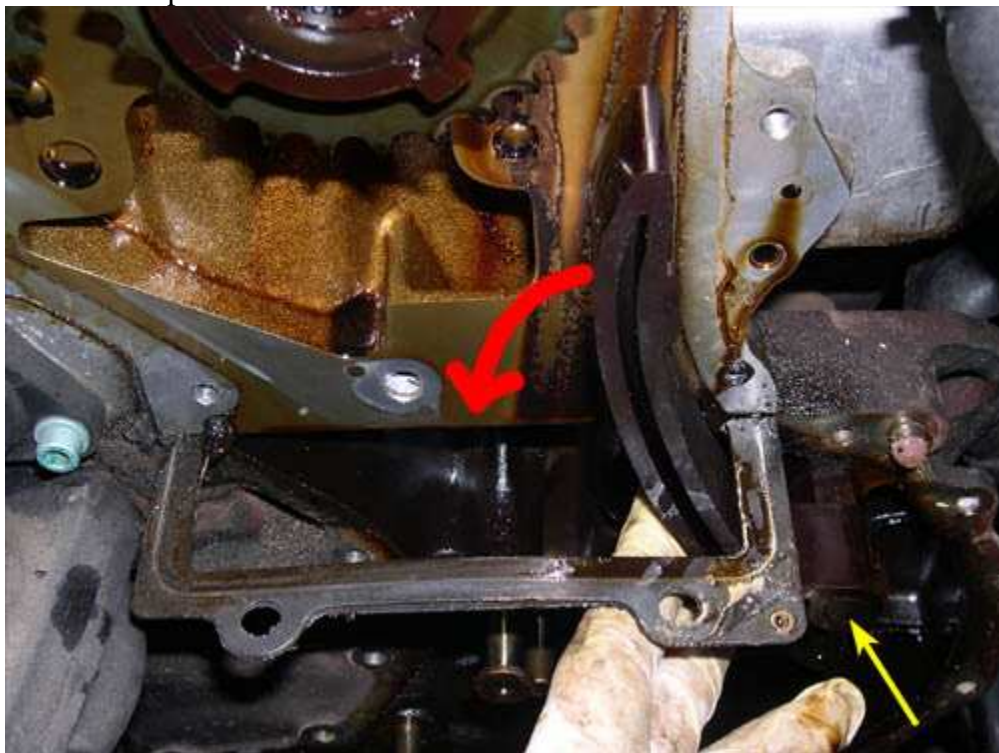
24. With the upper chain removed, the upper tensioner rail should fall down through the hole in the exposed headgasket, as indicated by the red arrow in the picture below. The tensioner rail pivots on a pin, which is indicated by the yellow arrow in the picture below.

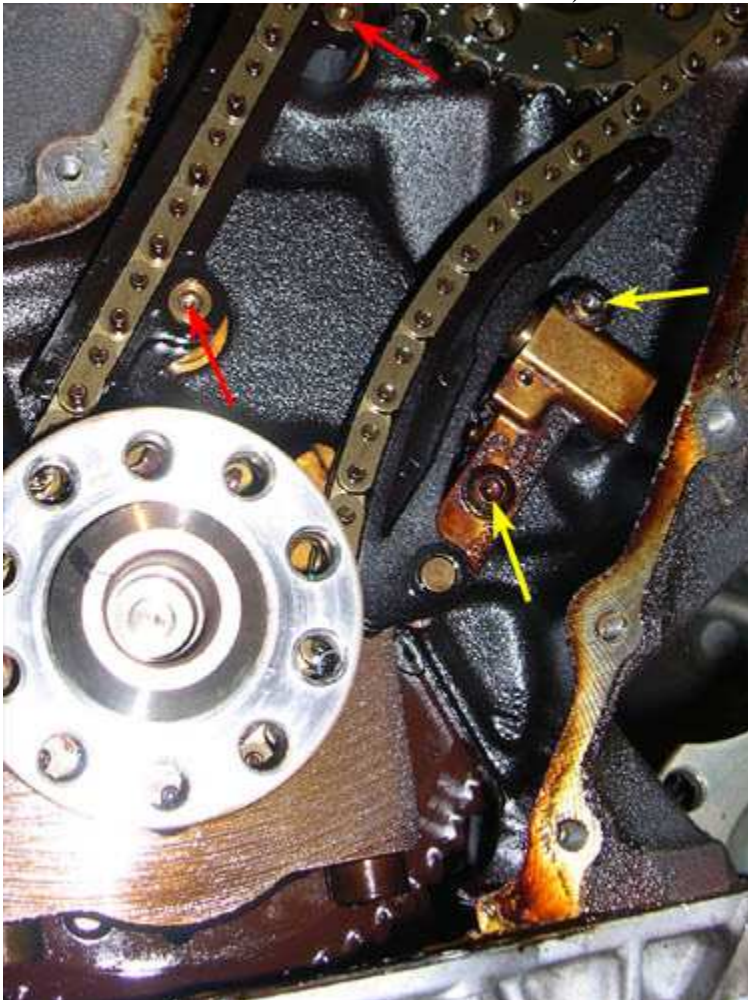
26. Remove the lower tensioner unit by removing the two (2) 5mm hex bolts indicated by the yellow arrows in the picture below (the tensioner will fully extend when removed if you don't hold the rail and body together or secure it with a U-clip like the one that comes with a new tensioner).

only goes on one way) and then remove the lower timing chain from the crankshaft sprocket. Finally, slide the lower guide rail off its guide pins, which are indicated by the red arrows in the picture above. You do not need to remove the guide pins.

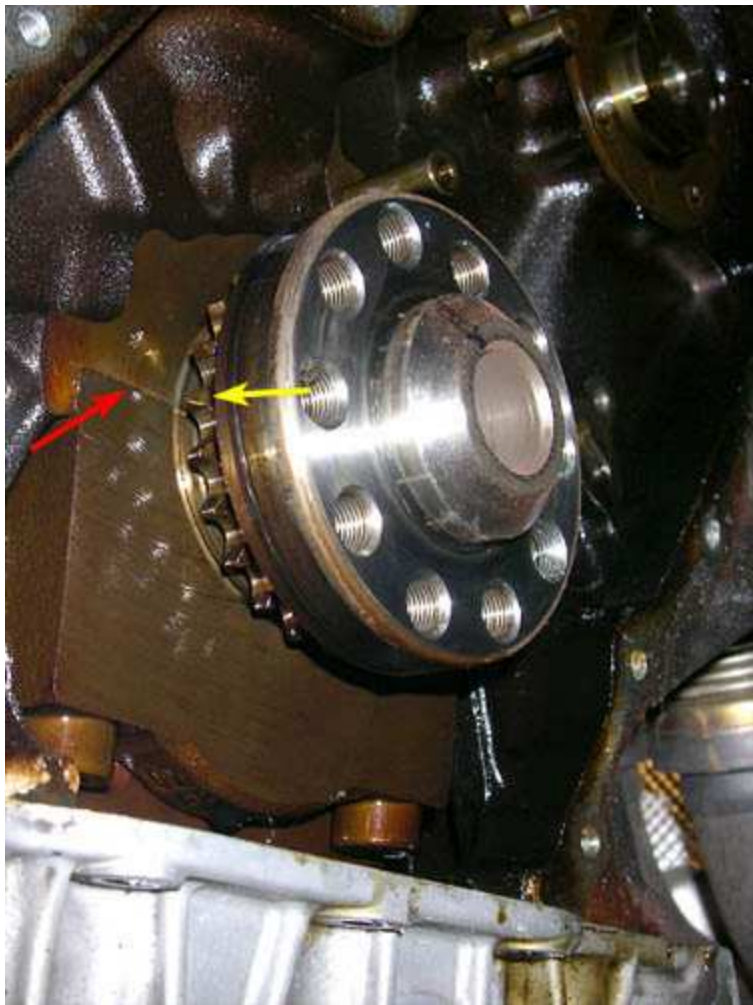
30. Before installing new timing chain parts, double check that the crankshaft is timed correctly. If the crankshaft is timed correctly, a ground tooth on the crankshaft sprocket (yellow arrow in the picture below) should line up exactly with the split in the main crankshaft bearing cap (red arrow in the picture below). This should be the case when the engine is at Cyl. #1 TDC (i.e., the notch on the crankshaft pulley and the timing mark on the block are lined up as shown in steps 5 and 6).

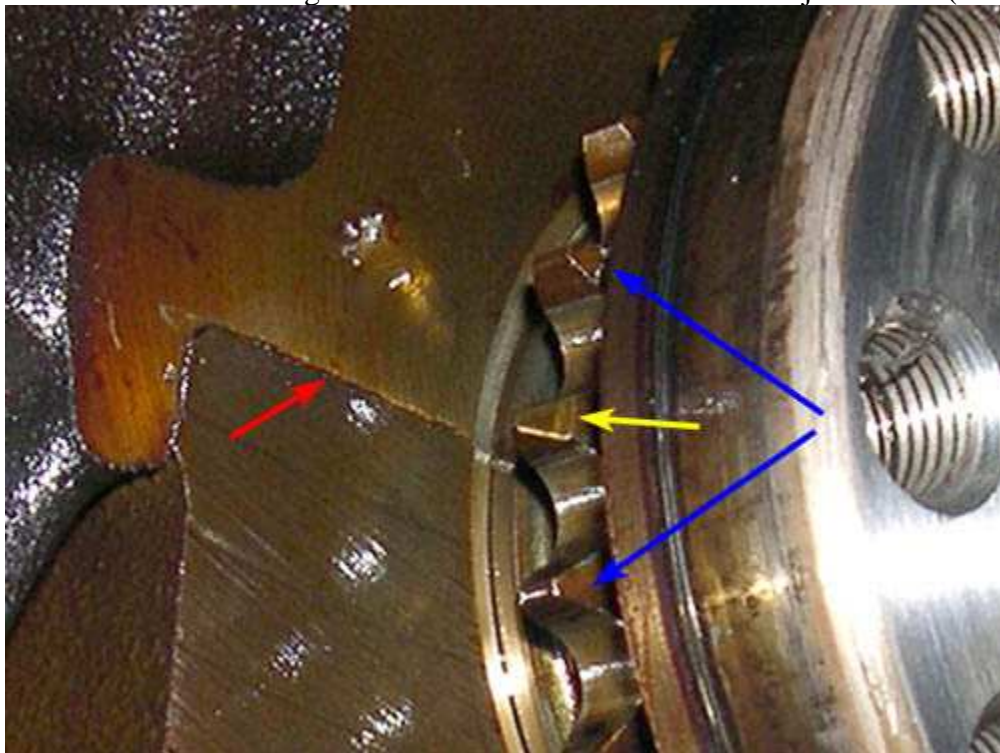
31. The picture below shows a close-up of the ground tooth (yellow arrow) and bearing split (red arrow). Note the difference between the ground tooth and the "normal" teeth adjacent to it (blue arrows).

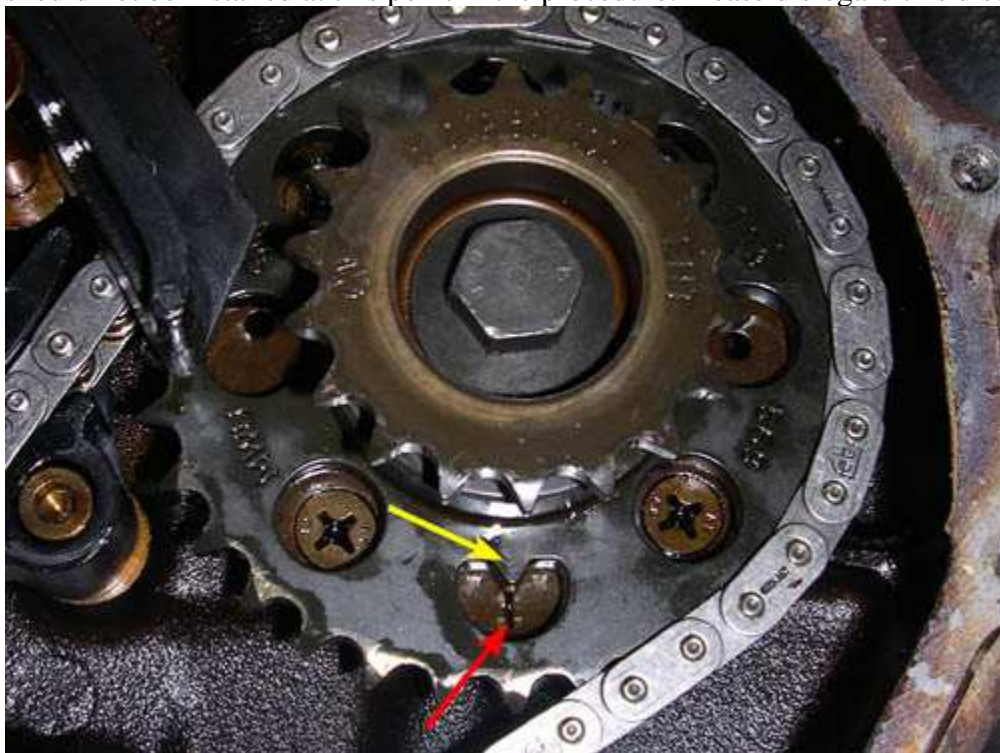
32. Slide the inner intermediate sprocket onto the intermediate shaft and rotate the sprocket until the pointer in one of the sprocket holes (yellow arrow in the picture below) lines up exactly with the vertical mark on the intermediate shaft thrust washer behind the sprocket (red arrow in the picture below). The intermediate shaft is timed correctly when the pointer and washer mark are lined up. Note: The picture below was taken out of sequence, and as a result, shows the lower chain,

outer intermediate sprocket, intermediate sprocket bolt, lower guide rail and upper guide rail already installed. They should not be installed at this point in the procedure. Please disregard this discrepancy between the text and photo.

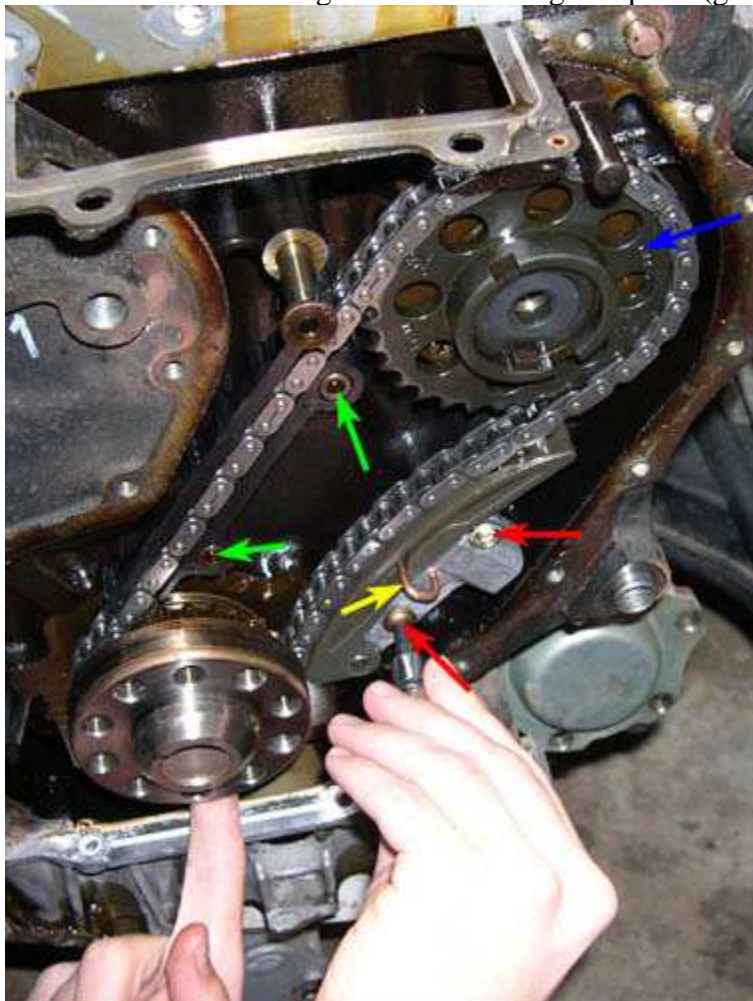
33. Slide the new lower guide rail onto its guide posts (green arrows in picture below).

34. Install the new lower timing chain onto the crankshaft sprocket, slide it into the lower guide rail and then over the inner intermediate sprocket (blue arrow in picture above). Make sure that all of the slack is on the rear side of the chain and that the crankshaft and intermediate shaft timing marks are still lined up correctly. Next, install the new lower

tensioner unit and torque the two tensioner bolts (red arrows in picture above) to 89 in-lbs (10 N-m). Finally, check again that the timing marks are lined up correctly and then remove the u-clip used to keep the tensioner fully compressed during installation (yellow arrow in picture). This will apply tension to the lower chain. NOTE: Be very careful not to accidentally pull the inner intermediate sprocket off of the intermediate shaft after the u-clip is removed or the lower tensioner will fully extend.
