REPLACING TIMING CHAINS, TENSIONERS AND GUIDES ON A MKIV 12v VR6

Written by: Dr. Gary Thompson (Vortex SN: VgRt6)

The following DIY outlines the procedure for replacing timing chain parts on a MKIV 12v VR6 engine.

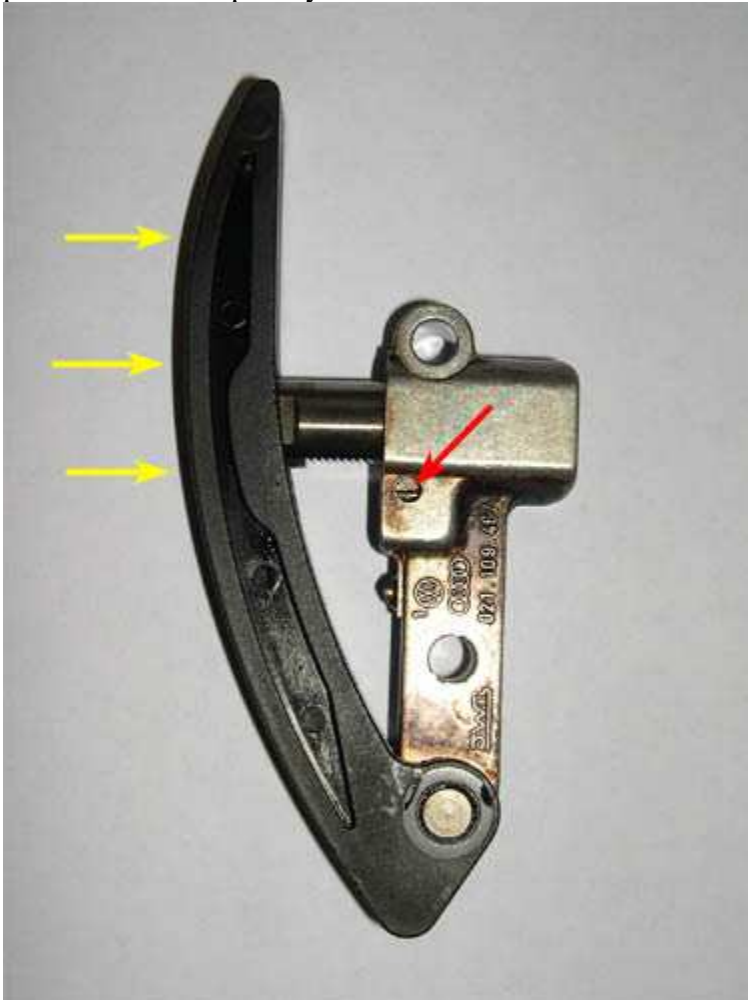
TIP: If your lower tensioner is fully extended (as shown in the picture below), it needs to be fully compressed, or reset, before installation. To do this, use a small screwdriver or similar tool to slide the ratcheting mechanism in the hole in the tensioner body (red arrow in picture below) toward the pivot point between the body and tensioner rail and then push in on the rail (yellow arrows in picture below). Remember, if you let go of the rail it will fully extend again. Either hold it in place with a U-clip or by hand until it is installed.

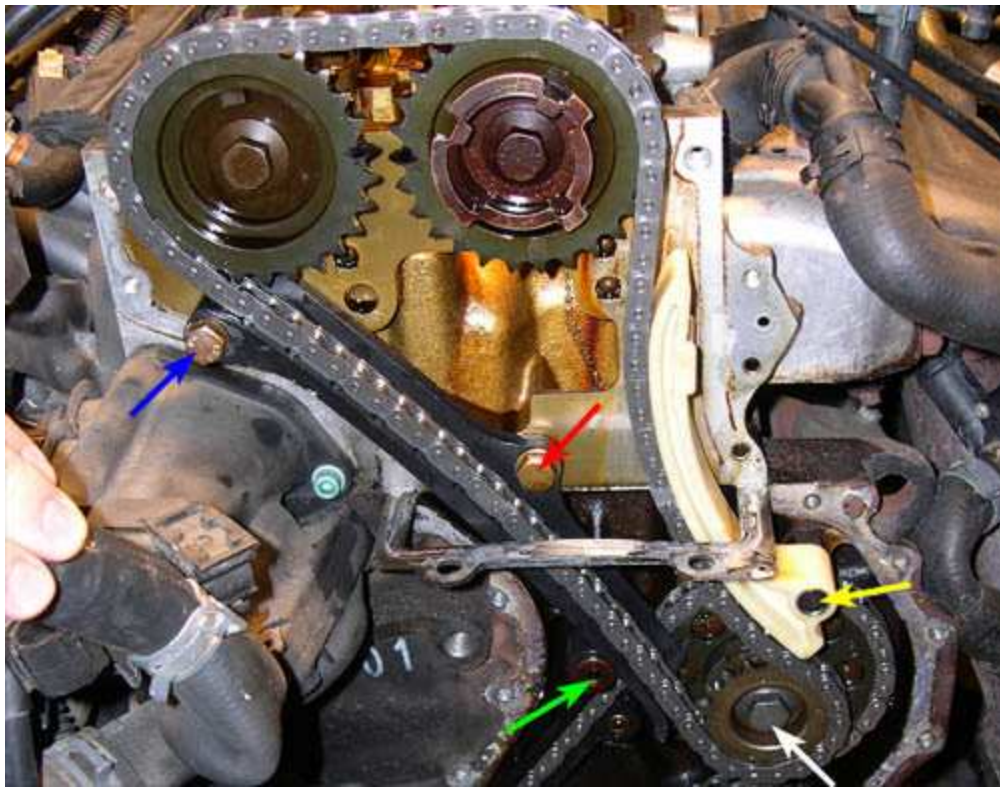
35. Slide the new upper tensioner rail onto its pivot pin (yellow arrow in picture below) and rotate the rail clockwise through the hole in the headgasket. Use a piece of tape or something similar to temporarily hold the rail in the upright position (remove the tape after the upper timing chain and outer intermediate sprocket have been installed). Next, install the new upper guide rail by sliding it onto its guide pin (green arrow in picture below) and then installing the two (2) 13mm bolts (red and blue arrows in picture below). Use Loctite (blue - med. strength) on the central, shorter bolt (red arrow) and torque both bolts to 15 ft-lbs (20 N-m).

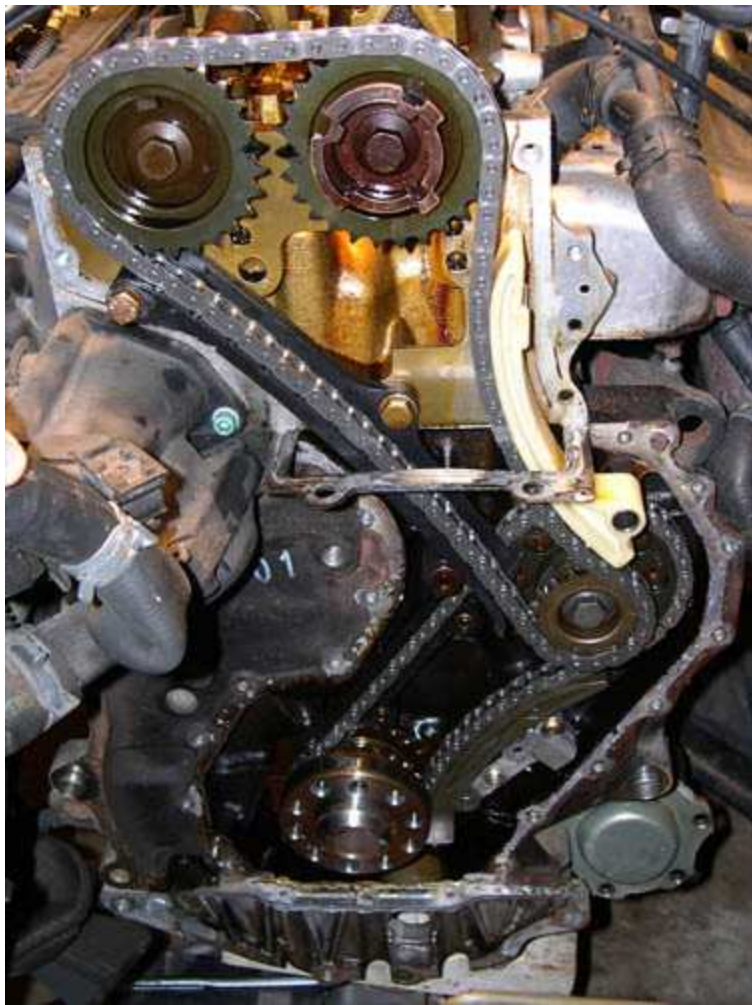
39. The new timing parts should now be correctly installed, as shown in the picture below.

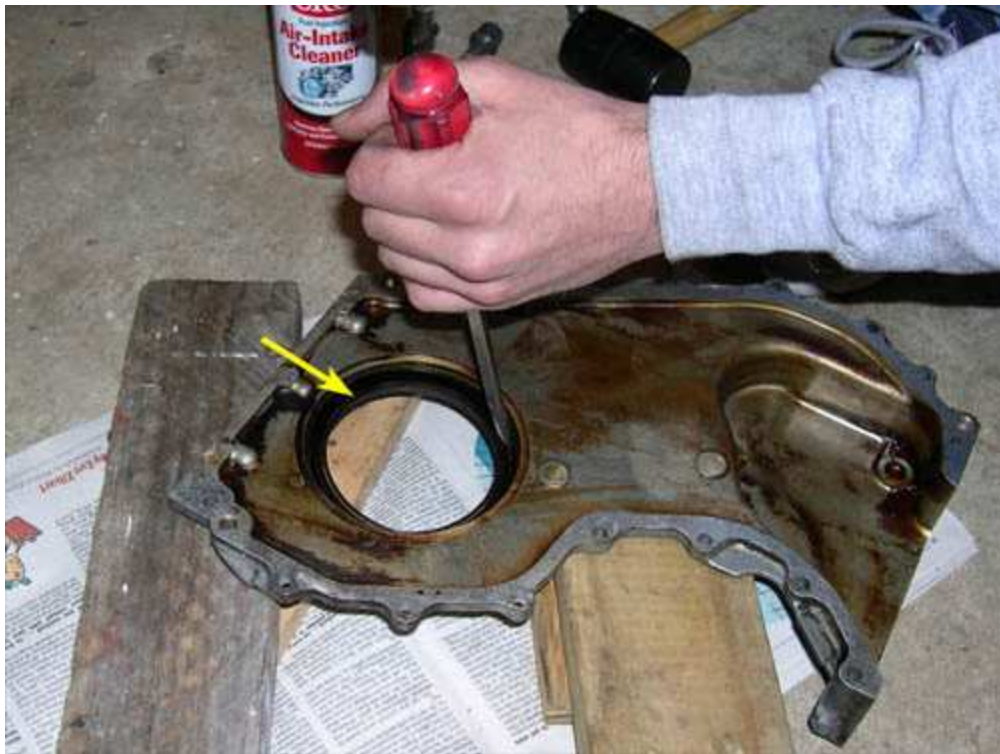
45. To remove the old rear main seal (yellow arrow in picture below), support the lower timing chain cover with a few pieces of wood with the inside surface of the cover facing up, as shown below. Using a screwdriver or other similar tool and a hammer, carefully pound the old seal out of the cover. The old seal may be in there tight, so you may have to pound pretty hard to get it out. Be careful not to mar the mating surface of the timing cover or the new seal may not seal properly when installed. Just take your time and pay attention and it should come out without any problems.

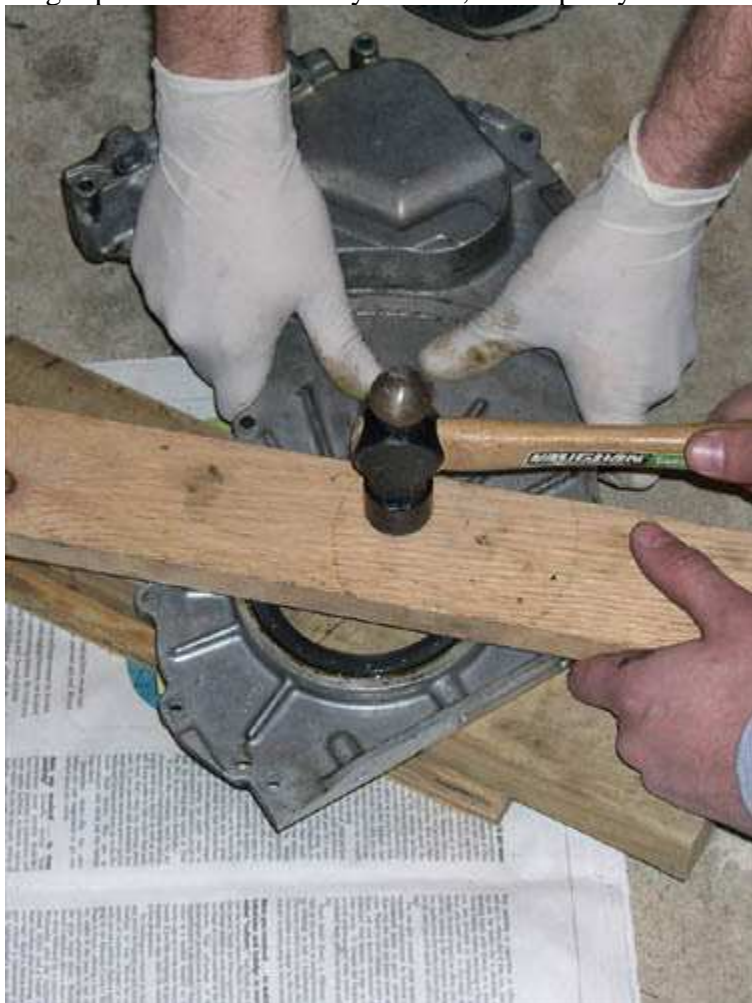
46. To install the new rear main seal, flip the timing chain cover over, apply some oil to the mating surfaces of the cover and seal and then carefully pound the seal into the cover using a hammer and a wide board, as shown in the picture below. Move the board around the perimeter of the seal while pounding to make sure that the seal goes in straight. The seal is installed fully when the outer edge of the seal lines up with the outer edge of the cover (at this point the board will no longer pound the seal in any further, so it's pretty much idiot-proof).

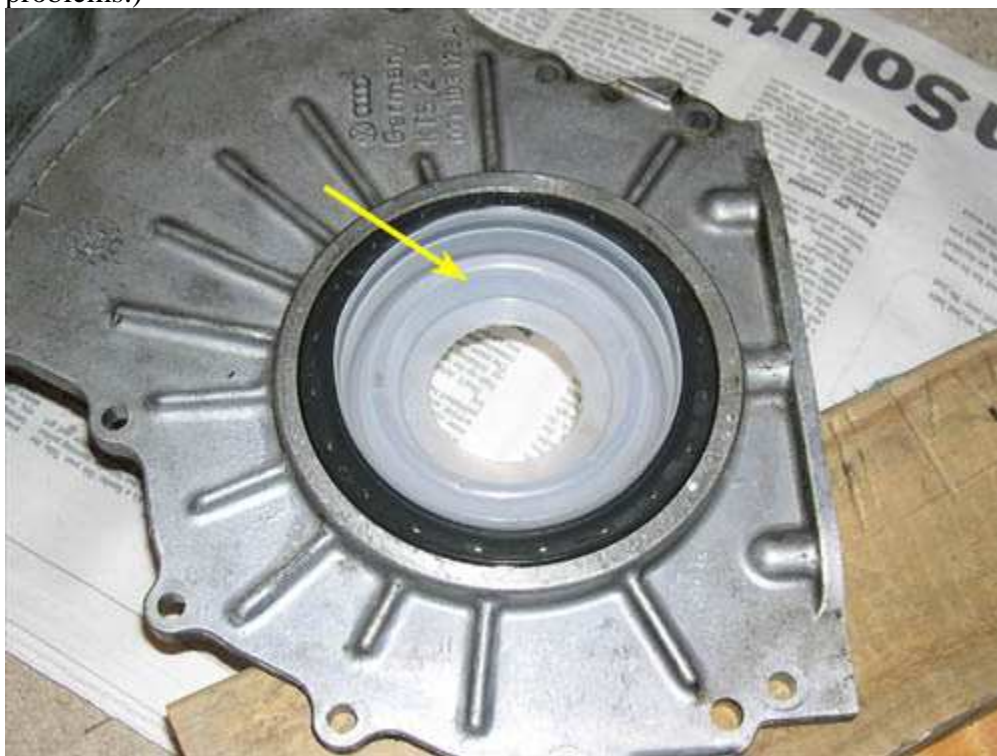
47. The picture below shows the new seal installed in the lower timing chain cover. Also shown is a plastic insert (yellow

arrow) that is provided with the seal to make the installation of the seal around the crankshaft flange easier when installing the lower timing chain cover. (We tried to use this piece when installing the cover, but it actually got in the way and kept popping out of the seal prematurely. We eventually gave up and just installed the lower cover without it without any problems.)

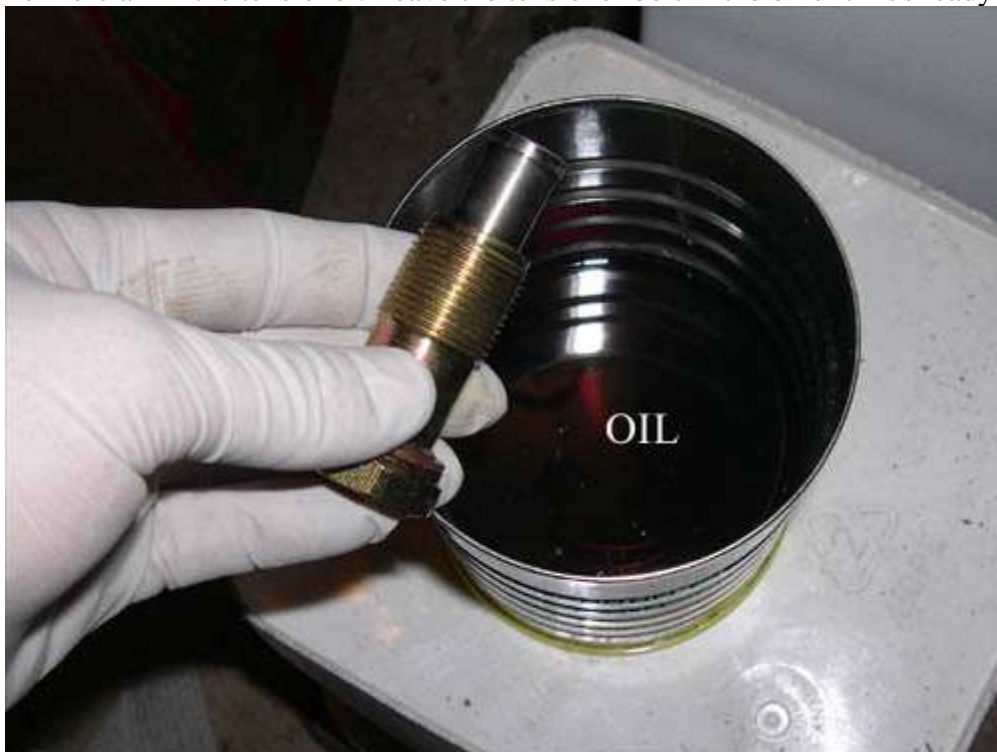
48. Before permanently installing the upper tensioner bolt, it is a good idea to bleed the air from it and fill it up with oil. Fill a coffee can or other container with about 4 inches of motor oil, as shown in the picture below. Place the tensioner bolt in the can with the plunger end down and the head end up (so that the feed hole is at the highest point). While submerged, press down on the bolt in the can to compress the plunger fully. This will force any air out of the tensioner. Release the tensioner while submerged to fill the tensioner with oil. Repeat this a few times until you're confident there is no more air in the tensioner. Leave the tensioner bolt in the oil until it's ready to be installed.

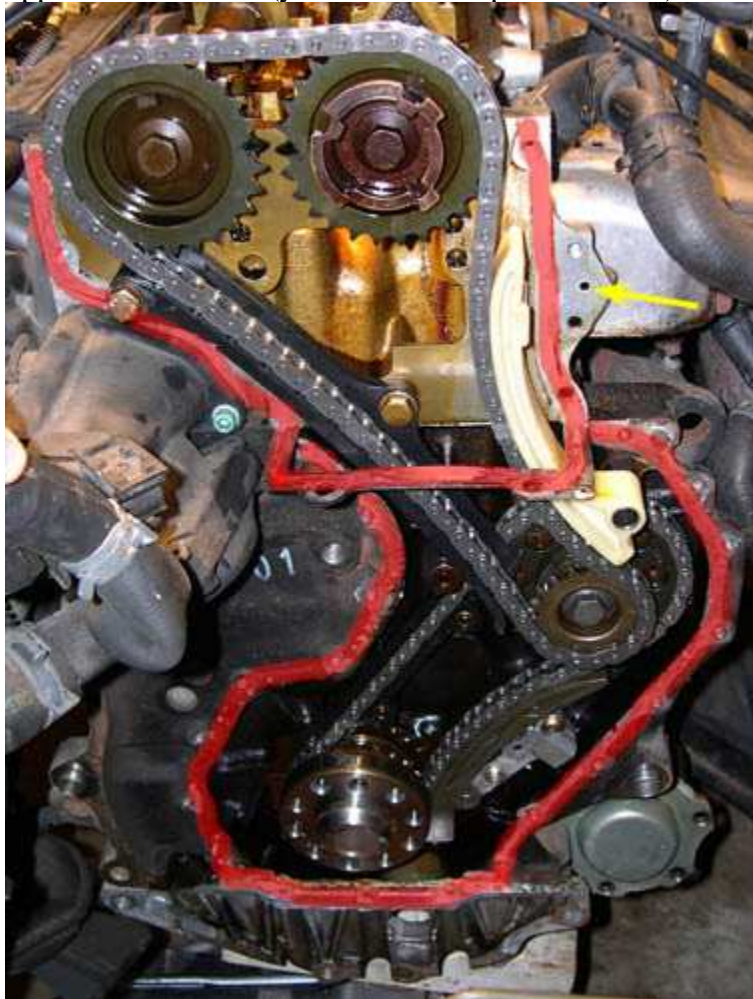
49. Apply RTV sealant to the mating surfaces of the timing chain covers. These surfaces are what contact the red shaded areas in the picture below (don't forget about on top of the oil pan and on both the top and bottom of the headgasket. Use ultra-grey import RTV to seal the timing chain covers since it is O2 sensor-safe. Make sure that the oil feed hole for the upper tensioner bolt (yellow arrow in picture below) will not be clogged with RTV when the upper cover is installed.

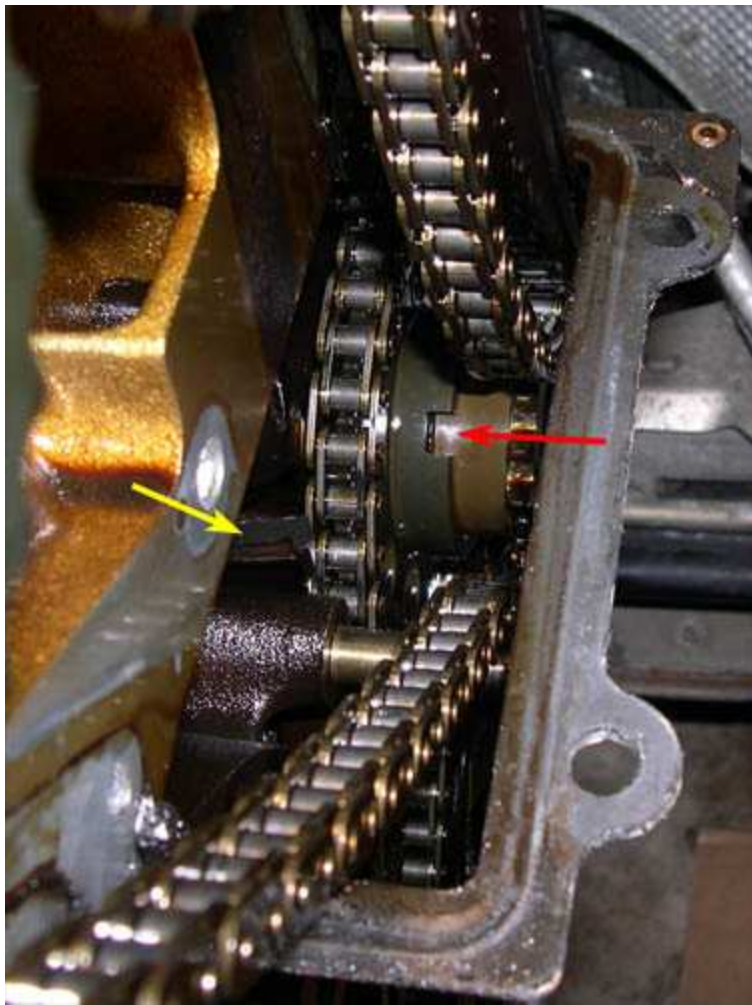
If possible, before removing the upper timing chain so you can remove the head, set the crank to Cyl. #1 TDC and don't rotate the engine until the head and upper timing chain have been reinstalled. If this is your situation, then the following information does not apply to you. Since this situation is not always possible (either the crank was not set to TDC before the upper chain was removed or the crank was turned with the upper timing chain disconnected), before reinstalling the head and upper timing chain, you MUST make sure to rotate the crank until Cyl. #1 is at TDC AND you can see the notch in the intermediate sprocket, as shown by the red arrow in the picture below.

If you do not do this, there is a strong possibility that when the upper timing chain is reinstalled, it will be one half of a tooth off relative to the lower timing chain. To make sure that this situation does not arise, turn the crankshaft until Cyl. #1 is at TDC and then check for the notch in the intermediate shaft. If it is not visible, turn the crankshaft another revolution and check again for the notch. Repeat the process until the crankshaft is at TDC AND you can see the notch in the intermediate sprocket. You may have to rotate as much as 3+ revolutions (4 would get you back to your starting place) in order for both to occur simultaneously. The amount of crankshaft revolution necessary will depend on how far off the crankshaft was from TDC or how much the crankshaft was rotated with the upper timing chain disconnected.

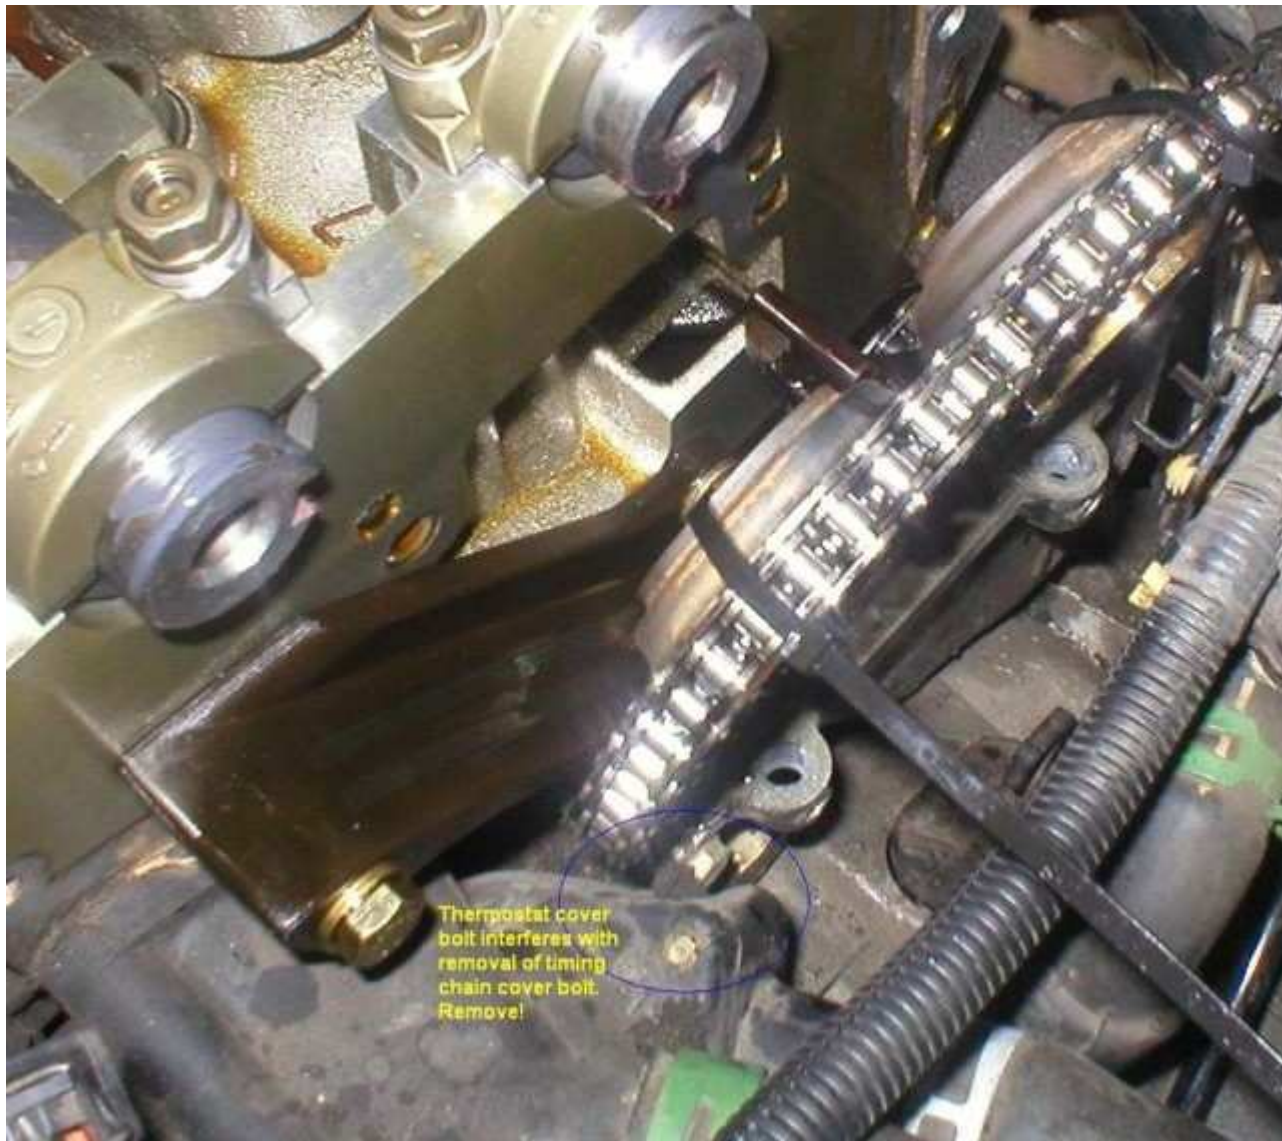
Thermostat cover bolt interferes with removal of timing chain cover bolt. Remove!
