VWvortex Forums > Golf IV & Jetta IV > DIY - Removing and cleaning a MKIV throttle body Post New Topic Start New Poll (throttle valve control module) [Archived]

REMOVING AND CLEANING A MKIV THROTTLE BODY (THROTTLE VALVE CONTROL MODULE)

The following outlines the procedure for removing and cleaning the drive-by-wire (DBW) throttle body (officially known as the throttle valve control module) on a MKIV VW. The procedures were based on a 99.5 Jetta GLS VR6 and may be different on MKIV cars with different engines (1.8T, 2.0), body styles (Golf, GTI, New Beetle) and from different model years. Specifically, the procedures for removing and reinstalling the throttle body (herein referred to as TB) may differ due to slight differences in the design and orientation of the TB, however, the general removal/reinstallation procedures, as well as the cleaning procedures should be very similar. Please do these procedures at your own risk and be ready to make small adjustments while doing them. Also, please be observant while removing parts so that they go back together correctly.

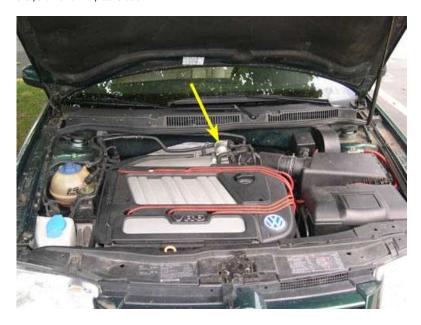
1. The TB is located at the back of the engine bay between the air intake hose and the intake manifold and is indicated by the yellow arrow in picture below.

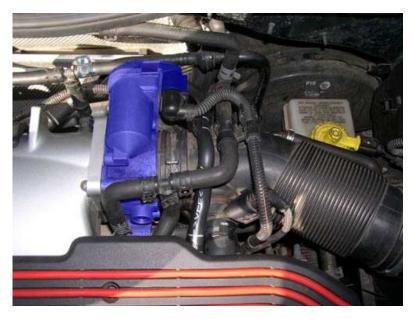
2. The TB is shaded blue in the picture below.

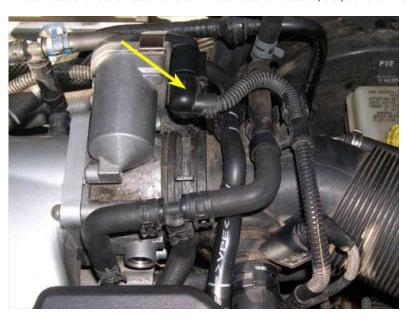
3. Remove the battery box cover and disconnect the negative (-) battery lead from the battery using a 10mm wrench or socket. Secure the lead away from the (-) battery post so that it does not accidentally touch it while you're working on the car. 4. Disconnect the harness connector from the TB. The connector is indicated by the yellow arrow in the picture below.

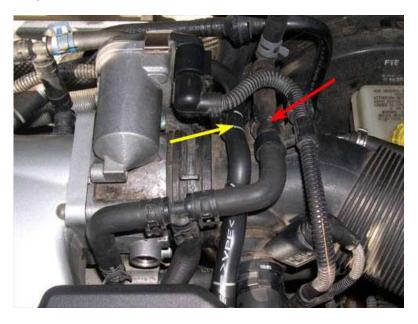
5. Unclip the coolant hose (red arrow in picture below) and the PCV vacuum-assist hose (yellow arrow in picture below) from the top of the air intake tube.

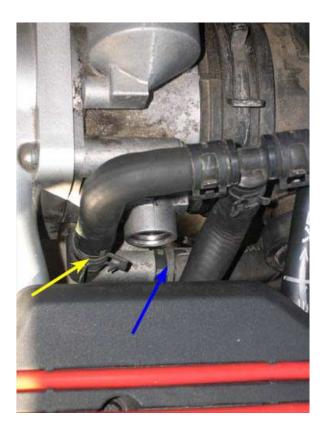
6. Disconnect the upper coolant hose (yellow arrow in picture below) and lower coolant hose (blue arrow in picture below) from the TB. To do this, use the appropriate tool (pliers or screwdriver) to release the tension from the hose clamp, slide the clamp down the hose and out of the way (for spring clamps, make sure the clamp is moved past the end of the nipple inside the hose or the clamp will reapply pressure to the nipple when released), and then pull the hose off of it's nipple.

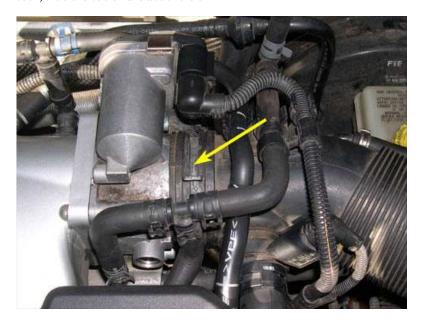
7. Release the tension from the clamp securing the main air intake tube to the TB (indicated by yellow arrow in picture below) and then slide the intake tube off of the TB.

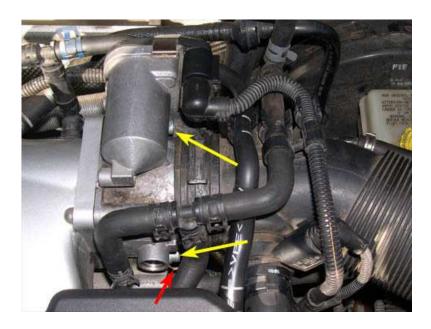
8. Using a 5mm hex/Allen wrench, remove the 4 long bolts that secure the TB to the intake manifold. There is one bolt at each corner of the TB, two of which are indicated by the yellow arrows in the picture below. Support the weight of the TB as you remove the last bolt. You wouldn't want the TB to fall - it is a delicate, high-precision device. Note that one of the bolts also secures a ground wire to the TB (indicated by red arrow in picture below). In my case, the ground wire was secured by the lower, front bolt, but a different bolt may be used in your car. Remember which bolt the wire was attached with so that it can be reinstalled in the same position.

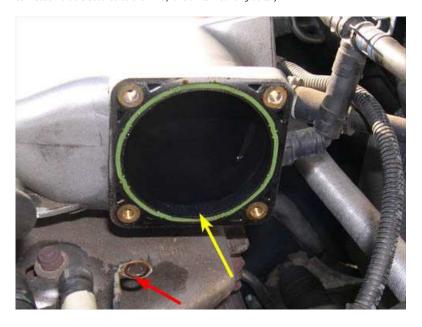
10. The yellow arrow in the picture below indicates the gasket that seals the rear of the TB to the intake manifold. Prior to reinstalling the TB (new or existing), either replace the gasket with a new one or decide to reuse the existing one. If you decide to reuse the existing gasket, make sure to clean it by wiping it with a rag or paper towel to remove any debris or contaminants that may be on the mating surface. (The red arrow in the picture below shows a better view of the ground connection that is secured to the TB by one of its mounting bolts.)

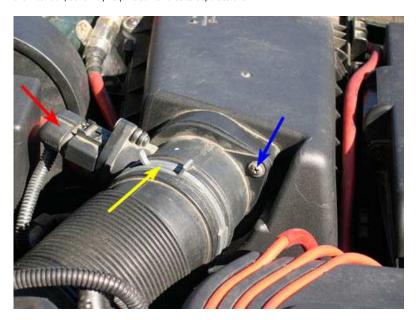
13. Release the tension from the clamp securing the main air intake tube to the MAF housing (indicated by yellow arrow in picture below) and then slide the intake tube off of the housing. If you're like me and are paranoid that anything you do under the hood can potentially harm the poorly-designed MKIV MAFs, you may also want to remove the MAF and put it in a safe place. It is not necessary to do this in order to remove the TB, but you never know with these MAFs. If you want to remove the MAF housing from the air filter box, disconnect the MAF harness connector (red arrow in picture below), remove the two Phillips screws that secure the MAF housing to the air filter box (one of the screws is indicated by the blue arrow) and GENTLY slide the housing out of the filter box. There is a large gasket sealing the two which snaps into the opening in the filter box, so it may require some force to separate them.

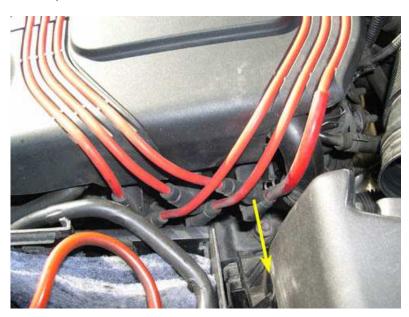
14. Carefully remove the spark plug wires from the ignition coilpack by pulling the rubber wire boots off of the posts on the coilpack, as shown in the picture below. This may be difficult due to the suction created by the seal between the boots and posts. I used a flat blade screw driver to carefully slide the boots off of the posts. (Be careful not to rip the boots if you do this or the engine may misfire when moisture is present.) I recommend that you mark each wire so that it is reinstalled on the correct post later on.

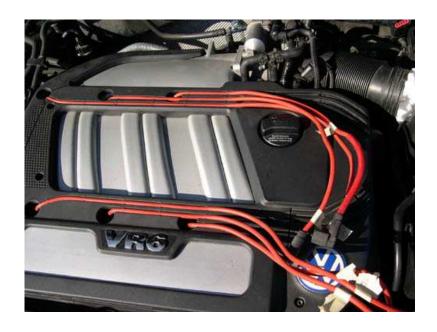
15. Unclip the spark plug wires from the channels in the engine cover, as shown below.

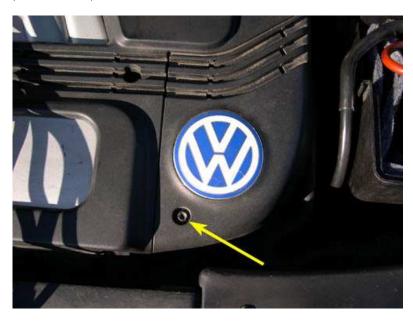
16. Remove the small engine cover piece with the VW logo on it by removing the single T30 Torx screw, indicated by the yellow arrow in the picture below.

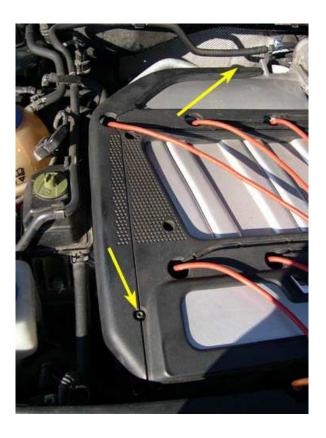
17. Remove the long, thin engine cover piece on the passenger's side of the engine by removing the two (2) T30 Torx screws indicated by the yellow arrows in the picture below.

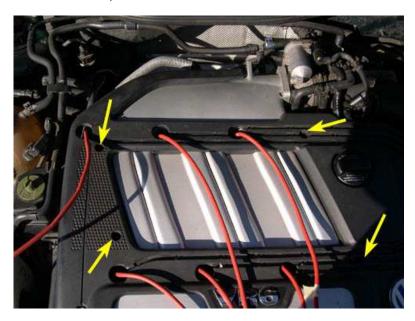
18. Remove the main engine cover piece by removing the four (4) T30 Torx screws indicated by the yellow arrows in the picture below. As you lift up on the cover piece, you will need to thread the spark plug wires through their respective holes in the cover in order to fully remove it.

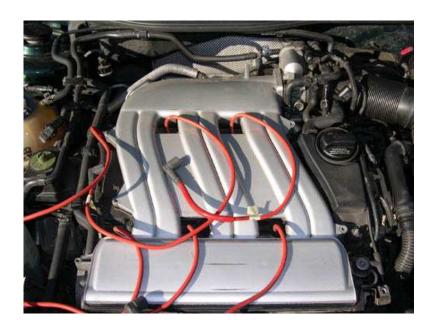
19. The picture below shows how the top of the engine should look with the three engine cover pieces removed.

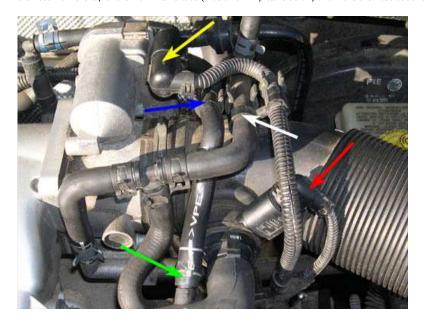
20. Disconnect the electrical harness connectors for the TB (yellow arrow in picture below) and PCV valve heater (red arrow in picture below). Next, unclip the TB harness connector lead from the top of the coolant hose which passes over top of the main air intake tube (white arrow in the picture below) and move the lead out of the way. Finally, disconnect the vacuum-assist hose (green arrow in picture below) from the PCV valve S-hose (between valve cover and main intake tube), unclip the hose from the top of the main intake tube (blue arrow in picture below) and move the hose out of the way.

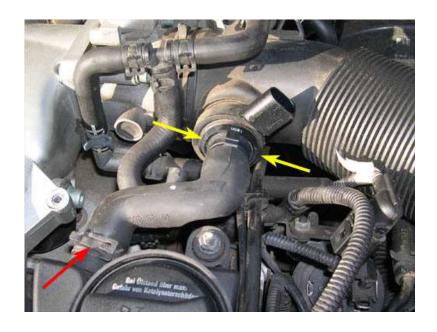
21. Disconnect the PCV S-hose from the PCV valve on the main intake tube by pushing the two serrated tabs together (yellow arrows in picture below) and carefully pulling the hose off. If you want to also clean the inside of the PCV S-hose (there WILL be oil in it), release the tension from the clamp on the other end of the S-hose (red arrow in picture below), slide the clamp up the hose a bit and then pull the hose off of its nipple. (Note the position of the bend in the S-hose relative to the bolt/nut just to the rear of the oil cap. There should be sufficient room between the hose and bolt so that the bolt does not cut into the hose. There is a depression on the underside of the hose at the bend to provide more clearance. Make sure to reinstall the hose in the same position later on so that abrasion does not occur.)

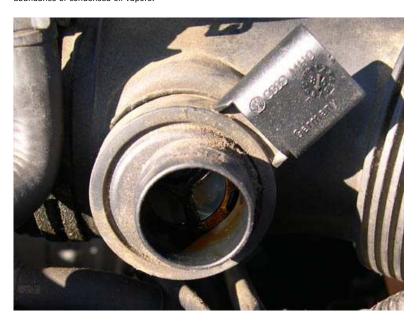
22. The picture below shows the inside of the PCV valve/heater on the main intake tube. If you look closely, you can see the abundance of condensed oil vapors.

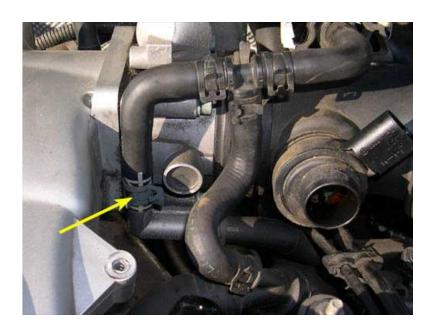
23. Disconnect the upper coolant hose (yellow arrow in picture below) from the TB. The nipple on the TB is approximately 1" long, so the clamp has to be moved up the hose at least that much in order to remove the hose from the nipple.

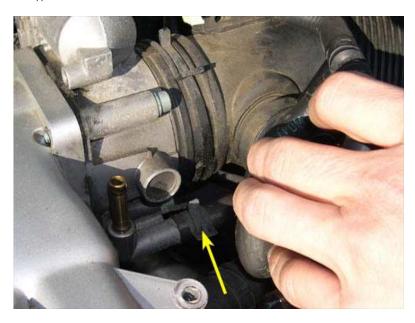
24. Disconnect the lower coolant hose (yellow arrow in picture below) from the TB. Again the nipple on the TB is approximately 1" long, so the clamp has to be moved down the hose at least that much in order to remove the hose from the nipple.

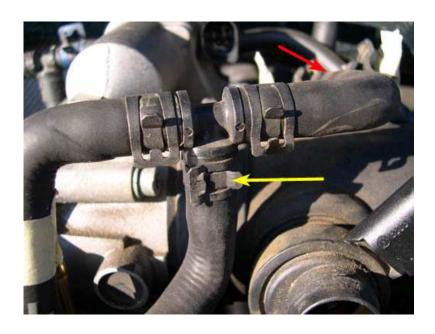
25. Disconnect the vertical coolant hose (yellow arrow in picture below) from the T-junction in front of the TB/main air intake tube. Next, unclip the horizontal portion of the coolant hose T-junction from the top of the main intake tube (red arrow in picture below) and then move the hose out of the way. At this point, there should be no coolant hoses attached to the TB, nor should there be any coolant hoses or electrical leads passing over the top of the main intake tube.

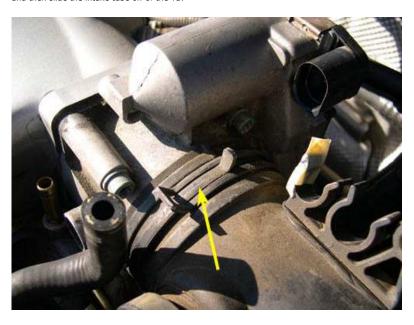
26. Release the tension from the clamp securing the main intake tube to the TB (indicated by yellow arrow in picture below) and then slide the intake tube off of the TB.

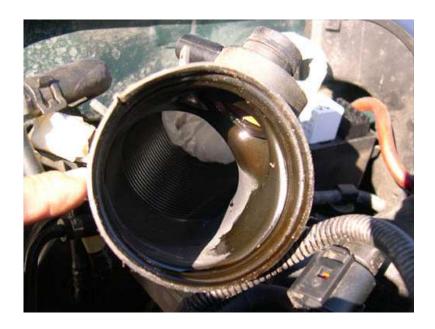
27. The picture below shows the large amount of condensed oil vapor in the main intake tube due to the PCV circuit. I wiped this oil off the inside of the tube with a paper towel. (I can only imagine how much oil is in the intake manifold and elsewhere in the engine. Someday I'll clean it all out.)

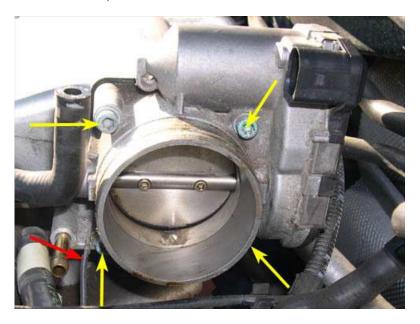
28. Using a 5mm hex/Allen wrench, remove the 4 long bolts that secure the TB to the intake manifold. There is one bolt at each corner of the TB, as indicated by the yellow arrows in the picture below. Support the weight of the TB as you remove the last bolt. You wouldn't want the TB to fall - it is a delicate, high-precision device. Note that one of the bolts also secures a ground wire to the TB (indicated by red arrow in picture below). In my case, the ground wire was secured by the lower, front bolt, but a different bolt may be used in your car. Remember which bolt the wire was attached with so that it can be reinstalled in the same position.

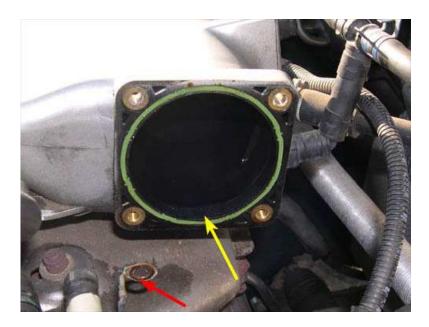
29. The yellow arrow in the picture below indicates the gasket that seals the rear of the TB to the intake manifold. Prior to reinstalling the TB (new or existing), either replace the gasket with a new one or decide to reuse the existing one. If you decide to reuse the existing gasket, make sure to clean it by wiping it with a rag or paper towel to remove any debris or contaminants that may be on the mating surface. I determined that the gasket in my car was in good enough shape to be reused, so that's what I did. No biggie. (The red arrow in the picture below shows a better view of the ground connection that is secured to the TB by one of its mounting bolts.)

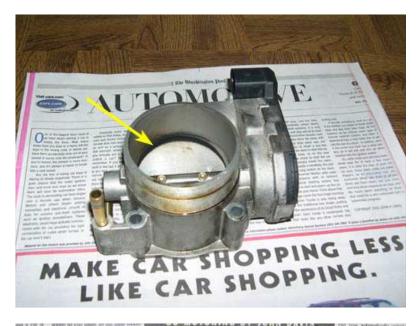
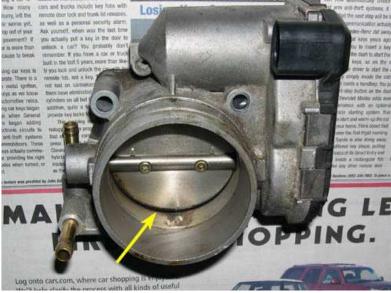
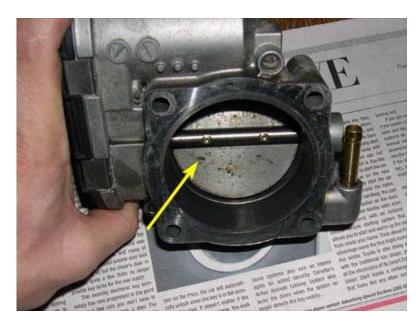
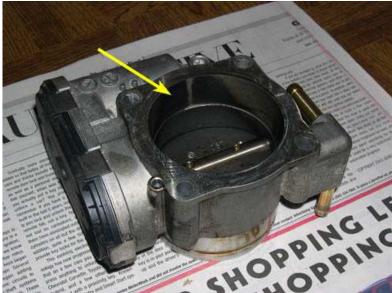
1. The four pictures below show different views of the inside of the throttle body. The yellow arrows in these pictures point to the oil, gum, varnish and other crap that deposits itself inside the TB over time. In my case, most of the deposits were located between the edge of the throttle valve and the TB wall (valve at idle position or fully closed) and on the roof of the TB wall behind the throttle valve.

2. To insure the proper operation of the TB, it is imperative that the deposits in the above pictures be removed. IMO, the most critical of these deposits are those which lie between the edge of the throttle valve and the TB wall. Normally there is a small 1-2mm gap between the edge of the valve and the wall. At idle, the valve remains fully closed and the air passing through this gap allows the engine to idle smoothly. As deposits build up in this gap, the amount of air that can pass through decreases and the ECM/DBW system must compensate by resetting the idle position of the valve from fully closed to open a few degrees or so. Naturally, as the amount of deposits increases, an increasing larger compensation must be made by the ECM. At some point, the ECM cannot compensate by opening up the valve any further and the following OBDII code is commonly stored:

5. To clean the TB, spray the TB cleaner onto the deposits inside the TB, allow it to soak in for a few seconds and then gently scrub away the deposits with the Q-tips and/or paper towels. Using this method, you should be able to remove all of the deposits EXCEPT for those between the edge of the throttle valve and TB wall. We'll get to those deposits shortly. First, here are some VERY important warnings.

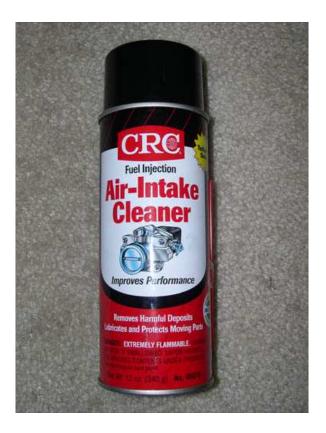
3. In order to safely clean the inside of the TB, you will need a can of intake/TB cleaner (the stuff I used is shown in the picture below - make sure to choose something that is relatively gentle and will not harm DBW TBs - some carb-type cleaners are not), something to gently scrub off the deposits on the throttle valve and on the TB wall (I used Q-tips and paper towels) and a sheet of ordinary white paper.

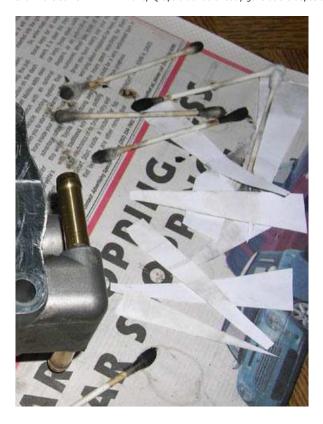
4. Cut the paper into thin, triangular pieces approximately 1" x 4" (size is not critical), as shown in the picture below. Also shown are some EXTREMELY dirty Q-tips that had already gone at the deposits in the TB by the time I took this picture.

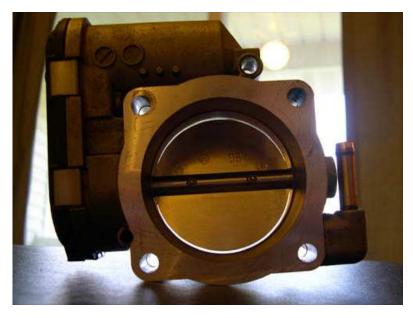
7. The picture below show how the gap between the edge of the throttle valve (in the fully closed position) and the TB wall should look once the deposits are removed from it.

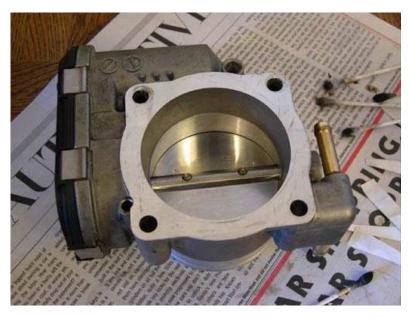
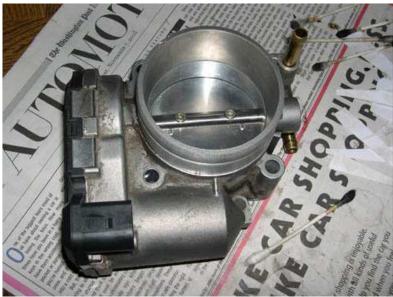
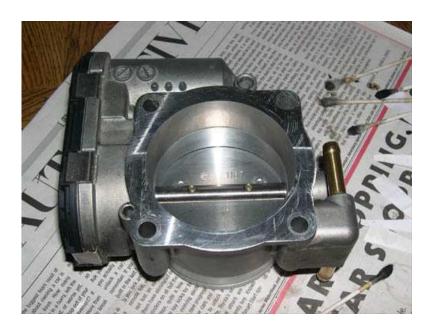
8. The pictures below show various views of the TB following the cleaning procedure. No big surprise that it looks much better than it did prior to the cleaning.

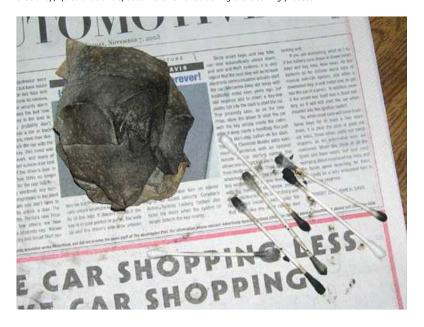
9. The pictures below of paper towels and Q-tips used during the cleaning procedure illustrate that while the TB did not look that dirty, quite a bit of deposits were removed during the cleaning process.

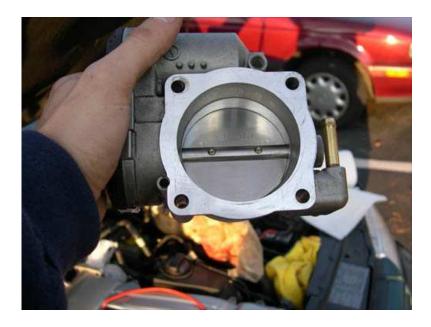
10. The picture below shows the cleaned TB ready to be reinstalled.
