Limp Mode Diagnosis Guide

This post is written in response to the number of times that TDI owners complain about "lack of power". It is a supplement to what is contained in the TDIFAQ troubleshooting section, specific to the A3 and B4 cars and is as thorough and systematic as possible, and it is linked to from the general "How-To" thread elsewhere on these forums.

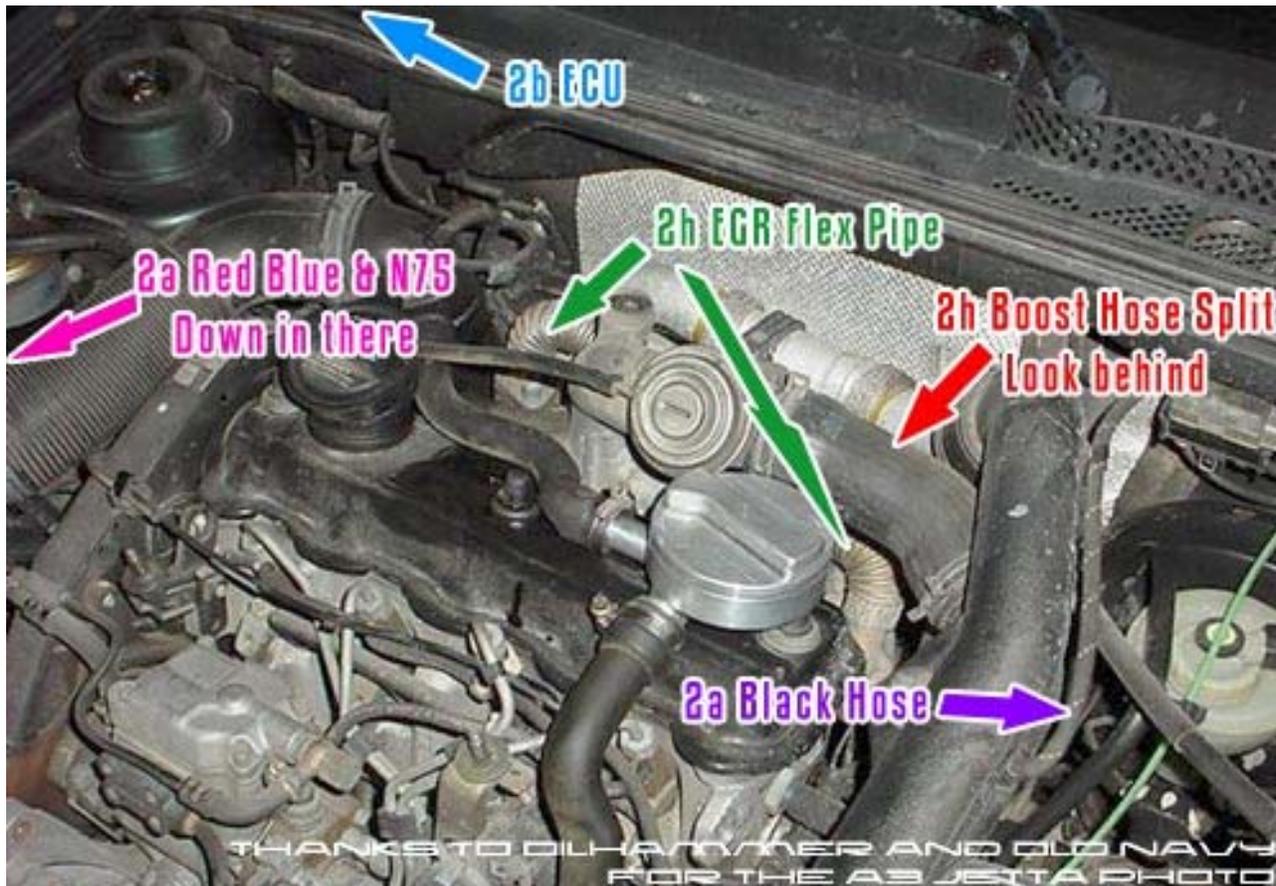
- a. Locate the "blue" and "red" hoses under the hood. Also locate the small diameter black hose at the center/rear of the engine compartment which connects to one of the black plastic intake pipes. If the latter black hose is not connected, there is your problem! If it IS connected, unplug it from the intake pipe and see if you can feel leaks by blowing into it by mouth. Leaks? There's your problem - replace it (or plug it in at the other end, if it has become disconnected at the ECU). No? How well does the hose fit on its connection point? If the rubber is hardened up and not sealing well, replace it. It is absolutely critical that there be no leaks anywhere in this hose or its connection points.

- f. It is also useful to compare readings from the "red" hose to the "black" hose at the intake pipe connection just before the intake manifold. They should give the same results. Otherwise, there is a leak in one of the control hoses. Find the leak and fix it, this will probably solve your problem.
