**ZF TRANSMISSION  
MODEL  
S5-42/S5-47/S5-47M**

**SERVICE MANUAL**

# SECTION 07-03B Transmission, Model S5-42 ZF

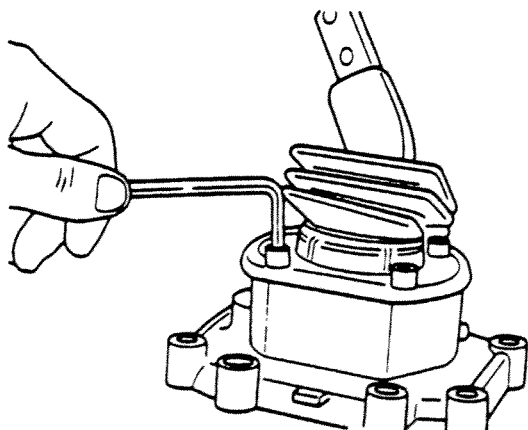
C8734-1A

Remove the four Allen-head capscrews from the shift control housing and remove the entire shifter assembly from the top of the transmission.

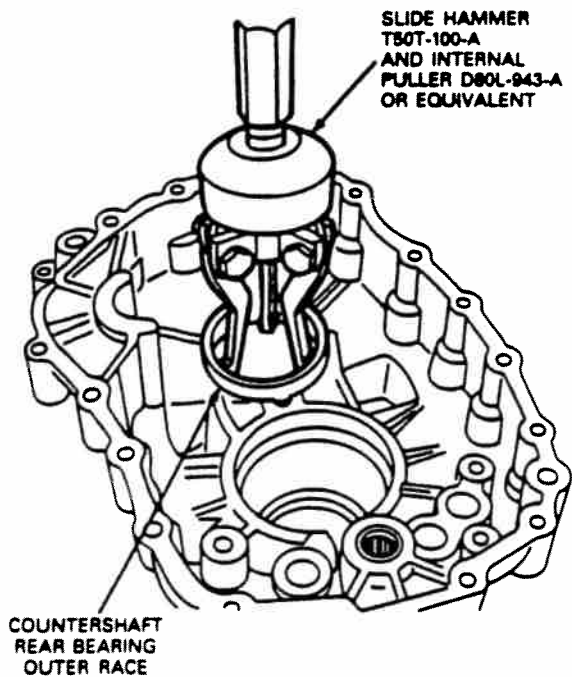
4. Using Impact Slide Hammer T50T-100-A and Bearing Cup Puller T77F-1102-A, remove the countershaft rear bearing outer race from the extension housing.

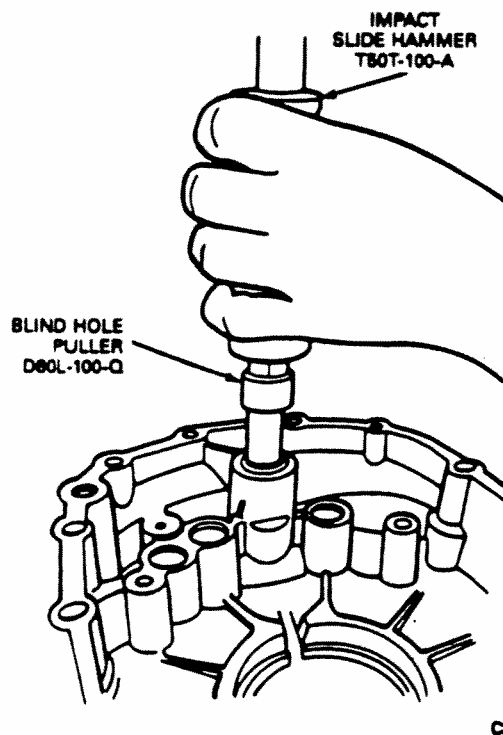
5. If required, remove the central shift rail bearing from the extension housing. Use Blind Hole Puller D80L-100-Q or equivalent and Impact Slide Hammer T50T-100-A to remove the bearing.

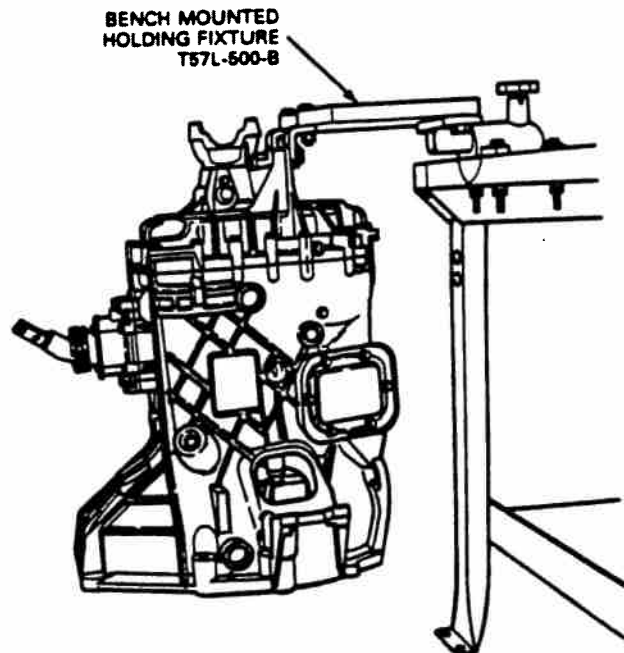
C8676-B

Attach the transmission (7003) to the Bench Mounted Holding Fixture T57L-500-B. Place the transmission in a vertical position with the case (7005) pointing downward.

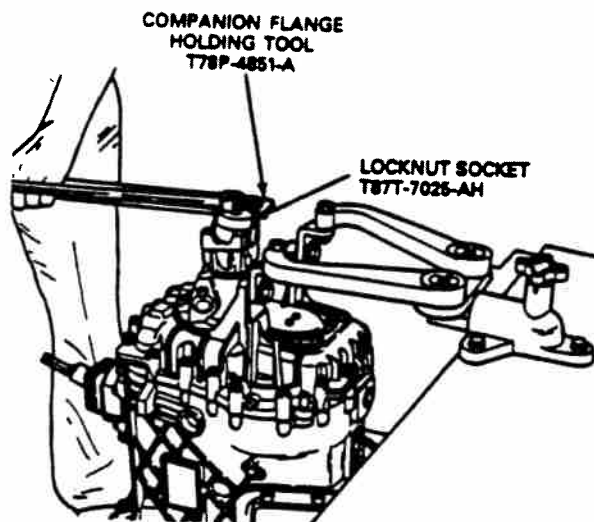
C8878-C

Loosen the spiral-lock yoke nut that holds the output flange to the mainshaft with Locknut Socket T87T-7025-AH. Remove the flange holding tool after loosening the nut.

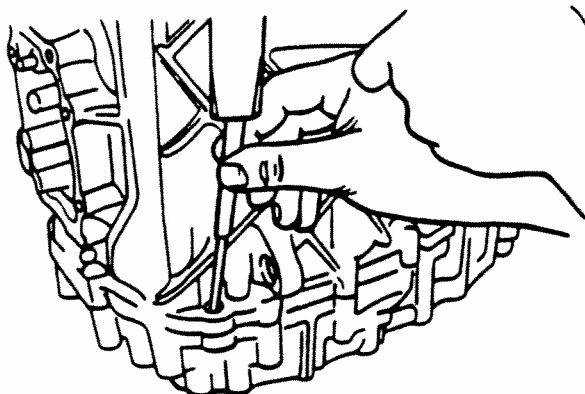
C8887-C

13. Remove the two remaining hex bolts from the extension housing.

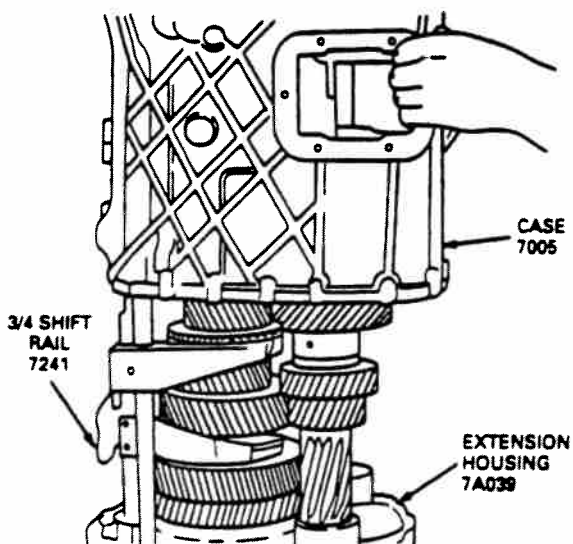
C8888-B

Carefully lift the case off of the extension housing. It may be necessary to push the main gear shift rail inwards to prevent it from "hanging up" on the case as it is being removed. Use care to make sure that the main gear shift rail is not lifted off together with the case. Refer to Case in this section for case disassembly and assembly procedures.

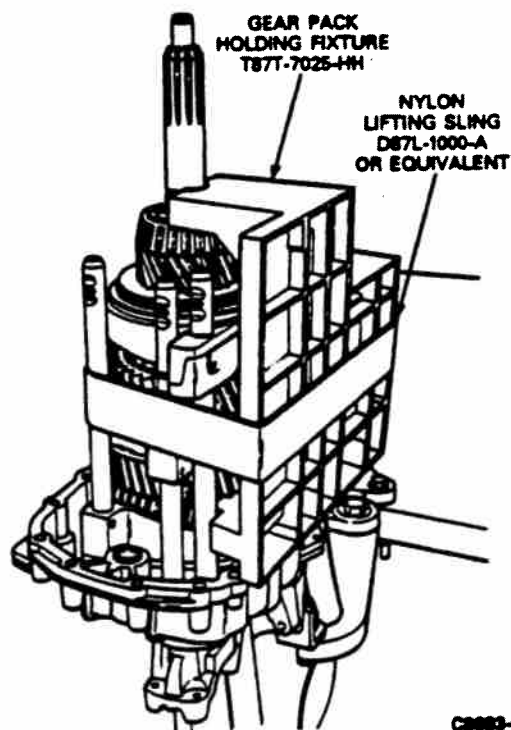
C9883-C

18. With the transmission in a vertical position, use Endless Lifting Sling D87L-1000-A or equivalent to strap Gear Pack Holding Fixture T87T-7025-HH to the mainshaft and countershaft cluster gear (7113). Pass the sling over the shift rails.

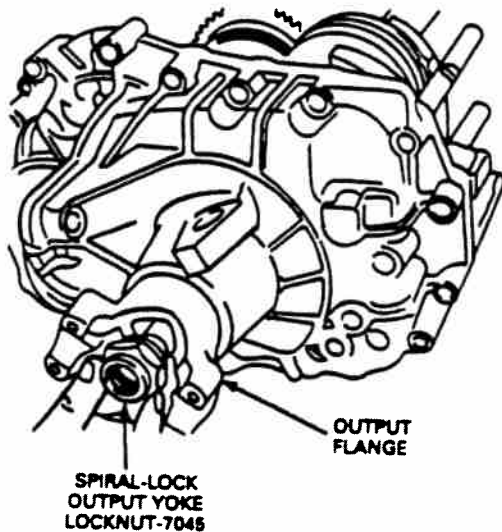
C9896-B

21. Remove the spiral-lock output yoke locknut from the mainshaft. Remove the flange from the mainshaft. If the mainshaft is difficult to remove, tap loose with a hammer.

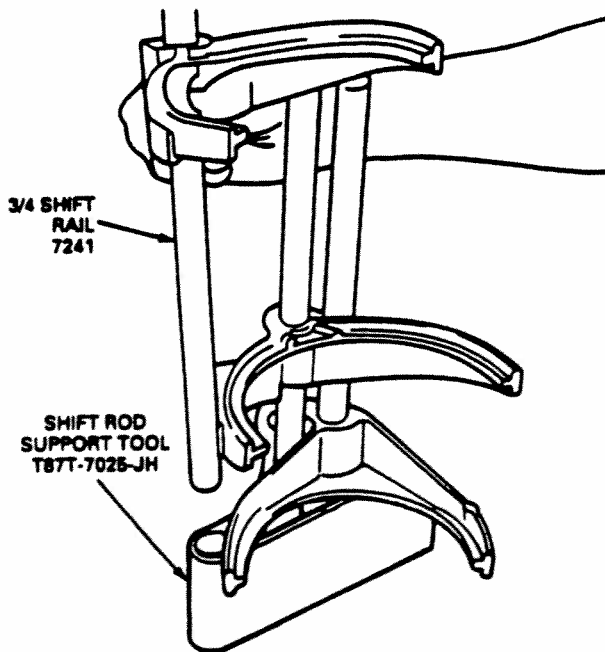
CS701-D

27. Mark each gear shifter fork (7230), shift rail, and position in the holding fixture to make reassembly easier. Lift the shift rails from the support tool. Refer to Shift Rails in this section for disassembly procedures.

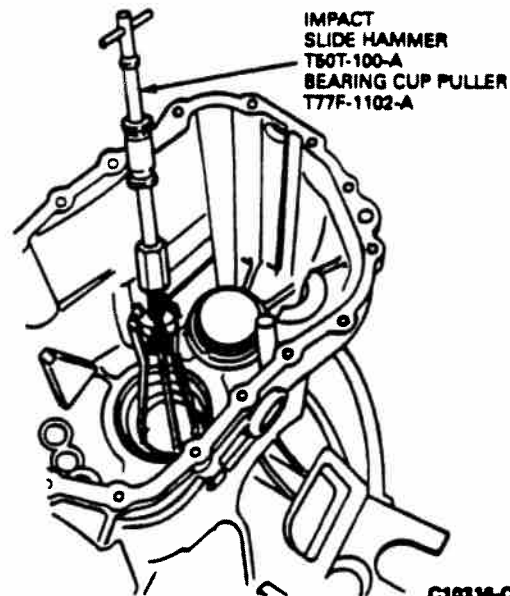
C10316-C

- NOTE: Case disassembly is required to enable reuse of smaller parts.  
Using Impact Slide Hammer T50T-100-A and Bearing Cup Puller T77F-1102-A, remove the input shaft bearing outer race from the case (7005).
- NOTE: The oil baffle will be destroyed when the race is removed. Discard the oil baffle and install a new one during assembly.  
Remove the oil baffle and input bearing front shims.

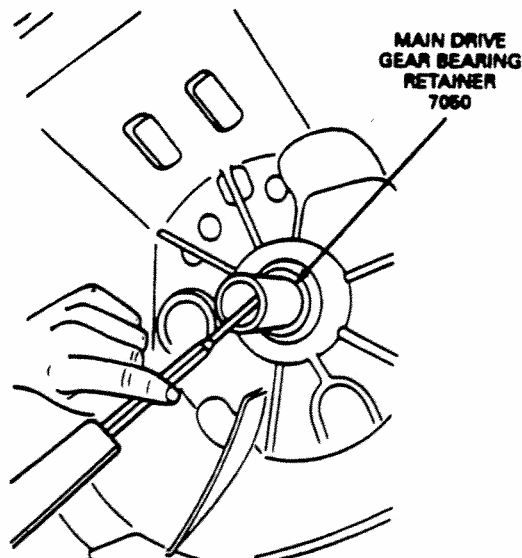
C8745-B

Using a punch, remove the oil seal from the base of the release bearing guide tube (7.3L and 7.5L housings only).

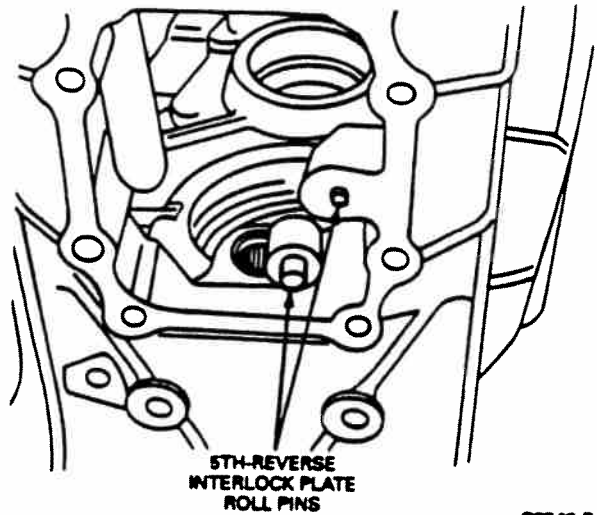
1. If they were removed, tap the 5th-reverse interlock plate roll pins into their bores in the case until the bigger one bottoms out (sticks out approximately 8mm (.315 inch); the small one sticks out 4-5mm (.158-.197 inch). Do not allow it to bottom out.

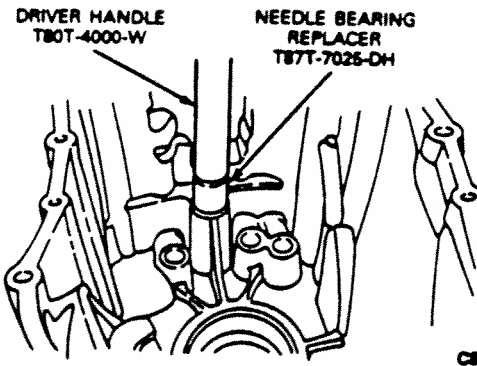
2. Heat the case in the area of the bearing bore of 5 / reverse shift rail to 160°C (320°F) with Rotunda Heat Gun 107-R0300 or equivalent. Drive the bearing sleeve in with Needle Bearing Replacer T87T-7025-DH and Driver Handle T80T-4000-W until it is flush with the surface of the bore.

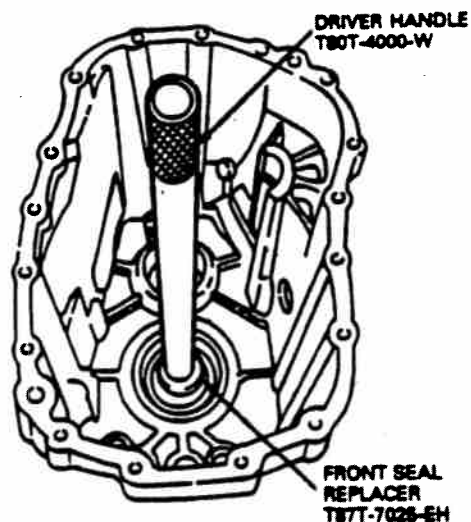
Position the oil seal in the case. Using Driver Handle T80T-4000-W and Front Seal Replacer T87T-7025-EH, drive in the oil seal until it seats against its stop.

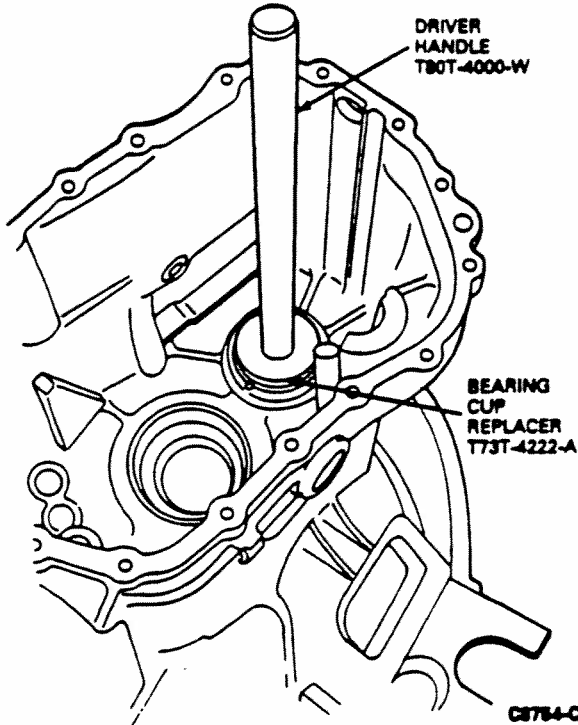
9. Position the input bearing front shim with proper thickness in the bore. Using Driver Handle T80T-4000-W and Bearing Cup Replacer T73T-4222-A, drive the output shaft bearing in until it seats against the stop in the case.

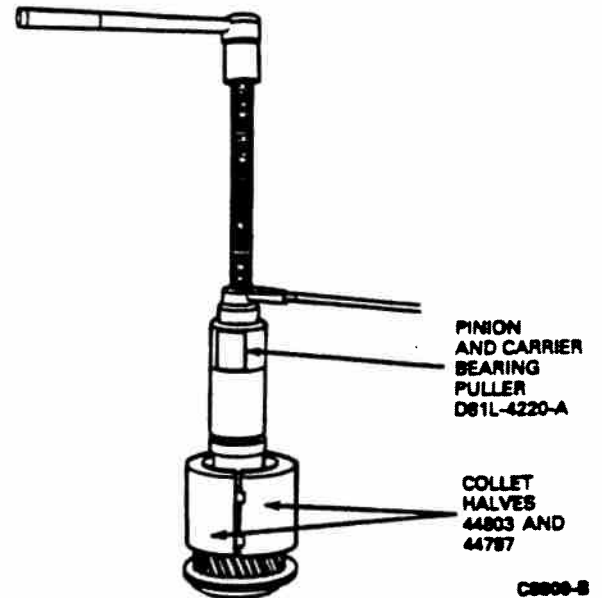
- Position the two Collet Halves (44803 and 44797) of the Pinion and Carrier Bearing Puller D81L-4220-A or equivalent around the bearing (7025). Install the Puller on the collet halves and pull the case bearing from the input shaft (7017).

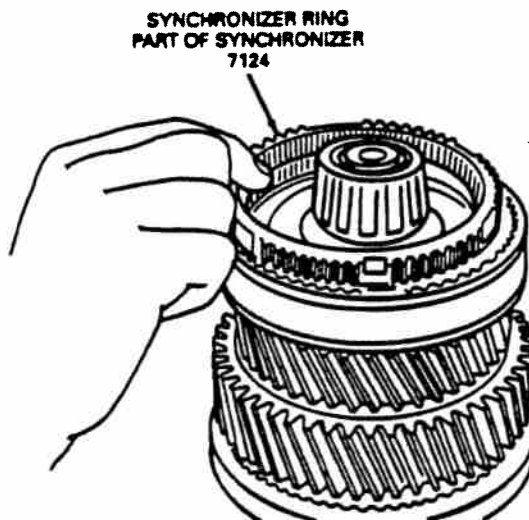
CS766-B

- NOTE:** Use brass pads or equivalent in vice jaws to prevent damage to mainshaft.  
Clamp the output end of the mainshaft firmly in a vise.
- Remove the synchronizer ring from the 3rd-4th synchronizer (7124).

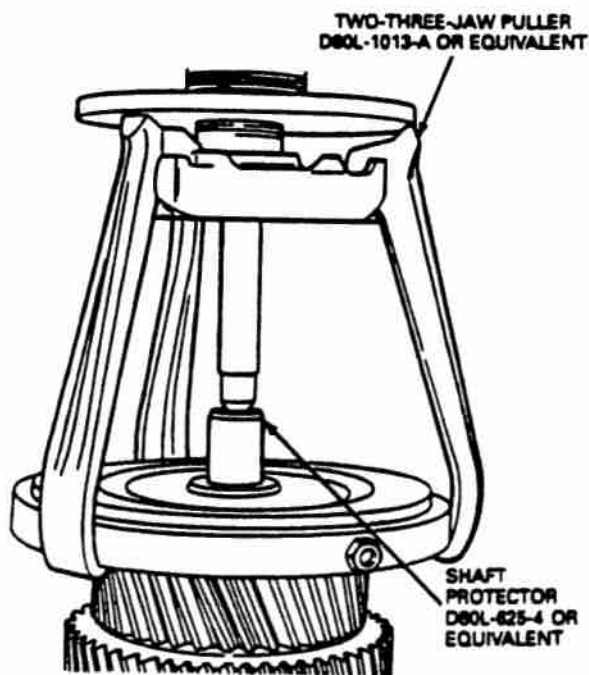
C8762-B

8. Place the Shaft Protector D80L-625-4 or equivalent on the end of the mainshaft. Place the Two-Three-Jaw Puller D80L-1013-A or equivalent on the assembled collet halves and retaining ring and pull the synchronizer from the mainshaft.

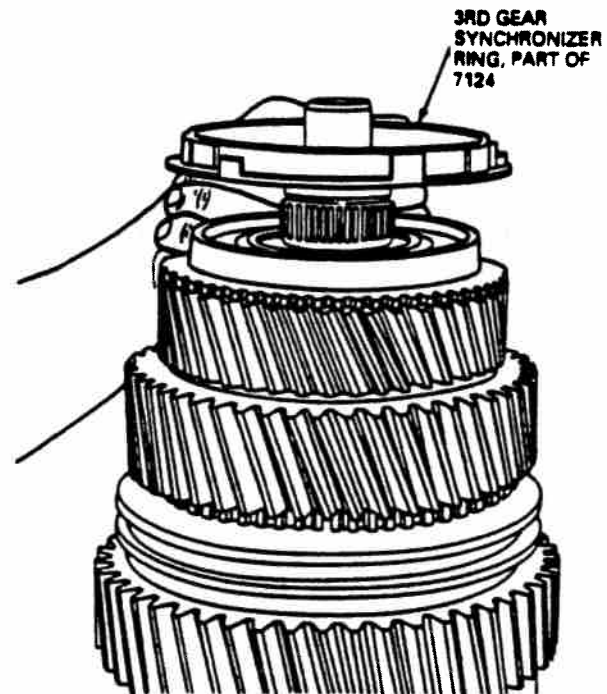
C8763-B

9. Remove the synchronizer ring (part of synchronizer) from the 3rd gear of mainshaft.

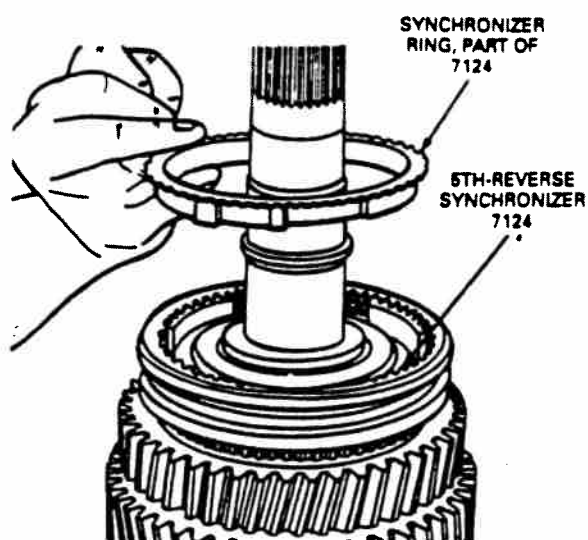
CS771-B

22. Remove the synchronizer ring (part of synchronizer) from the 5th-reverse synchronizer.

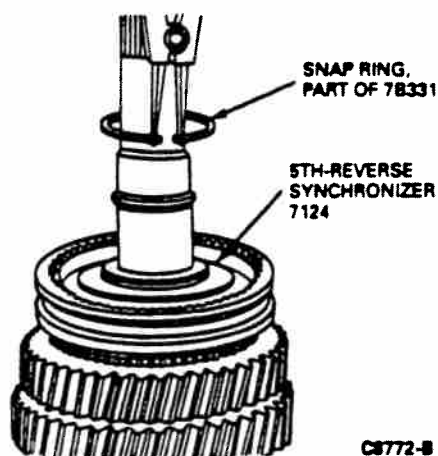
CS772-B

23. Remove the snap ring (part of small parts repair kit) retaining the 5th-reverse synchronizer to the mainshaft.

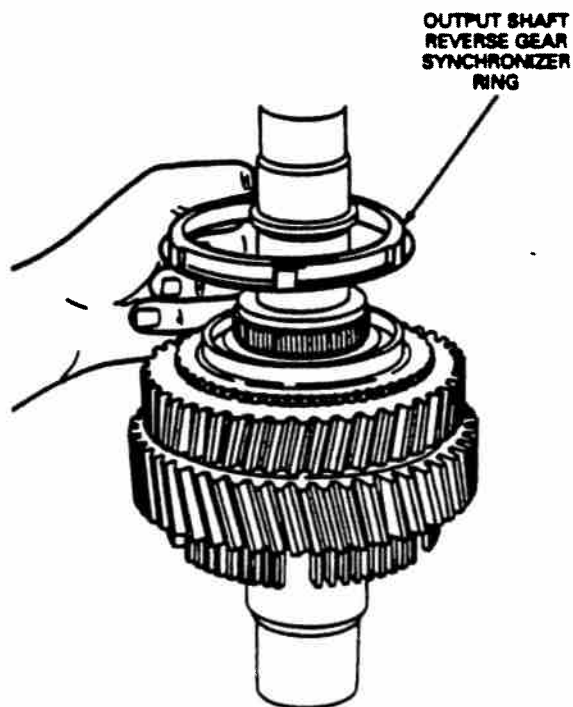
CS776-B

27. Remove the synchronizer ring (part of synchronizer) from the reverse idler gear and bushing (7141).

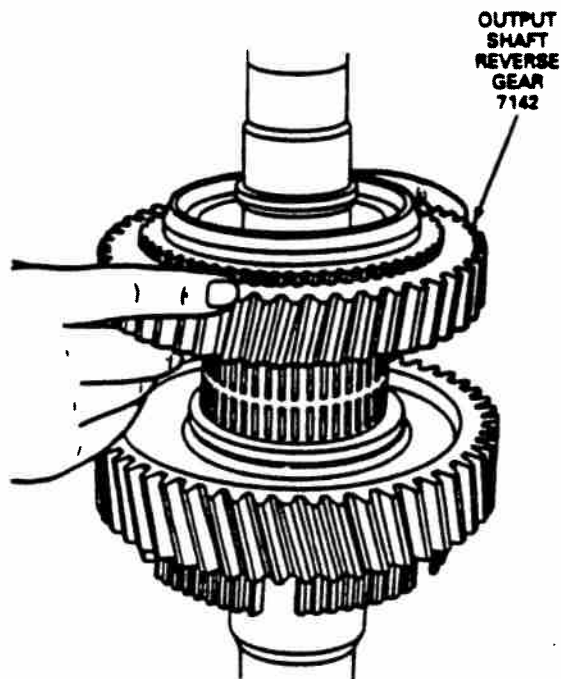
CS777-B

28. Remove the reverse idler gear and bushing from the mainshaft.

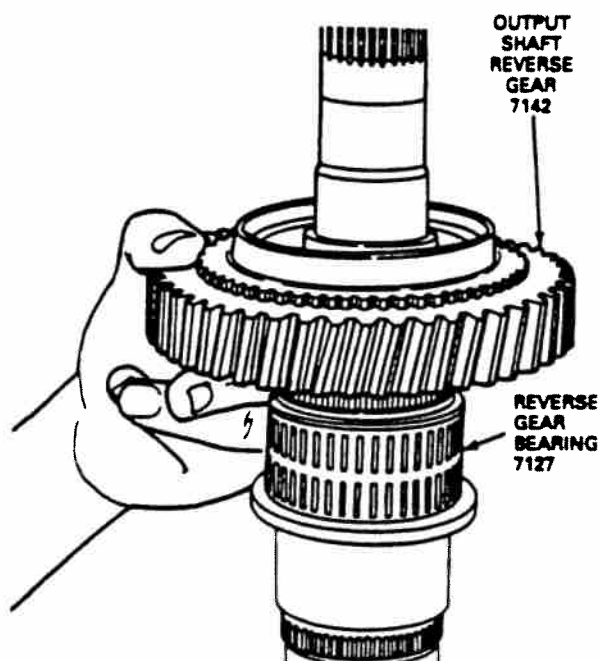
C8782-B

Place the reverse idler gear and bushing on the mainshaft over the reverse gear bearing. The clutching teeth on the reverse idler gear and bushing must face upwards.

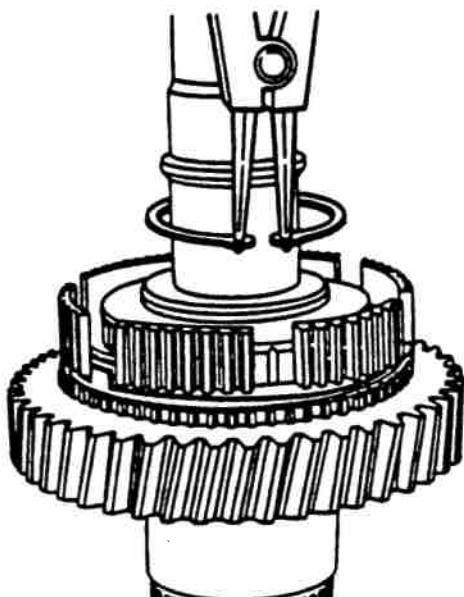
C8788-C

Install the snap ring (part of small parts repair kit) on the mainshaft next to the 5th-reverse synchronizer. The clearance between the snap ring (part of small parts repair kit) and the synchronizer should not be more than 0.1mm (0.004 inch) with zero clearance preferable.

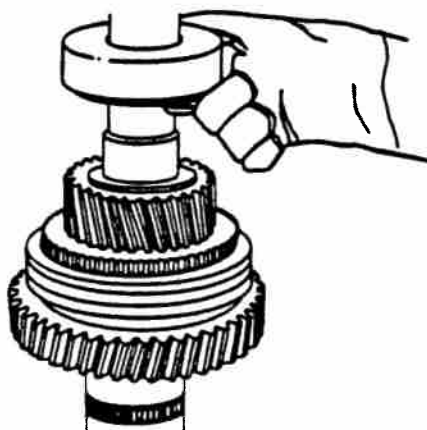
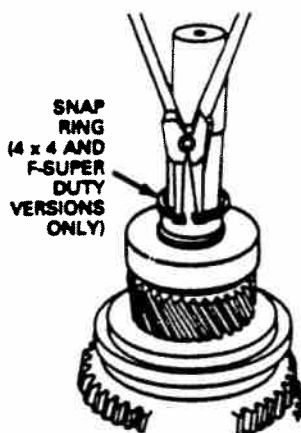
C8782-C

Check the end play of the 5th gear. End play must be 0.15-0.35mm (0.006-0.014 inch).

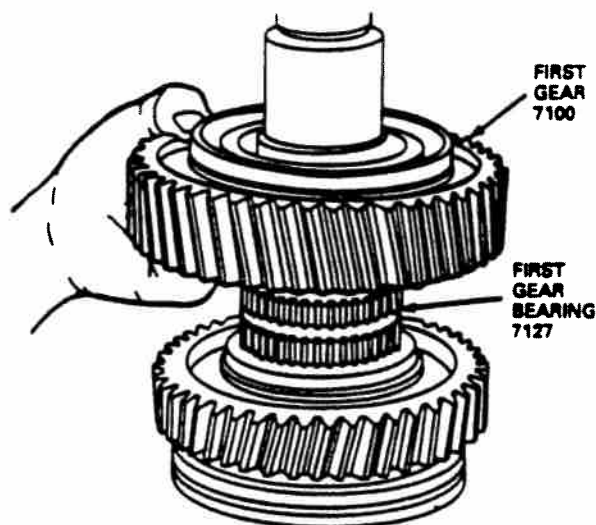
C8783-B

18. NOTE: Use brass pads or equivalent to prevent damage.  
Turn the mainshaft over and clamp it at the output end.
19. Place the gear bearing on mainshaft.
20. Place the first gear over the first gear bearing on the output and fifth gear drive shaft with the taper facing up.

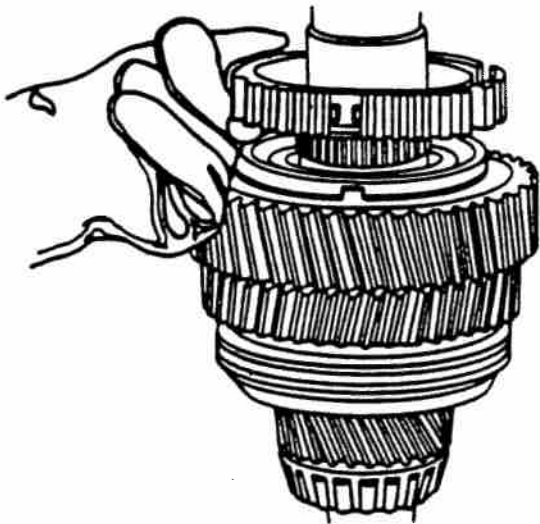
C8786-D

Heat the 1st-2nd synchronizer to 160°C (320 °F) with Rotunda Precision Metal Gear/Bearing Heater 130-00002 or equivalent. Position the synchronizer on the mainshaft so that the short lugs on the synchronizing ring (part of synchronizer) engage in the shallow gaps in the synchronizer. Lightly tap the synchronizer down until it stops against the synchronizer ring (part of synchronizer). When proper installation is made, the word "ENGINE" will be visible on the synchronizer.

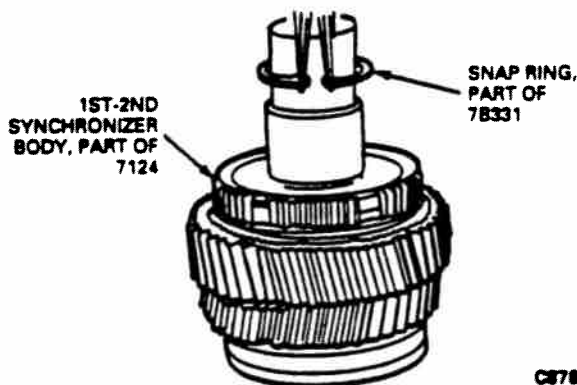
C8788-B

23. Install a new snap ring on the mainshaft next to the 1st-2nd (part of small parts repair kit). Clearance between the snap ring and the synchronizer should not be more than 0.1mm (0.004 inch).

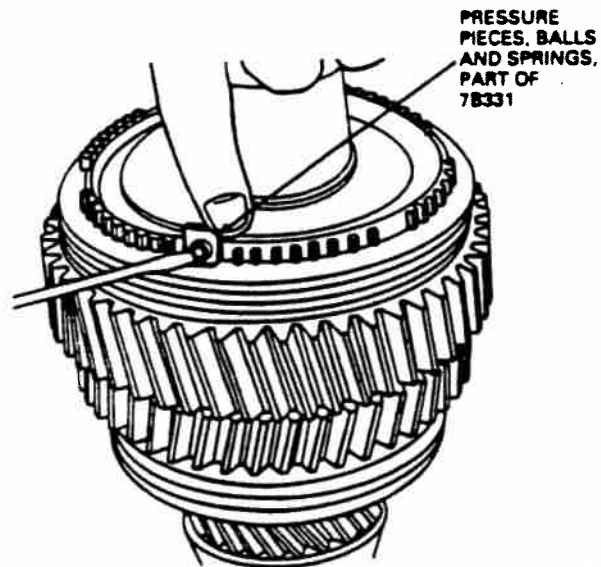
C8787-B

27. Raise the pressure pieces (part of small parts repair kit) slightly with a screwdriver. Push in the balls (part of small parts repair kit) with a screwdriver and slide the pressure piece so that it rests against the ball.

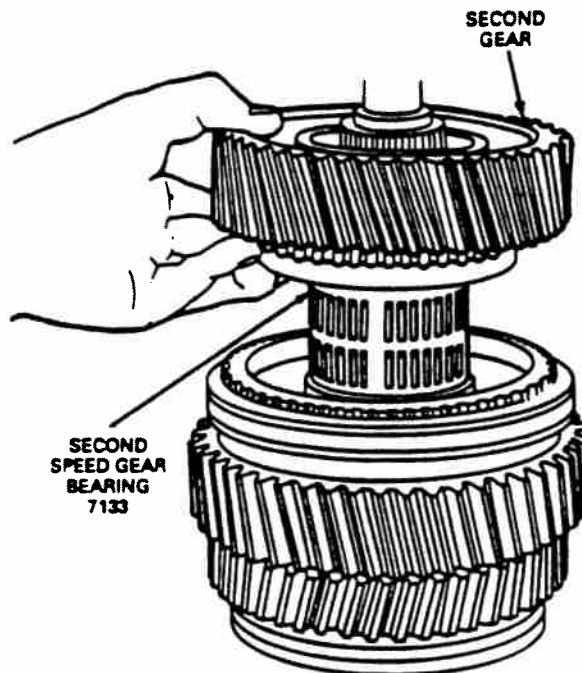
C8800-B

30. Place the second speed gear bearing on the mainshaft.
31. Place the 2nd gear over the second speed gear bearing on the mainshaft. The taper of the 2nd gear must face down on the mainshaft.

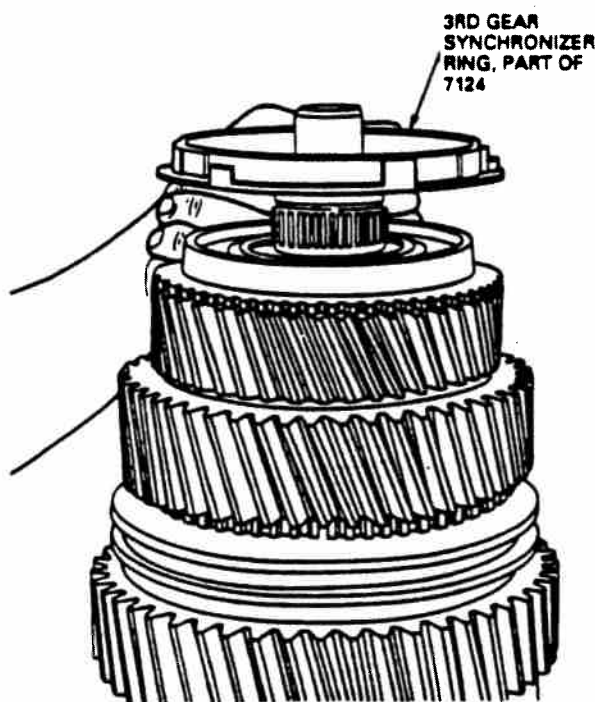
CS763-B

39. Place the 3rd gear synchronizer ring (part of synchronizer) on the taper of the 3rd gear.

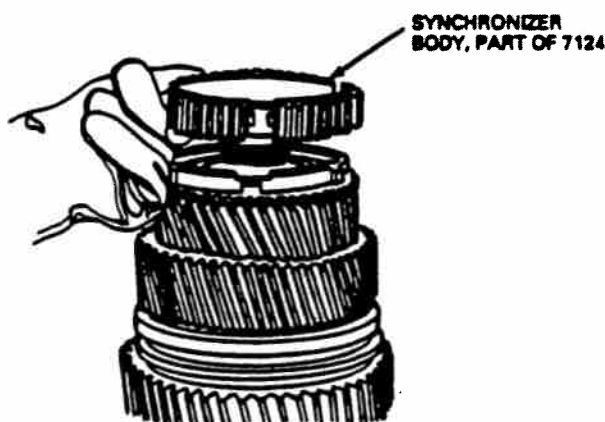
CS993-D

Heat the 3rd-4th synchronizer with Rotunda Precision Metal Gear/Bearing Heater 130-00002 or equivalent to a maximum 160°C (320°F). Position the synchronizer on the mainshaft so that the short lugs on the synchronizer ring (part of synchronizer) engage in the shallow gaps in the synchronizer. Lightly tap the synchronizer down until it stops against the synchronizer ring (part of synchronizer). The recess in the synchronizer must face upwards.

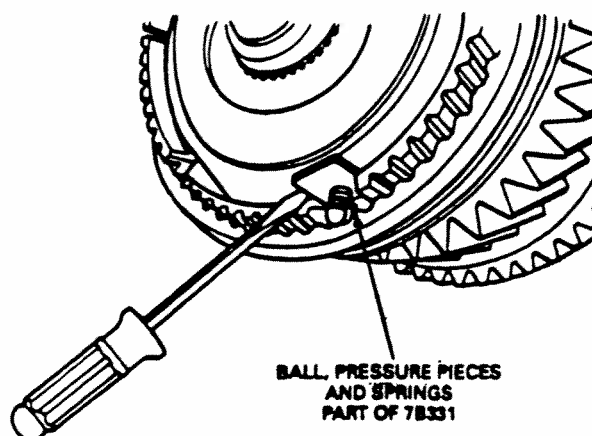
C8805-B

45. Raise the pressure pieces (part of small parts repair kit) slightly with a screwdriver. Push in the balls (part of small parts repair kit) with a screwdriver and slide the pressure piece so that it rests against the ball.

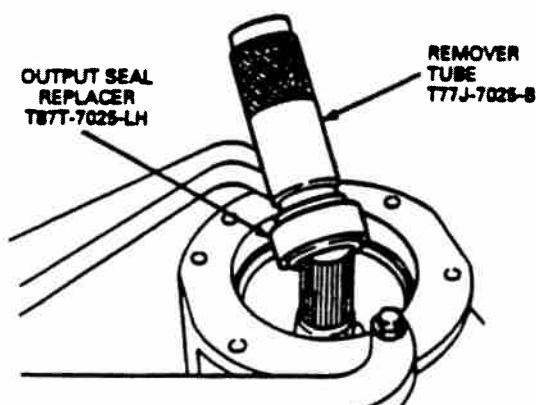
4 x 4 AND F-SUPER DUTY TRANSMISSION  
REAR OIL SEAL INSTALLATION

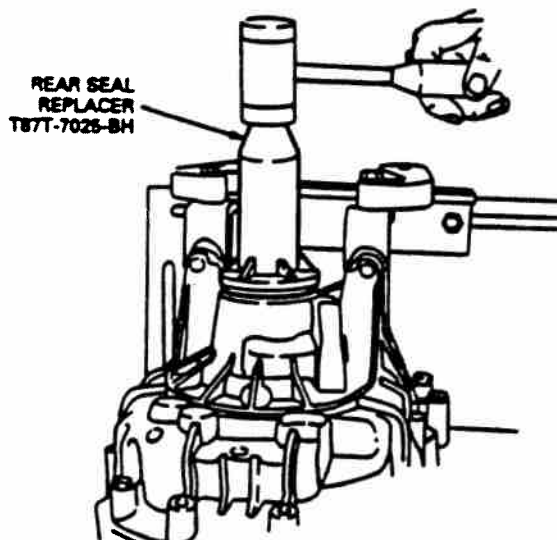
4 x 2 TRANSMISSION REAR OIL SEAL  
INSTALLATION  
(EXCEPT F-SUPER DUTY)
